**MANITOBA METIS FEDERATION – MATRIX
SOLUTIONS INC. PARTNERSHIP**

INDIGENOUS CONSTRUCTION MONITORING

WEEKLY REPORT

SPREAD 7

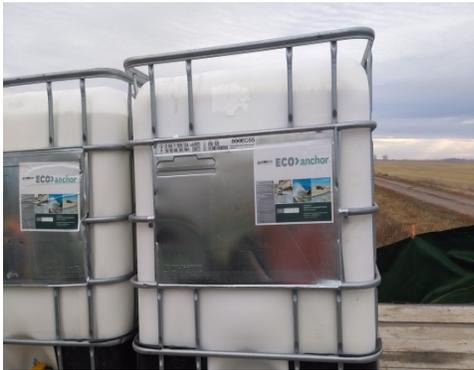
RD#2(SSKP 809+300)

This is product they use to spray
the topsoil to keep it from blowing away
Photo taken facing east

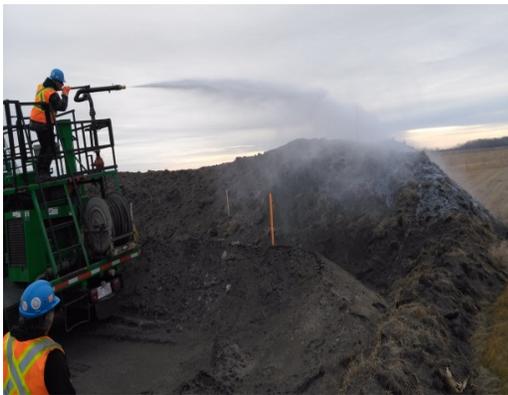
RD#2 (SSKP 809+300)

Banister spraying the topsoil with the product call
synthetic copolymer dispersion. Photo taken
facing east

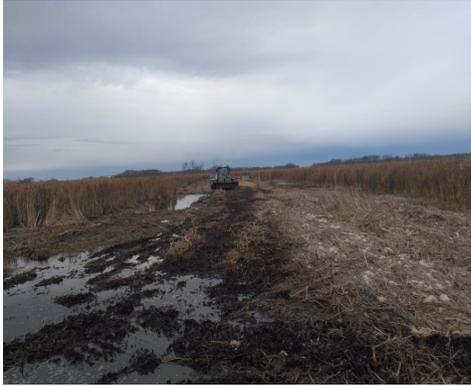
RD#28 (SSKP 847+900)

Banister tramping down the cattails there using a snow cat. Photo taken facing west

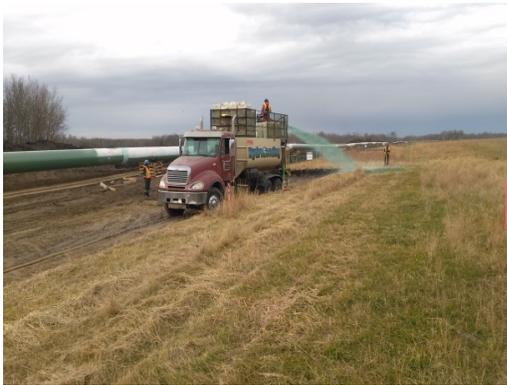
RD#28(SSKP 847+900)

Banister spraying mulch they use this as a barrier on the buffer. Photo taken facing west

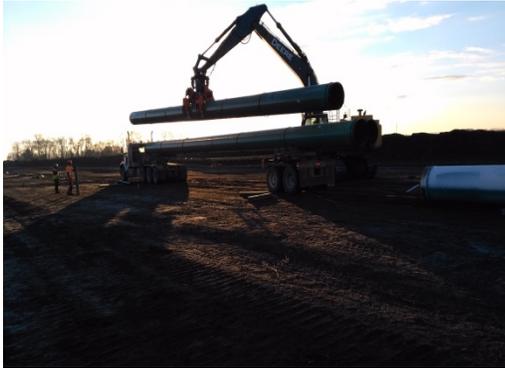
RD#3 (SSKP 811+300)

This is the stringing crew at sf 3. Photo taken facing south

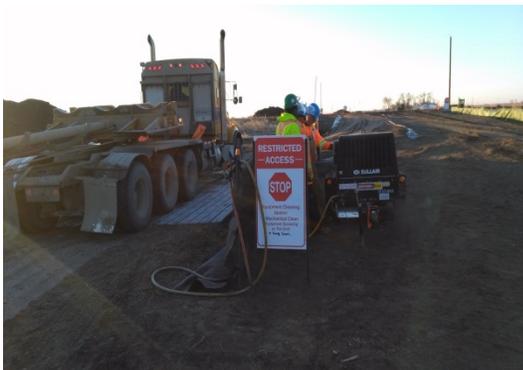
RD#3 (SSKP 811+300)

This is the cleaning station where all equipment got to get clean and bleach sf3 before leaving this area. Photo taken facing south

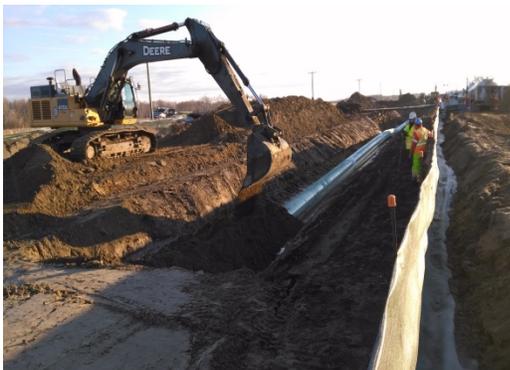
RD#13 (SSKP 820+654)

Banister backfill crew. Photo taken facing east

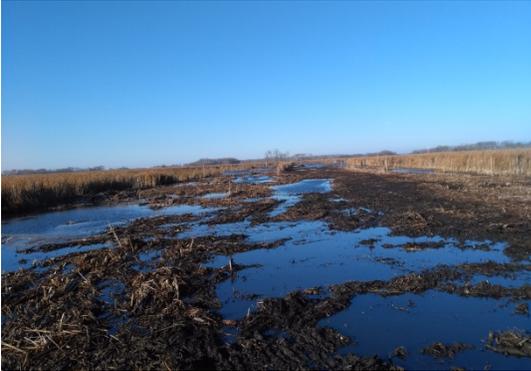
RD#28 (SSKP 841+300)

This is the area where banister tramping the cattails. Photo taken facing west

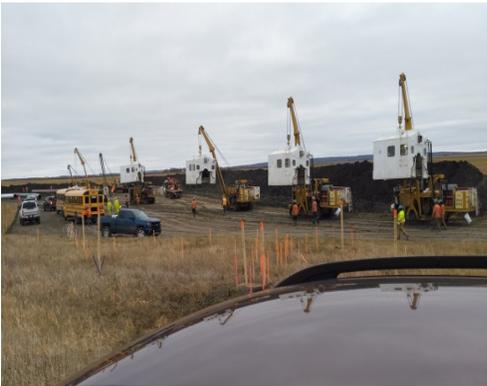
RD#62(SSKP 903+400)

This is the main welding crew They are moving towards sf 63. Photo taken facing south

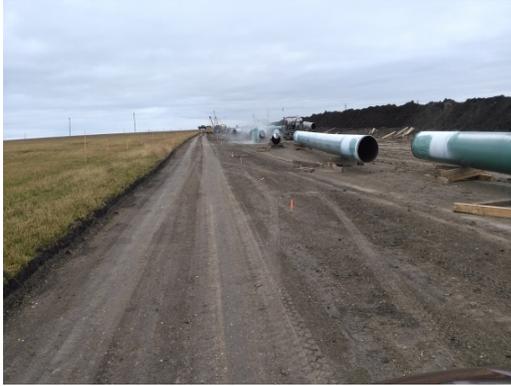
RD#62 (SSKP 904+100)

This is the sandblasting crew. The crew is moving east site is very clean. Photo taken facing east.

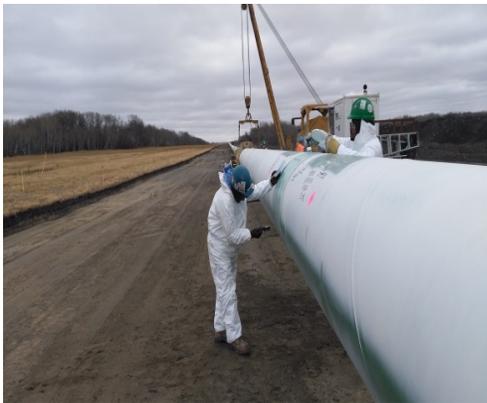
RD#37 (SSKP 903+100)

Banister coating crew. The crew comes behind after they jeep the pipe and coat the defects. Photo taken facing east

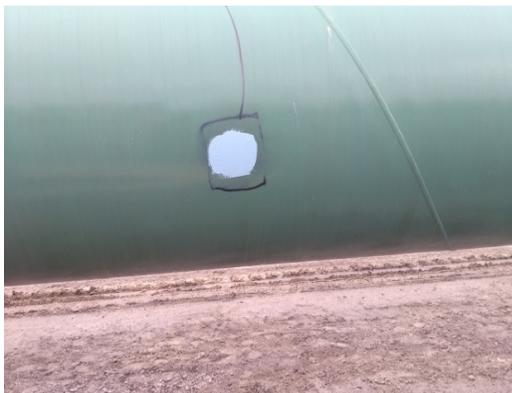
RD#37 (SSKP 903+100)

This is the reason why the pipe is jeeped. Coating crew comes and repairs the defect area with epoxy. Photo taken facing south

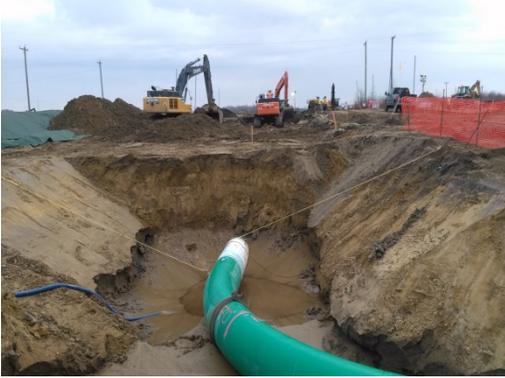
Traditional Land Use : 1 Trenching crew digging up heritage site HER-156 Archeologists present SSKP 842+000; RD#14 (SSKP 821+100) Banister is prepping the site to get the tie-in to the bore pipe ready. They have to cut the road open so they could get this bore pipe installed. They have sign set up stating the road is close and they also have flaggers on site; RD#16 (SSKP 823+400) Monitor banister backfilling the pipe at SF 16. The type of material they're using for backfilling is the sand that was dug up to make the ditch. This site is very well organize and clean; RD#28 (SSKP 842+000) Monitor banister trenching east of sf 28. The crew is lowering the pipe into the ditch. Banister is also putting down geo-tech for extra protection so the subsoil doesn't get mixed with the topsoil. Banister is doing a very good job of working around the archeology site east of sf 28. This site is also very organize and clean; Work forecast; Go back and monitor the ROW tomorrow.

This is the site where they cut the road open to install the bore pipe this site is very well identified with signage. Photo taken facing east

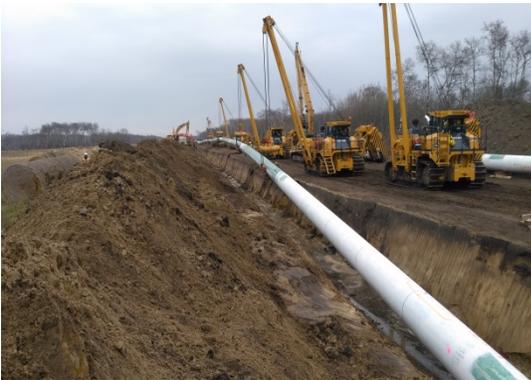
RD#28 (SSKP 842+000)

This is banister lowering end crew the crew is doing a good job of working by the archeology site. Photo taken facing east

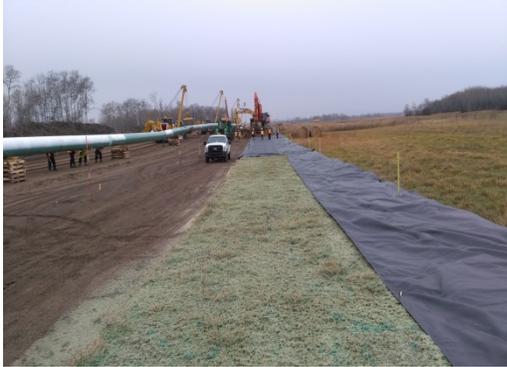
RD#28 (SSKP 842+000)

Banister taking extra precautions by laying down geo-tech so the subsoil don't get mix with the topsoil. Photo taken facing west

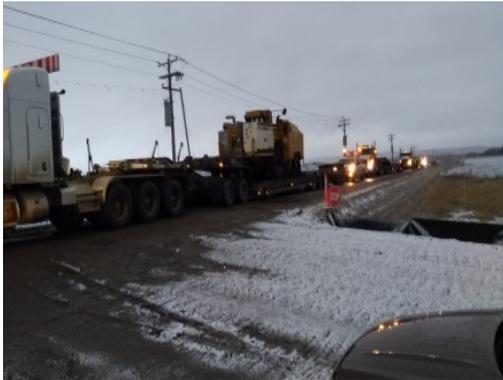
RD#63 (SSKP 904 +400)

Banister de-mobilizing and loading the equipment at RD#63. Photo taken facing south

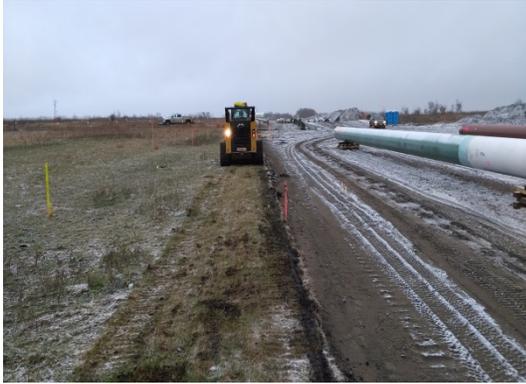
RD#38 (SSKP 863 +300)

Banister mowing the buffer to prepare for mulch to be applied. Photo taken facing east

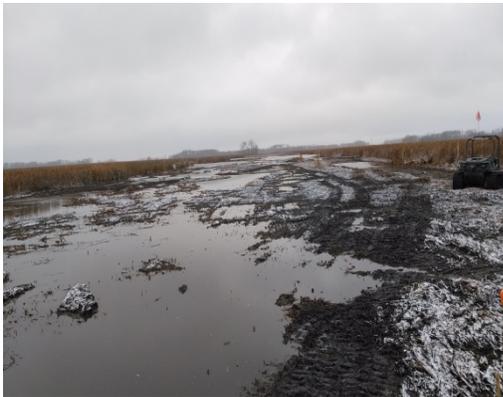
RD#28 (SSKP 841 +300)

Banister tramping down the cattails they have complete this wetland area. Photo taken facing west

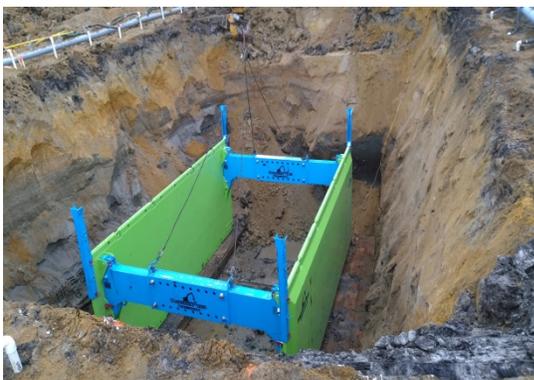
RD#1 (SSKP 808+568)

Banister prepping the ditch with a trench box This site is where the de-watering station RD#1. Photo taken facing north

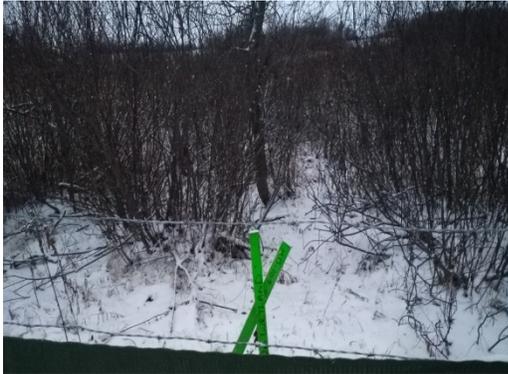
RD#51 (SSKP 885.89 +885.95)

This area is a wetland area MB-107. Photo taken facing south

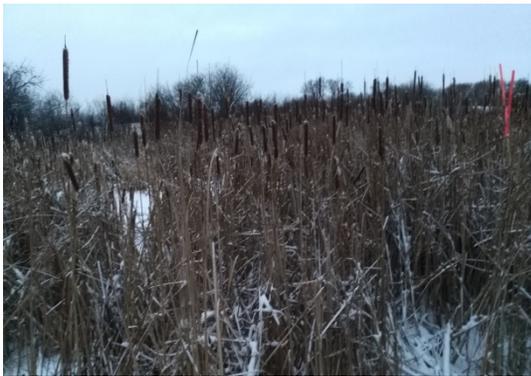
RD#51 (SSKP 885.89 +885.95)

Wetland crossing MB-107 Seasonal marsh (class 3) Rare plant observed at this area.

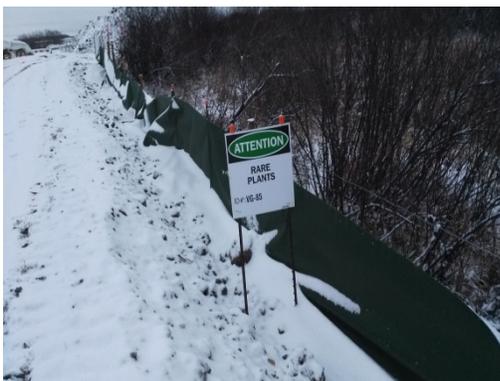
RD#51 (SSKP 885.89 +885.95)

Field Observation	# of occurrences	Description and Mitigation Measures	Mitigation Status	Further Action Required (Yes/No)
Medicinal or Cultural Plants	N/A	November 3, 2018; Rare plant area VG-85 Crystalwart (<i>Riccia fluitans</i>) there was approximately 2000-5000 thalli observed by 30m area during the 2914 supplemental vegetation surveys; Rare plant

Rare plant area VG-85 Crystalwort (*Riccia fluitans*). Photo taken facing east

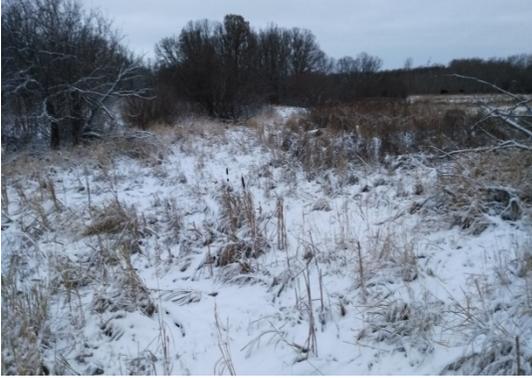
RD#51 (SSKP 885.65 +885.70)

This is a wetland crossing Seasonal marsh
(class 3). Photo taken facing south
