**MANITOBA METIS FEDERATION – MATRIX
SOLUTIONS INC. PARTNERSHIP**

INDIGENOUS CONSTRUCTION MONITORING

WEEKLY REPORT

SPREAD 7

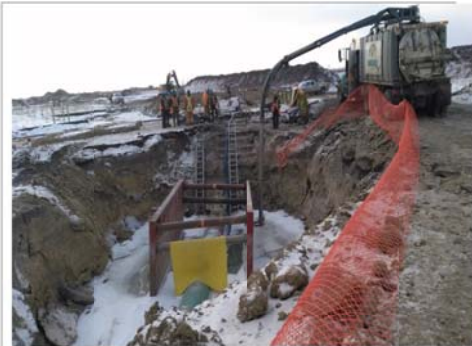
RD#17 (SSKP 824 +900)

Hydro vac is on site sucking up the mud
prepping the site for the pipe to be
re-scanned and coated
Photo taken facing south

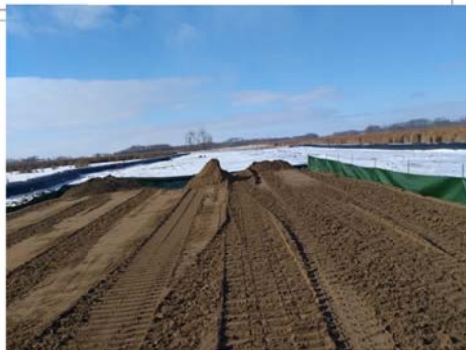
RD#28 (SSKP 841 +300)

Aqua Dam area
Wetland area MB-054
semi permanent marsh (class 4)
Photo taken facing west

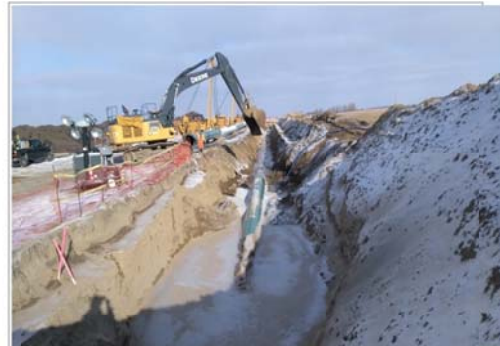
RD#21 (SSKP 827 +600)

Banister prepping the trench for a tie-in
The pipe got to be jeep before they lower
the pipe in the trench so there no defects
Photo taken facing north

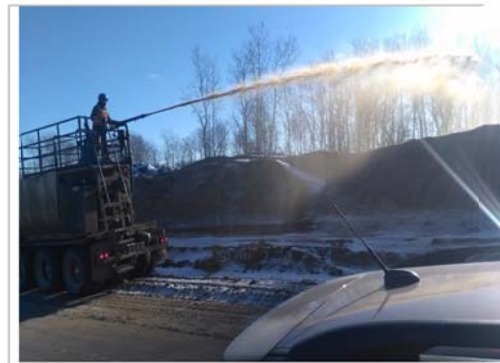
RD#28 (SSKP 843.75 to 843.91)

Banister applying beet juice and tree
sap
on top of the topsoil to keep it from
blowing

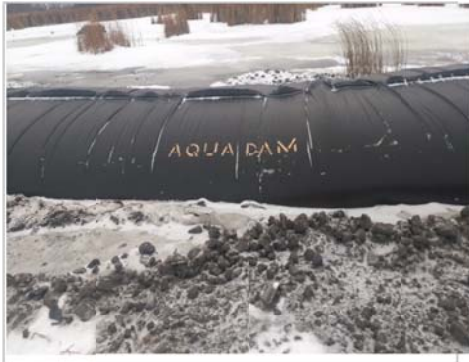
RD#27 (SSKP 839 +580)

| | | Nov 20, 2018: Wetlands: 1 (SSKP 839+580) Monitor banister at the aqua dam. This area is a wetland area MB-053 ephemeral/temporary marsh (class 1/ class 2) wetland complex. | Further mitigation required | |

Aqua Dam sf 27
Wetland area MB-053 ephemeral/temporary
marsh (class 1 /class 2)
Photo taken facing south

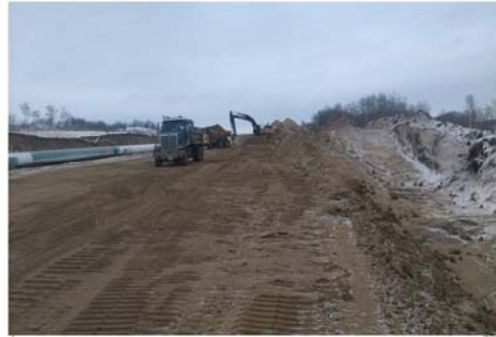
RD#28 (SSKP 843 +300)

This is area where banister hauling
sand
material for the aqua dam sf 28 west
Photo taken facing east

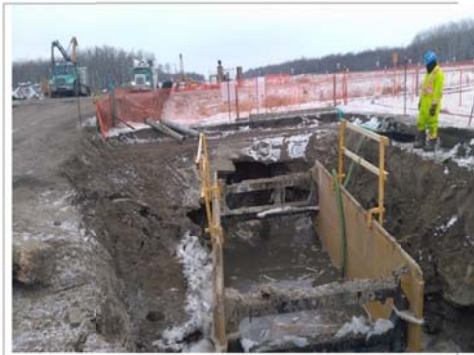
RD#38 (SSKP 863 +300)

Heritage Resource Feature ID# 160
Banister has completed the reaming
prepping the site for the bore pull
Photo taken facing west

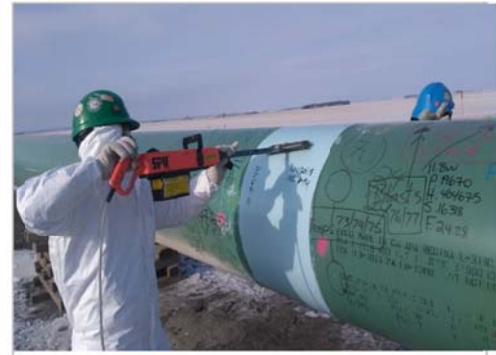
RD#60 (SSKP 900 +300)

Banister coating crew at sf 60
After the coating is applied they have to
use
a jeeper to make sure there no defects on

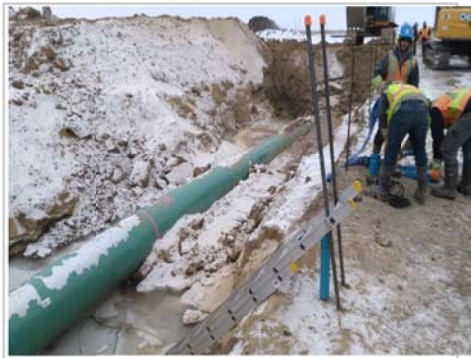
RD#21 (SSKP 827 + 600)

Banister cleaning out the trench so they
could start doing the backing filling
Photo taken facing south

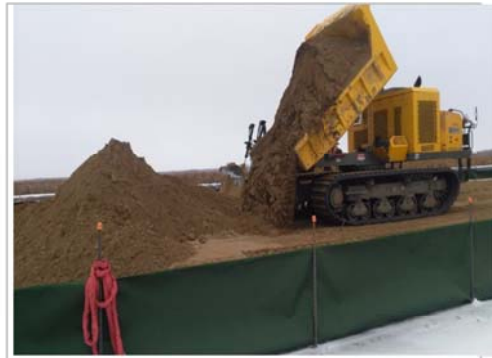
RD#28 (SSKP 843 +500)

Banister hauling ramp material
MB-054 semi permanent marsh (class 4)
Photo taken facing north

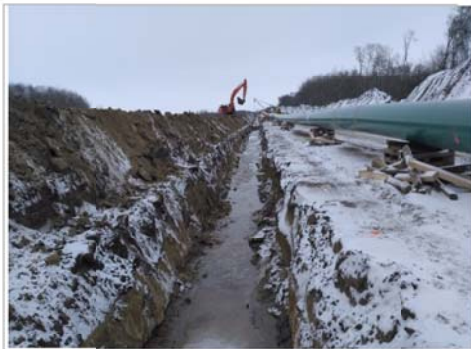
RD#33 (SSKP 856+100)

Banister prepping the trench at sf 33
pumping water to lower in the pipe
Photo taken facing east

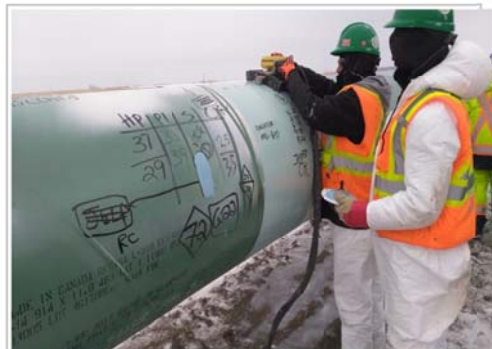
RD#48 (SSKP 881 +800)

Mainline coating crew
They repair any defects on the pipe
Photo taken facing north

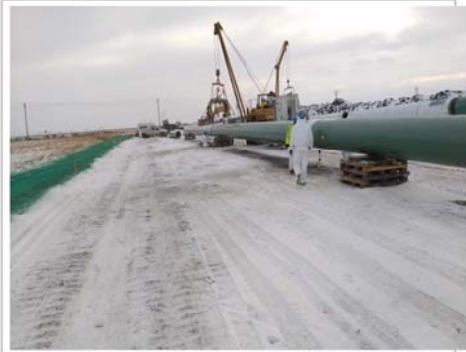
RD#63 (SSKP 904 +100)

Banister mainline coating crew
The crew is doing amazing job of cleaning
as they move forward
Photo taken facing east

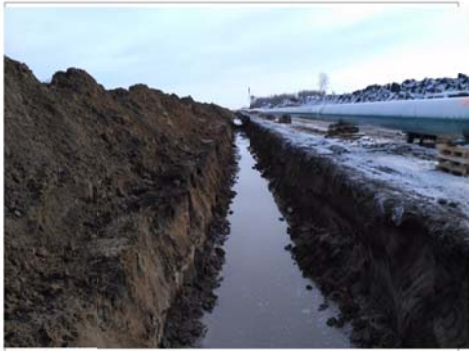
RD#33 (SSKP 857 +500)

This is the site where banister got to
pump the water out of the trench
before they could lower in the pipe
Photo taken facing east

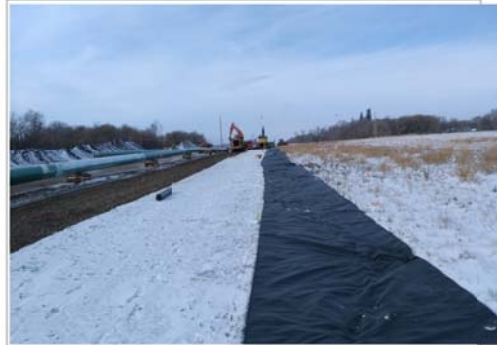
RD#34 (SSKP 858 + 800)

Banister trenching between sf 33 and sf
34
They also laid down geo-tech to protect
the 5 meter buffer

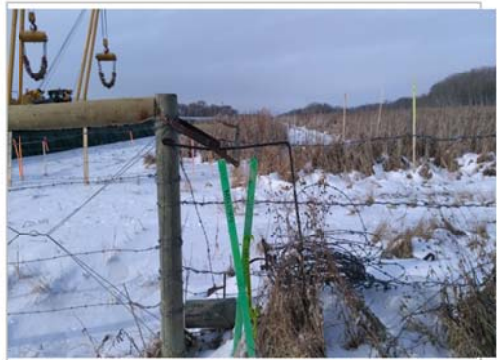
RD#33 (SSKP 857.13 to 857.54)

| | | Nov 22, 2018: Wetland MB-084 seasonal marsh (class 3) wetland complex (SSKP 857.13 +857.54) Trenching crew in area. Further mitigation required yes. | Future mitigation required | |

Banister doing some trenching at the
Wetland MB-084 seasonal marsh class 3
Photo taken facing west

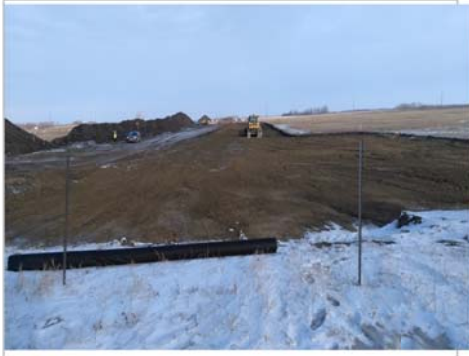
RD#21 (SSKP 827 +600)

Banister completed the back filling at sf 21
The site is very clean and organized
Photo taken facing north

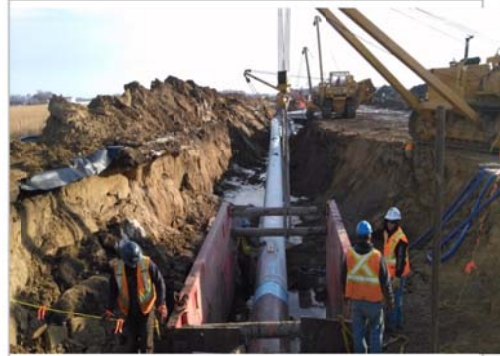
RD#22 (SSKP 829 +269)

Banister doing a tie-in at sf 22
Photo taken facing east

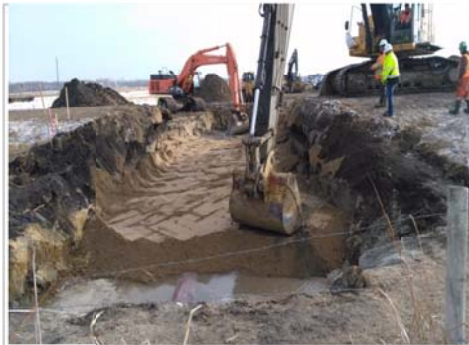
RD#26 (SSKP 836 +383)

Banister back filling the open cut road
They are using sand and gravel to back fill
Also will be doing a compact test
Photo taken facing east

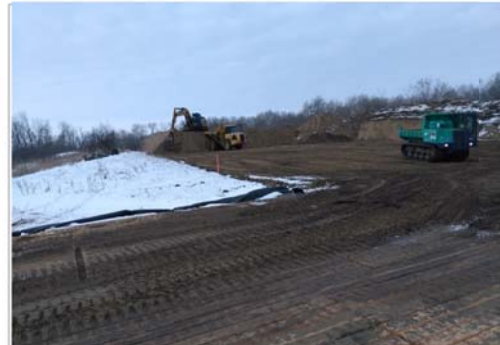
RD#27 (SSKP 839 +580)

Banister hauling ramp material for the
aqua dam MB-053 ephemeral/temporary
marsh
(class 1/ class 2)

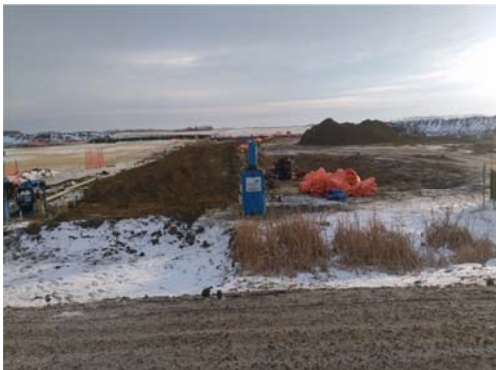
RD#1 (SSKP 808 + 568)

Banister has remove this de- watering system

at sf 1 the site very clean and organized
Photo taken facing east

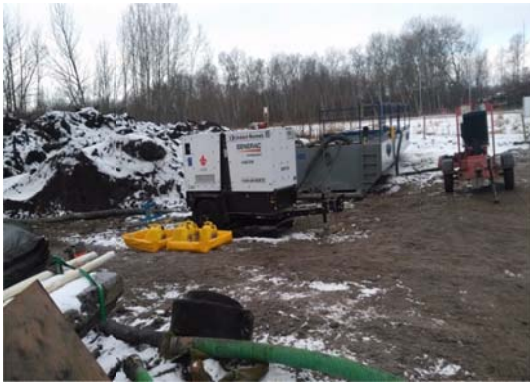
RD# 12 (SSKP 819 + 500)

Banister has set up a de-watering system at
sf 12. The site is equipped with drip trays as you
can see. Photo taken facing west

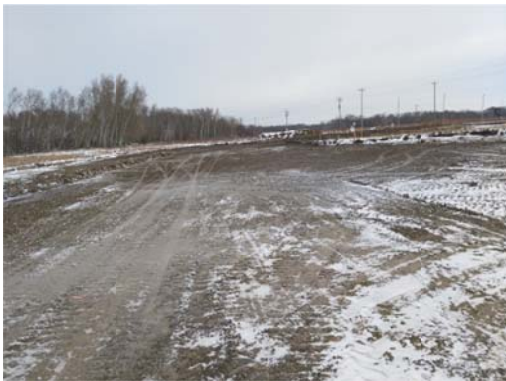
RD# 13 (SSKP 821 +008) (821 +183)

has a filter system. The pig pen collects all the silt that's being pump from de- watering system; RD# 13 (SSKP 821 + 008 to 821 +183) Banister has completed the back filling and levelling at the native prairie site. The crew is taking extra precaution at these sensitive areas; Work forecast: Go back and monitor the ROW

Native prairie
Photo taken facing north

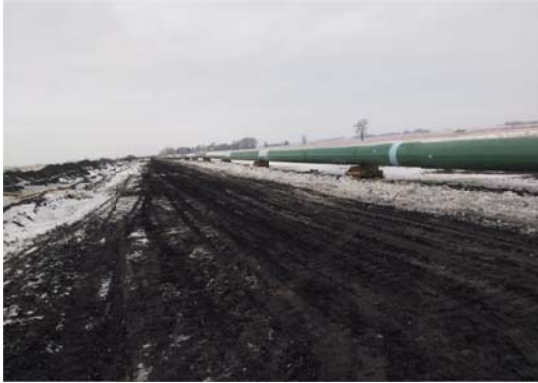
RD#1 (SSKP 808 + 200)

Banister have completed the coating sf 1
Moving to the high risk quarter sf 2
Photo taken facing west
