**SWAN LAKE FIRST NATION – MATRIX SOLUTIONS  
INC. PARTNERSHIP**

**INDIGENOUS CONSTRUCTION MONITORING**

**WEEKLY REPORT**

**SPREAD 7**

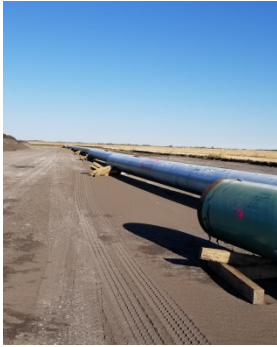
Sept 10/18 KP\_813+200.0  
Photo taken facing south.  
Unloading pipe

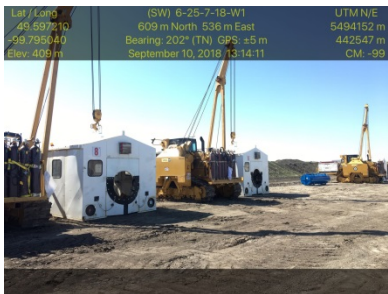
Sept 10/18  
Description & Location: SSKP 899+950  
3 automatic welders  
18 sections to weld for Black Creek bore  
Photo taken East

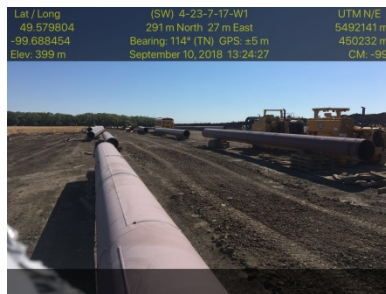
Sept 10/18  
Description & Location: SSKP 908+000  
Sections of pipe all End Prepped  
Ready to be welded  
For the Souris River bore Photo taken east

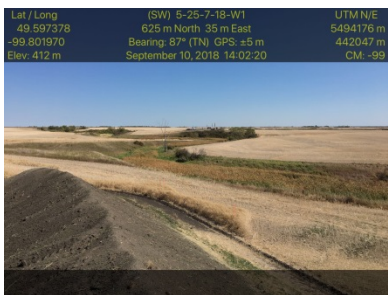
Sept 10/18  
Description & Location: SSKP 899+760  
Black Creek Water Course  
Work being done active all week  
Facing East

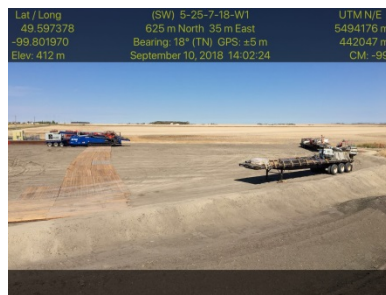
Sept 10/18  
Description & Location: SSKP 899+760  
HDD pad for Black Creek  
Entry hole for bore will start here

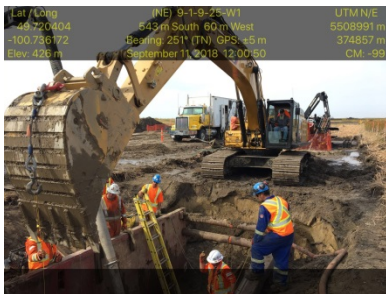
Sept 11/18  
Description & Location: SSKP 828+222  
Hydro-vac sucking water up  
Excavator removing clay and water  
Drilling crew changing out reamer  
In Wetlands facing South West

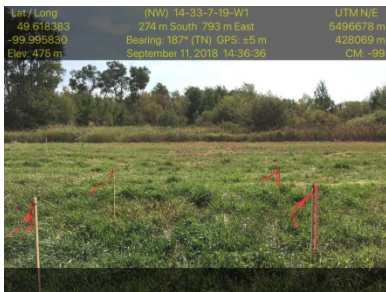
Sept 11/18  
Description & Location: SSKP 884+890  
Wasp area labelled with stakes/red ribbon  
Also Traditional Land Use area for Hunting  
Also A Seasonal Marsh Wetland Class 3  
Heritage Sensitive area Photo facing South

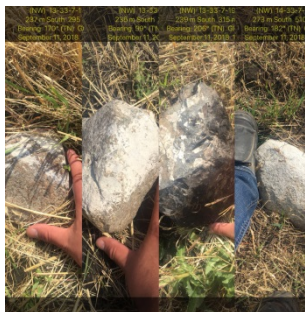
Sept 11/18  
Description & Location: SSKP 884+300/750  
Rocks spread out over laocation  
May need to mitigate Rock Shield for pipe

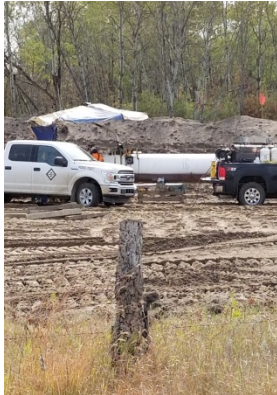
Sept 12/18  
Description & Location KP-819+500  
Photo taken facing north.  
Worker's welding the pipe at SF # 12

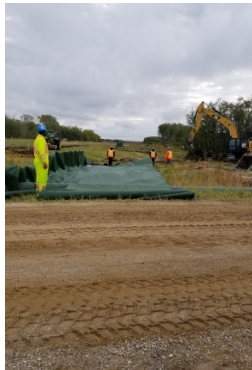
Sept 12/18  
Description & Location KP-838+132.8  
Semi-Permanent Marsh Class 4 Wetland  
Photo taken facing east.  
Worker's laying geo tech at entrance of SF # 27

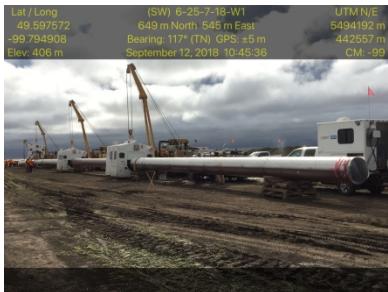
Sept 12/18  
Description & Location: SSKP 899+760  
Poor Boy crew cleaning and checking bevels making sure good, pre-heating. The automatic welders doing a Root, Hotpass and Cap, photo taken SE

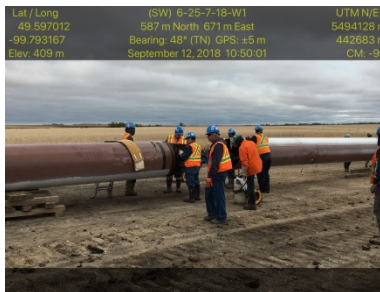
Sept 12/18  
Description & Location: SSKP 899+760  
Getting ready to line up pipe and start the root weld, the pipe was previously pre-heated before this process photo North

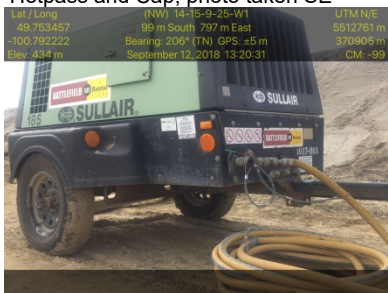
No Heavy Haul Trucks sign knocked down and broken needs reinforcement as winds overcame it location at road 48N & 143W intersection. At Rd # 12 the road that we use at crossing needs to be fixed from the ruts were causing. At Rd # 17 there's a compressor that's not self-contained for spills and it has no spill tray. Stop sign at Rd # 20 on east side of road crossing needs to be fixed with new 2x2 wood and reinforced, also at Rd # 21 the stop sign on the north side of crossing has been dispositioned by heavy winds and needs alignment with reinforcement. Rd # 60 at the Black Creek access there's an overhead powerline sign down on the north side that I had asked almost two weeks ago for Enbridge to get the contractor Banister to repair which I stated on previous reports that it needs to be fixed. These are safety and environmental concerns and I let my supervisor know I hope they are dealt with because the NEB (National Energy Board) will flag these as deficiencies and by fixing them will make our job safer with proper mitigation and give the NEB less to worry about.

Sept 12/18  
Description & Location: SSKP 822+300  
Not a self contained unit for spills  
Needs spill tray  
Environmental Coordinator said they need them

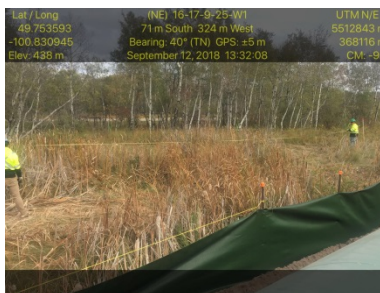
Sept 12/18  
Description & Location: SSKP 819+175  
Semi-Permanent Marsh Class 4 Wetland  
Measurement crew staking in wetlands  
Photo facing North

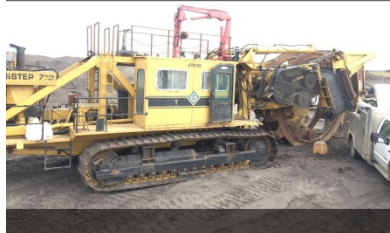
Sept 13/18  
Description & Location: SSKP 813+100  
Ditcher has arrived as of yesterday  
Side boom holding bore head in sling  
Mechanic is doing maintenance getting it ready  
54 foot digging wheel  
Will start ditching crew on Sept.24th

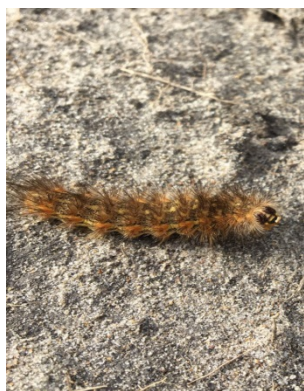
Sept 13/18  
Description & Location: SSKP 809+520  
Unidentified caterpillar on ROW

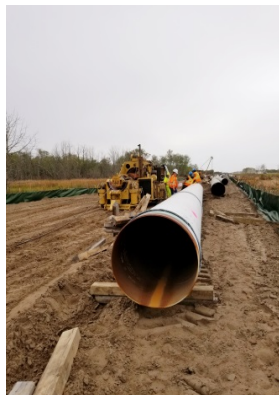
Sept 14/18  
Description & Location KP-819+239  
Photo taken facing west  
workers getting pipe ready for the bending machine

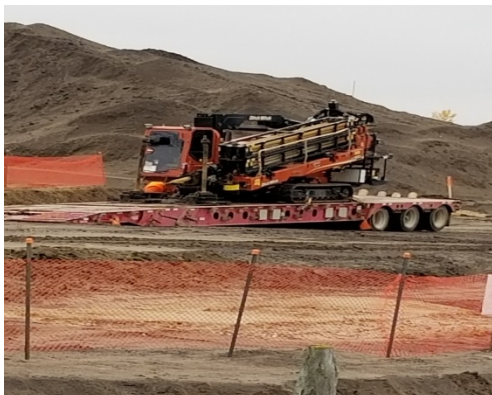
Sept 15/18  
Description & Location KP- 838-132.8  
Photo facing north  
Equipment operators waiting to get machines washed

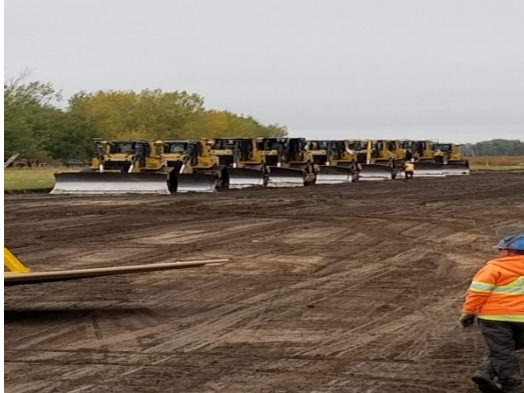
Sept 15/18  
Description & Location KP- 838-132.8  
Equipment operators waiting to get machines washed

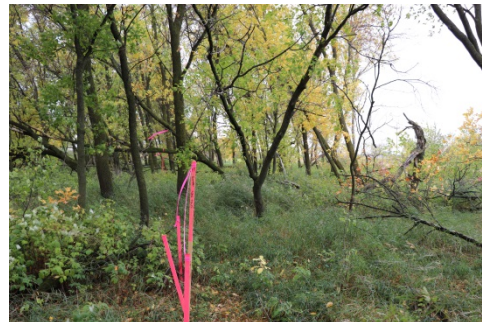
Sept 15/18  
Description & Location: SSKP 865+ 260  
Broad Leaf Treed Swamp Wetland  
South Boundary (pink) stakes  
Area swept for bones, artifacts, wildlife, etc.

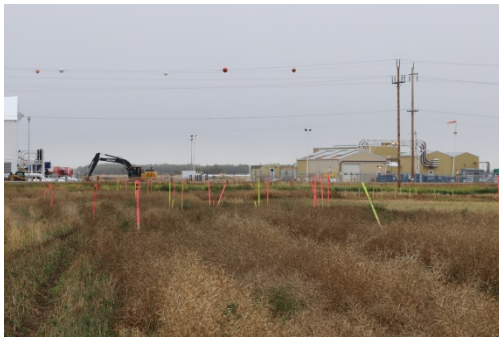
Sept 15/18  
Description & Location: SSKP 865+000  
West Souris Pump Station facing West  
Stakes indicating boundary and clipper line  
Farmers crops need to be removed

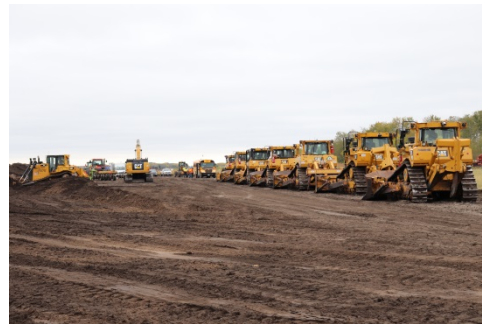
Sept 15/18  
Description & Location: SSKP 836+600  
Cleaning section 200 m west  
Dozers lined up waiting to be cleaned  
Dozer to left pushing topsoil  
Photo facing west

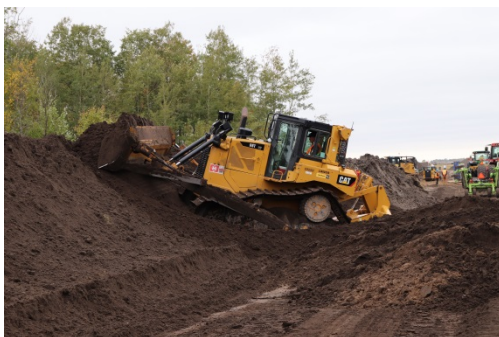
Sept 15/18  
Description & Location: SSKP 836 + 700  
Dozer pushing and piling topsoil  
Photo facing west
