**SWAN LAKE FIRST NATION – MATRIX SOLUTIONS
INC. PARTNERSHIP**

INDIGENOUS CONSTRUCTION MONITORING

WEEKLY REPORT

SPREAD 7

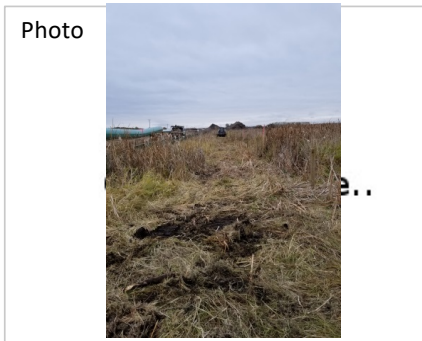
Description & Location KP- 820-000
Photo taken facing east.
Fencers putting up the fence.
MB 1139-5 class 4. Wetlands semi marsh complex

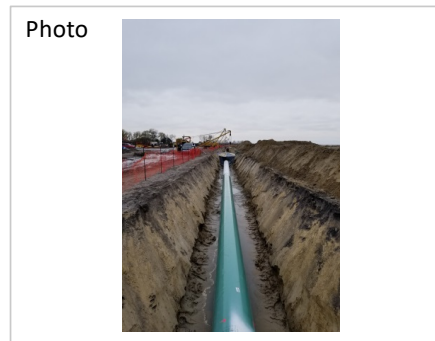
Description & Location KP-814+800
Photo taken facing west.
Welders are welding the tie-ins.

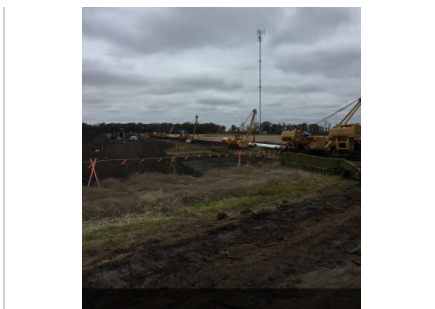
Description & Location: SSKP 907+833
Souris River HDD section
Welders finishing up weld
Side Booms holding pipe in place
Facing northwest

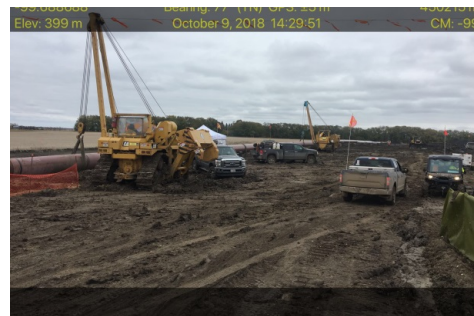
Description & Location: SSKP 907+833
Souris River HDD section
Welders finishing last weld for section
Side Booms holding pipe
Photo facing northeast

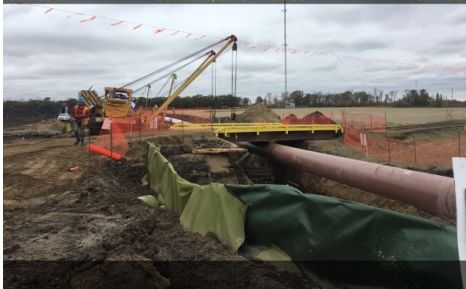
Description & Location: SSKP 907+833
Souris River HDD section
Bridge complete pipe resting under bridge
Very congested area stayed out of way
Photo facing northwest

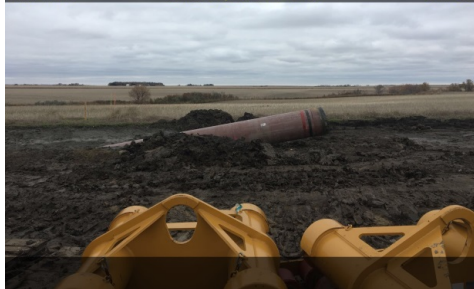
Description & Location: SSKP 899+860
Black Creek HDD section
Pipe from bore sticking out of ground
East of Black Creek
Photo facing north

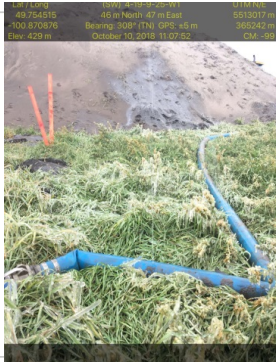
Description & Location: SSKP 816+200

After our morning meeting the juniors would go monitor Rd # 28 as it's a sensitive area with lots of work going on. The senior would start from beginning to end of the line as there is lots of work being done. SSKP 816+200 holes in drainage lines going into field needs to be fixed as its spraying unfiltered water from ROW trench onto field. I let the Tie in foreman for Banister know immediately and politely as well as Environmental Inspector for Enbridge so its dealt with ASAP. SSKP 817+800 Sandblasting in bell hole inside trench box, preparing pipe to be coated. With the hydro vac crew standing by to help drain the water that's going into trench. We now have a Wetlands crew and they were in background of picture below stripping and trenching wetland crossings from Rd # 8. SSKP 852+370 to 856+100. Stringing crew has strung out pipe through wetlands MB-076/077/078/079/080/081/082. SSKP 907+000 Souris River HDD site has punched through with drilling and the next step is to attach 42" reamer than the pull. The test heads are welded on the Souris River HDD section as well. They will fill pipe on Friday and Saturday and test on Monday October 15th. SF # 28 Prep crew working east of SF # 28 at KP-847+000. Poor boy crew are east of SF # 28 at 844+000. The main gang welders are east of SF # 28 at KP-845+100. Walked the right away to the rare plant in the wetlands (cyperus schweinitzii) S2. SF # 6 Ditch wheel trenching the line for the pipe. South side of SF # 6. 3 Excavators pushing the top soil aside so that it does not fall back into the line that the ditch wheel is stripping at SF # 6.

Drainage water lines
Pumping water out of Ditch into pigpen
Holes in line spraying field
Facing northwest

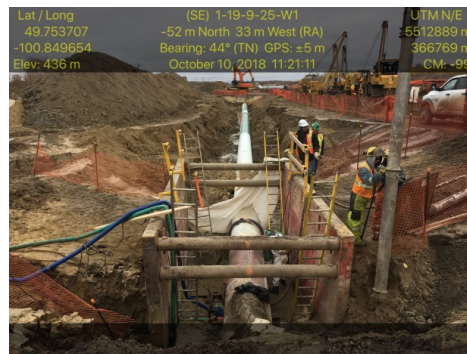
Description & Location: SSKP 817+800

Congested work area
Coating, Hydro vac, Booms and
Excavators. Trench box for unstable
trench walls Facing east

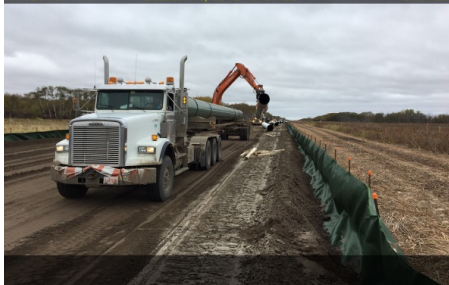
Description & Location: SSKP 856+100

Stringing Crew in Wetlands
MB-082 Broad-Leaf Swamp
Have been in wetlands past 3 days
Facing west

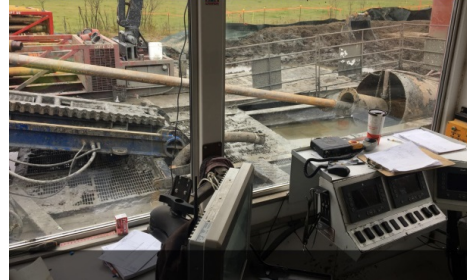
Description & Location: SSKP 907+000

Souris River Somerville HDD
Operations for drilling
In process of attaching 42" reamer
Facing North

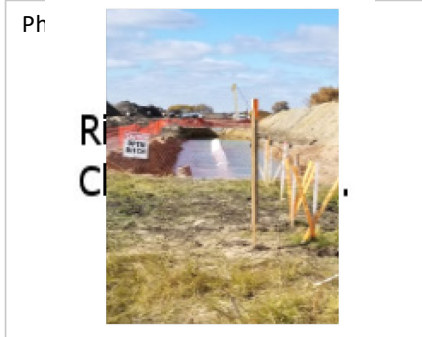
Description & Location: KP 836+409

SF# 26 Open ditch 3/4 full of water. No activity. Walked up the SF checked for garbage, any sort of spills gas or oil. Cigarette butts. SF # 30 Walked up the right away. cigarette butt on the ground near the pipe. Bevelling clean up crew were picking up shavings.

Photo taken facing west.
Open ditch 3/4 of water

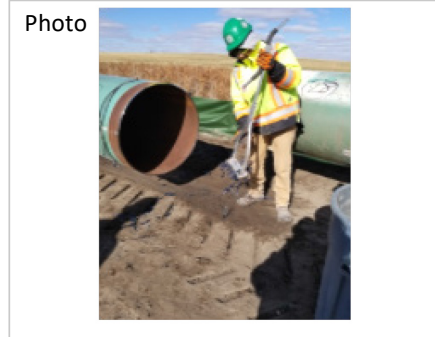
Description & Location: KP 851+560

Photo taken facing south.
Beveling crew cleaning up the shavings
with a magnet broom.

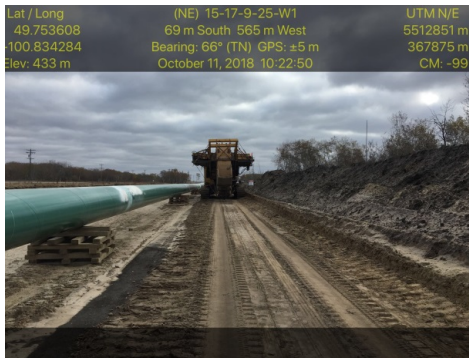
Description & Location: SSKP 818+100

At Rd # 8 around SSKP 818+100 The Ditcher was going slowly down ROW through a narrow area that had soil and pipe to close together for the Ditcher to make it through (picture below) great job by the foreman for stopping Ditcher and getting him to go back so they could properly widen the access more. Also the Wetland crew moved to Rd # 8 to start stripping and trenching wetland crossings. In this area I also observed welders between Rd # 7 & 8. SSKP 840+419 In TLU-66 a Traditional Land use area there is hunting 225 m south of the project during hunting season. Also in the area spread across more than 2 km's is the Grade crew working throughout 5 wetlands in close proximity to each other the wetlands were MB-050/051/052/053/054 from SSKP 838+000 to SSKP 840+419. They are also installing wetland ramps. SSKP 907+600 & 908+250 The Souris River HDD section has both test heads welded and rigged up for test. They will start filling tomorrow and be done on Saturday. Than test on Monday October 15th. After test is completed they will coat and pre-jeep the section.

Ditcher from Trenching crew
Was driving towards me
To narrow to make it through
Facing east

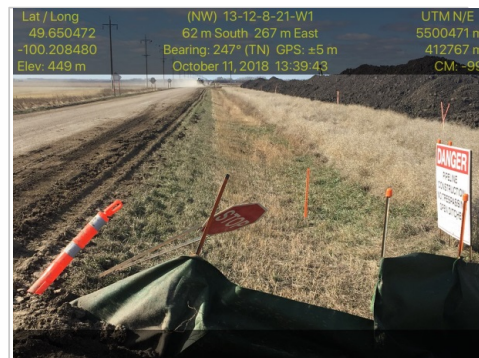
Description & Location: SSKP 868+875

Rd # 32 has no stop signs installed by road crossing.

Yesterday I reported a All Vehicles Stop sign was knocked down approximately 1.2 km east of intersection 44N+123W. Today in same area west across the tracks of 1st sign knocked down, the other one has been knocked down. most likely clipped by farming equipment. At Rd # 42 both stop signs are knocked down by road crossings. Also I've been picking up lots of different garbage on the ROW and on gravel roads. Some of the common things I pick up are gloves. Also I've picked up bungee cords, geo tech, rope

On both sides of crossing
Stop signs knocked down
Also Rd # 31 and 32 no stop signs
Reported to Enbridge, facing west

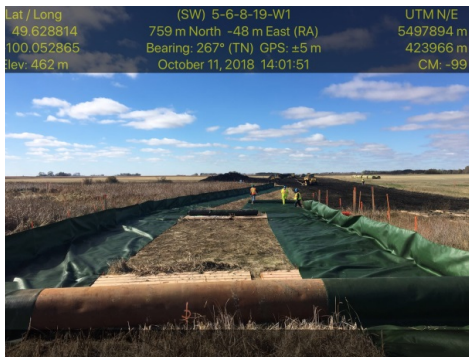
Description & Location: SSKP 840+419

Grade crew stripping around wetlands
Workers setting up access wetlands ramp
In TLU-66 and several wetlands
Facing west

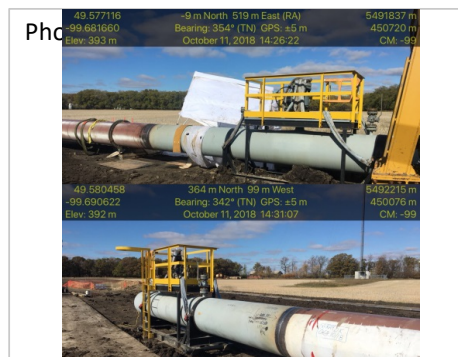
Description & Location: SSKP 907+600

Souris River HDD section test heads
Both test heads on west/east side
Section is now rigged up for test
Filling today and tomorrow

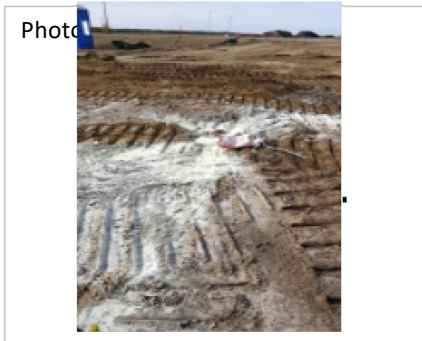
Description & Location : KP 850+895
Photo taken facing east.
Dozer backed onto the fire extinguisher at SF # 29

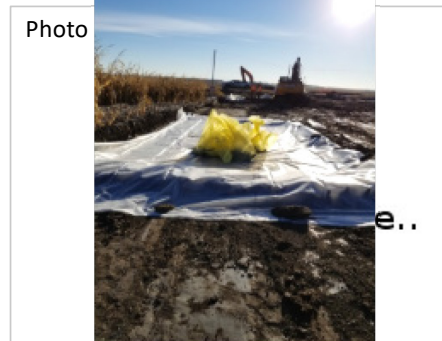
SSKP 882+080 I arrived at Rd # 49 and just to the west about 15 m that area of the spill had already been contained. The area was flagged off and identified. Apparently a Grader leaked diesel onto the ground into the soil. It was reported and dealt with immediately. SF # 49 Excavator at the spill scooping up the contaminated soil which is in well contained bags ,moving them onto poly. Workers are flagging off the site where the spill happen. They will restripe the area than environmental will test the area to make sure there is no contamination left in the area. All the proper procedures were taken in handling the area. SF # 29 D-8 Dozer was at the entrance of SF# 29 south side KP-850+895.1 was backing up when his fire extinguisher fell off the dozer, onto his tracks and down onto the ground when he proceeded to back up onto the fire extinguisher. Flatten the extinguisher, powder on ground. excavator picked it up and placed it onto a black blanket, workers pick-up the remaining powder with shovels. The powder and sand that was placed on the blanket was well contained.

Description & Location : KP 882+099
Photo facing west.
Well contained contaminated soil.

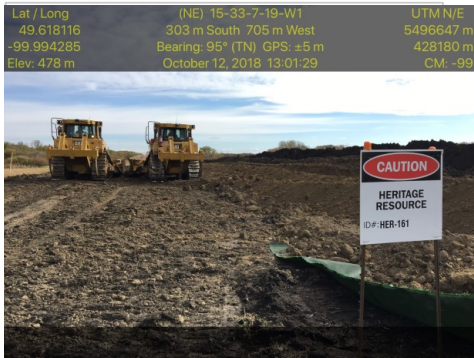
Description & Location: SSKP 885+020
Heritage Resource area HER-161
Dozers working together stripping
Cultural monitors assessing area
Facing east

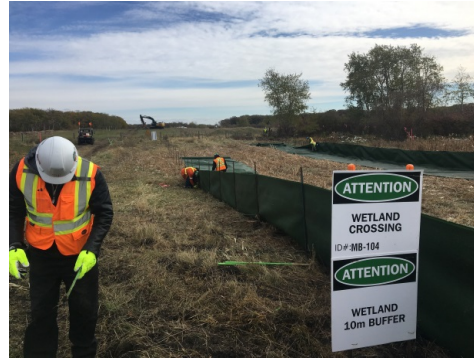
Description & Location: SSKP 885+250
Seasonal Marsh Class 3 MB-104
Installing wetland ramps
Cultural monitor to the left
Facing east

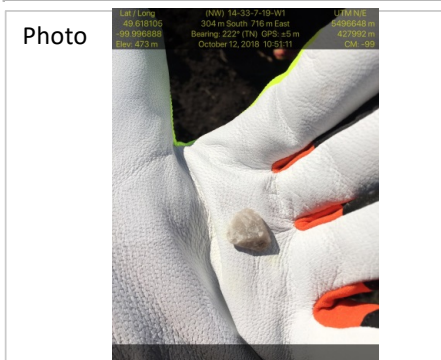
Description & Location: SSKP 885+130
Sun Stone rock
Found while with Monitor and Biologist
Many rocks found and some flakes
In Heritage area HER-186

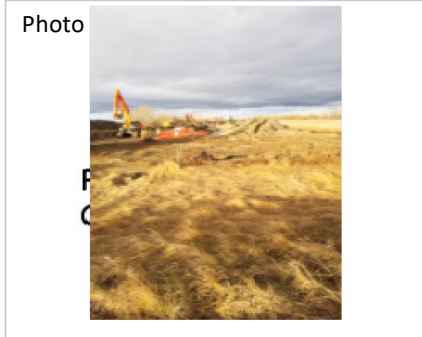
Description & Location KP-815+300

Photo facing south
Excavator parked in the wetlands

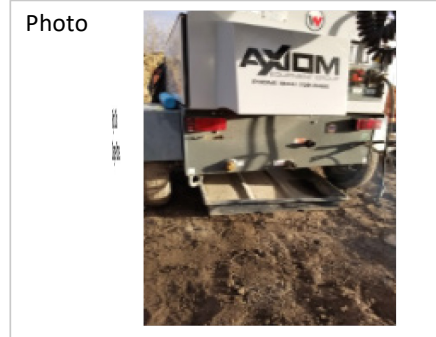
Description & Location KP-817+900

Photo taken facing north.
Generator & lighting plant well contained.
Checked for oil, leaks. No concerns

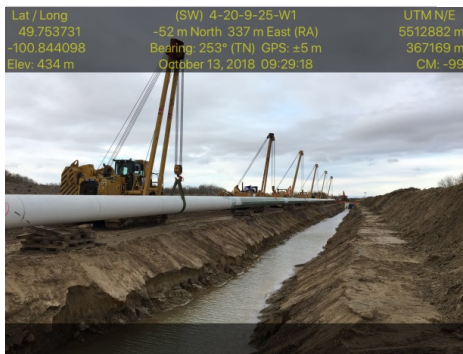
Description & Location: SSKP 818+200

After morning meeting, we would go to monitor more sensitive areas where work activities are taking place. SSKP 818+200 The Tie-in crew was working in MB-1039 Semi-Permanent Marsh Class 4 Wetland Complex. The Side booms had a 7 joint section in their cradles preparing to lower pipe into trench and start the tie in.

Tie In crew
Getting prepared to low pipe into trench
Side Boom hold pipe while they weld in trench
Facing southwest

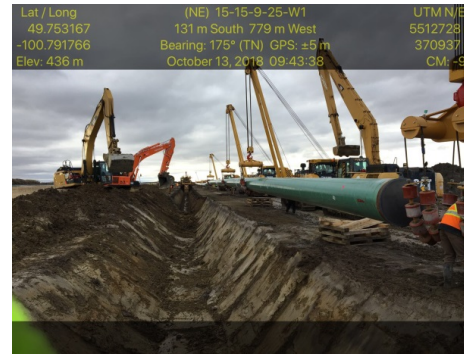
Description & Location: SSKP 822+025

SSKP 822+025 The Trenching crew was digging ditch with dry soil conditions and Lowering in was setting up cradles on pipe to prepare to lower into trench.

Trenching & Lowering in crews
Dry soil conditions helped trenching
Excavators, Side Booms and Ditcher
Facing south

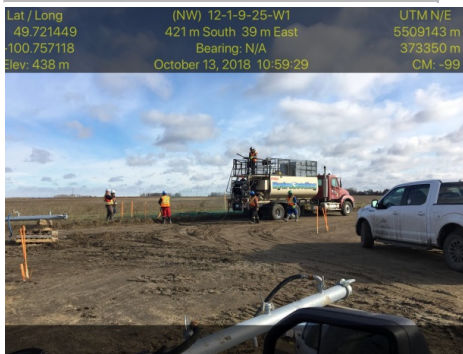
Description & Location: SSKP 827+700

SSKP 827+700 The Buffer Mulch crew was mowing the buffer and rolling the top soil. They also prepped the mulch spread heading east of Rd # 21. They had to stop and get filter cloth for the pipe as there was strong winds that were blowing the mulch on the pipe. It was noticed right a way and was corrected than they continued on.

Buffer Mulch Crew
Mulching the buffer
Strong wind conditions slowed work down
Facing Northeast

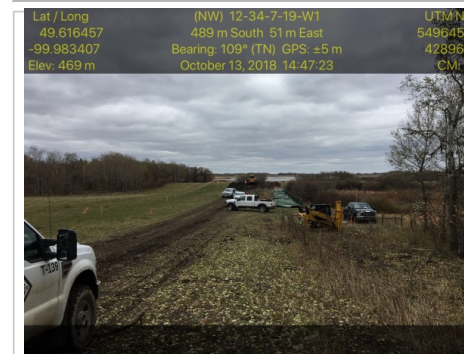
Description & Location: SSKP 886+260

Access & Fencing Crew
Building wetland ramps
Installing perimeter fence
Facing east
