**SWAN LAKE FIRST NATION – MATRIX SOLUTIONS
INC. PARTNERSHIP**

INDIGENOUS CONSTRUCTION MONITORING

WEEKLY REPORT

OCTOBER 15TH TO OCTOBER 20TH

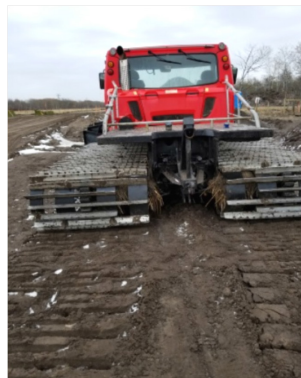
Oct 15/18 Description & Location KP- 884+072
Photo taken west.
Grater waiting for workers to blow any debris that is on machine before it can cross road at SF 51

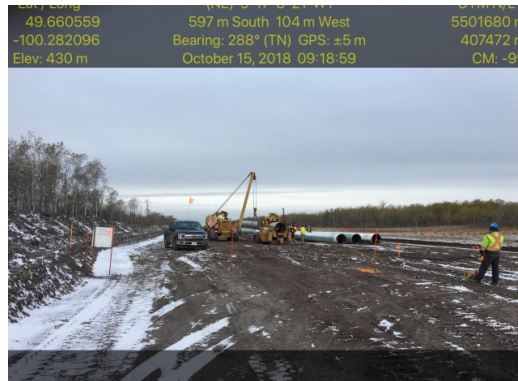
Description & Location: SSKP 864+667

Stringing crew
Offloading pipe on ROW
Conditions on ground were frozen
Facing Northwest

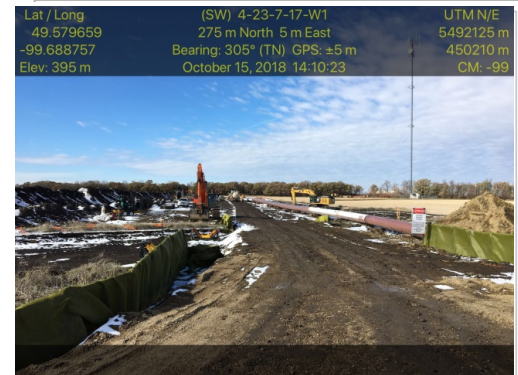
Description & Location: SSKP 828+550

Buffer Mulch & Coating repair crews
Mulching the ROW
Repairing indications on pipe
Facing northeast

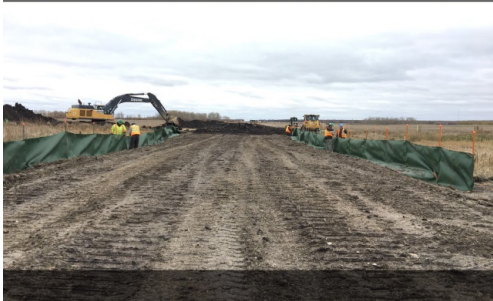
Description & Location: SSKP 818+250

Wetlands crew
Digging up wetlands for trench
Side booms standing by to lower in
Facing northwest

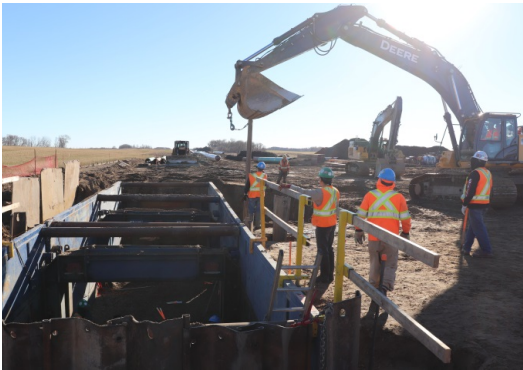
Description & Location KP-817+741.1

Photo taken facing south
Side booms placing the pipe into trench
Tie in crew will weld once in clamps

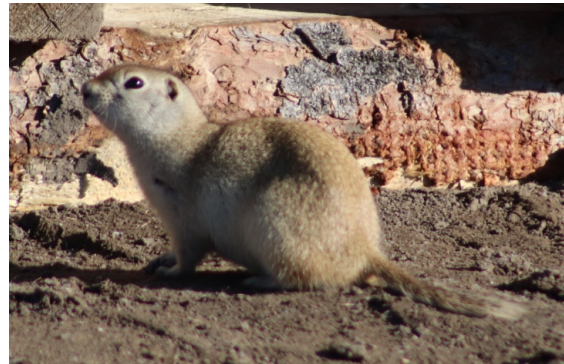
Description & Location: SSKP 850+000

Wetland Complex. The ground where they were working is very unstable. They did amazing job with the trench box and even pounded plates to help secure it more. They also used a pulley with chain to secure plates to the trench box for extra support. On spread 3 & 4 of the L3R I seen a worker I helped train on the utility crew I was on. Was nice to see him doing well. SSKP 849+760 Animal Observation on ROW seen a Richardson's Ground Squirrel under skid pile under pipe. They will hibernate for winter soon. SSKP 843+925 Blasting flat deck truck was stuck in the sandy conditions on the ROW. A Dozer safely pulled the truck out. Coating mainline working through sensitive areas. Wetlands MB-060 Broad-Leaf Treed Swamp Wetland Complex SSKP 843+250 MB-061 Broad-Leaf Treed Swamp Wetland Complex SSKP 843+340 MB-062 Ephemeral/Temporary Marsh Class 1 & 2 SSKP 843+550 MB-063 Ephemeral/Temporary Marsh Class 1 & 2 SSKP 843+750 SSKP 828+000 Lowering in and Backfill crew working through wetlands. MB-038 Seasonal Marsh Class 3 Wetland Complex SSKP 828+530 MB-039 Seasonal Marsh Class 3 SSKP 828+925. SF # 6 Side booms placing the side bend pipe than the workers will weld the tie-in. Cigarette butt found on the ground near the bend in the pipe. All containers and jugs are in proper containment on SF # 6 west side. SF # 6 east side. Pig pen on the road allowance was full, Badger hydro vac truck their pumping out the pig pen. Work truck had 3 jerry cans on the back of it I spoke to the foreman and he corrected it. He put the jerry cans in a spill tray. SF # 7 East Monitored the ROW for cigarette butts, gas, garbage or diesel spills. No concerns. SF # 42 East. Very congested pipe gang moving very fast. Observed the equipment for leaks or spills. No issues.

Bores and Test crew
Installing trench box and pounding plates
Plates to support trench box
Facing east

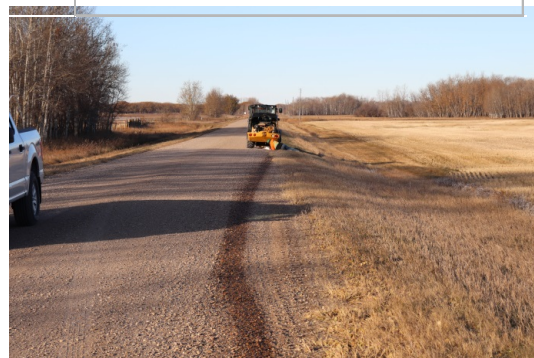
Description & Location: 46N by Road # 30

Small front end loader
Leaking oil on gravel road
Operator didn't know he was leaking
Facing west

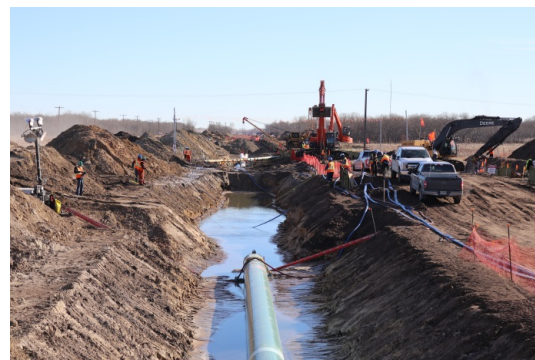
Description & Location: SSKP 818+347

Tie In crew
Preparing bell hole for welding tie in
Lots of water and unstable trench walls
Facing east
