**SWAN LAKE FIRST NATION – MATRIX SOLUTIONS
INC. PARTNERSHIP**

INDIGENOUS CONSTRUCTION MONITORING

WEEKLY REPORT

SPREAD 7

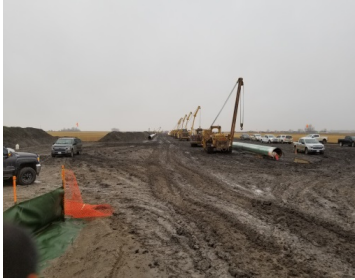
Description & Location KP-809+899.

Photo taken facing south.
Welders waiting for weather conditions to change at RD # 2.

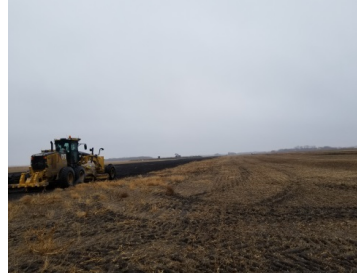
Description & Locations KP-813+200

Photo taken facing east.
Parked equipment due to wither conditions. Topsoil put back on the right away.

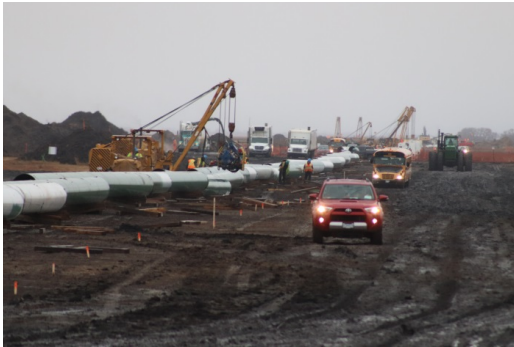
Description & Location: SSKP 809+400

Main Gang welders
Also in picture to left was End Prep
Wet conditions on ROW
Facing south

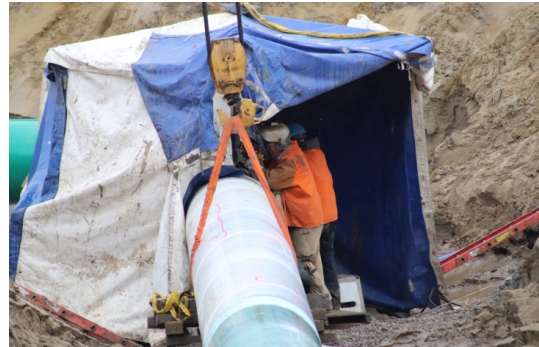
Description & Location: SSKP 821+000

Tie In crew
Welders welding at side bend
Side Booms holding pipe in place
Facing west

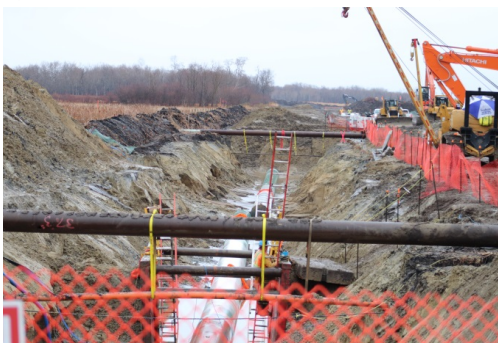
Description & Location: SSKP 821+200

Hole has been prepared for Tie Ins
Underground facilities exposed
Trench box set up where they will weld
Facing east

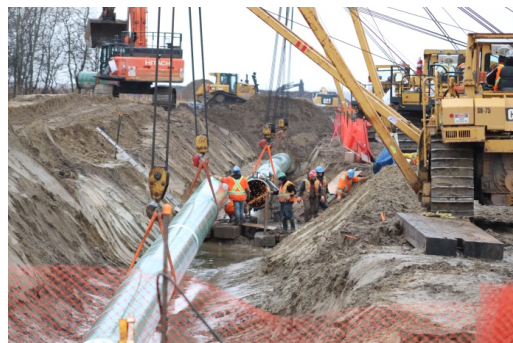
Description & Location: SSKP 824+500

Tie In crew preparing pipe
Welders helper grinding end of pipe
Next step they will Tie it in and weld
Facing south

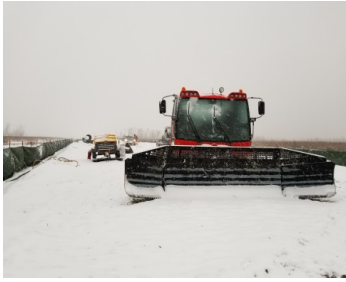
Description & Location KP-841+300 137 W
Photo taken facing east. Parked snowcat.
MB-054. Wetlands semi permanent complex
marsh. Class 4.

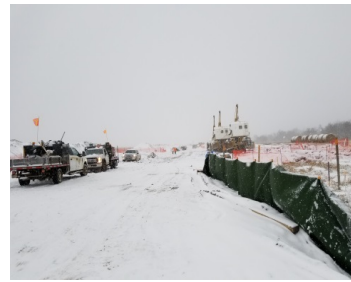
Description & Location KP-838+132.8
Photo taken facing west.
Poor boy shacks being moved

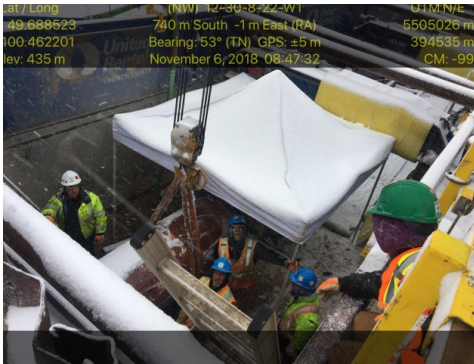
Description & Location: SSKP 850+000
Track Bores crew
Weld and push carrier pipe
Side Boom holding pipe in trench box
Facing southeast

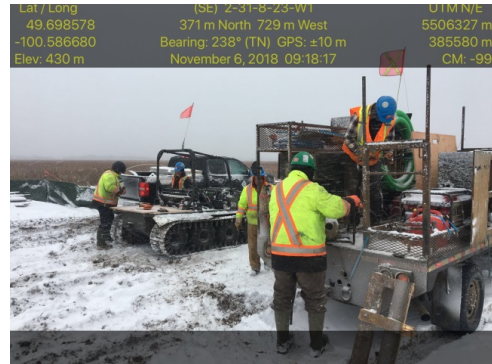
Description & Location: SSKP 841+000
Access Crew
Unloading water pumps
Getting prepared to install aqua dam
Facing southwest

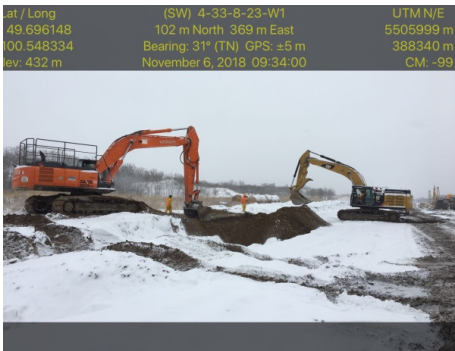
Description & Location: SSKP 843+700
Backfill Mainline
Excavators backfilling trench
Each operator has a swamper with them
Facing northeast

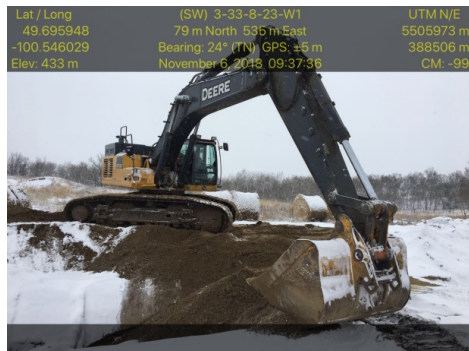
Description & Location: SSKP 843+900
Backfill Mainline
Excavator putting in a plug in trench
Helps maintain water levels
Facing north

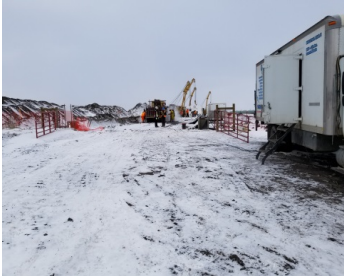
Description & Location 810+100 50 N

Photo taken facing south.
Workers washing the equipment before
proceeding on the right away to continue
with the welding.

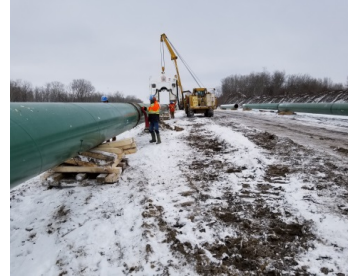
Description & Location 838+132.8 139 W

Photo taken facing east.
Side booms moving the poorboys onto
the pipe.

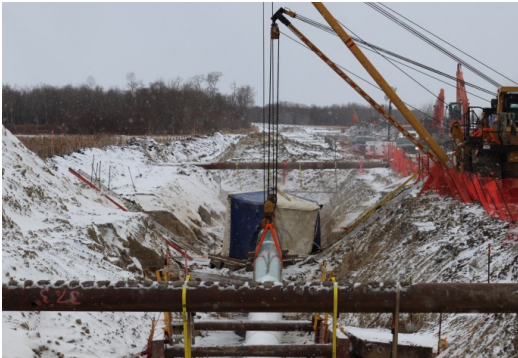
Description & Location: SSKP 821+280

Backfill Tie In crew
Finishing last weld east of Rd # 14
After tie in complete they will backfill
Facing east

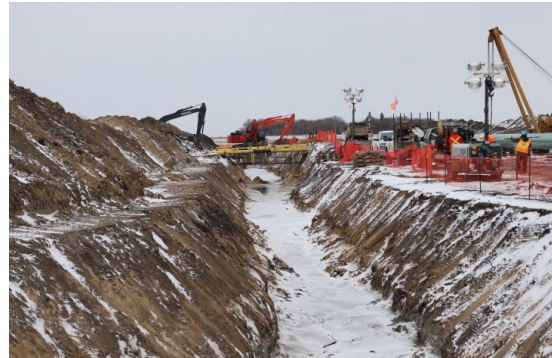
Description & Location: SSKP 825+500

Wetlands crew
Excavating east of the CNR
Excavating Tundra lines
Facing south

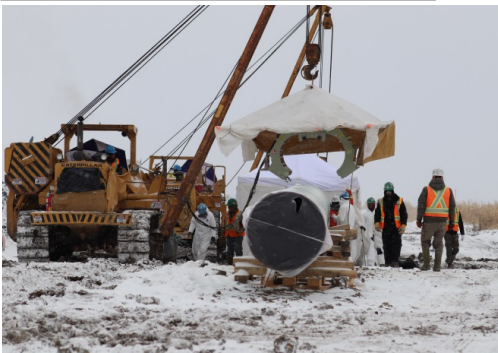
Description & Location: SSKP 882+000

Coating Mainline
Using tarp around induction coil
Condition was snowing slows production
Facing west

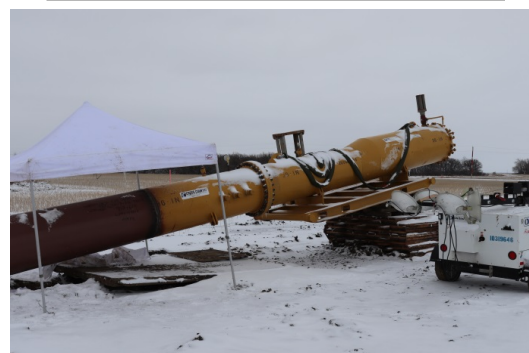
Description & Location: SSKP 907+620

| Watercourse Crossing | 1 | 1 MB-WC32 Watercourse Souris River SSKP 907+620. | HDD bore end pipe has a welded catcher on it that's used for running the pig through pipe clearing out any remaining water | |

Souris River HDD bore section
The catcher welded on end
Used to push remaining water out of line
Facing north

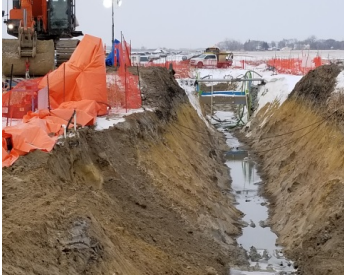
Description & Location KP-808+568.2

Photo taken facing west.
Excavator digging up the road between RD # 1 and RD # 2. Both sides of the road are blocked off.

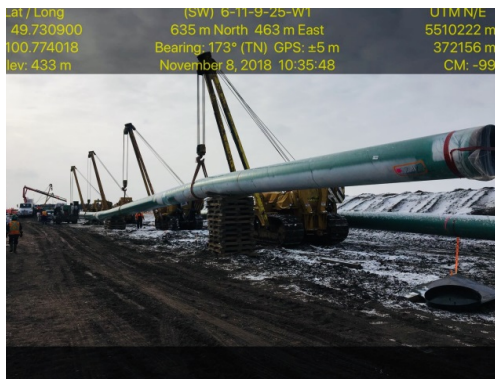
Description & Location: SSKP 825+500

Tie In Crew
Side Booms getting ready to lower in
Skids piled high because of bend in pipe
Facing south

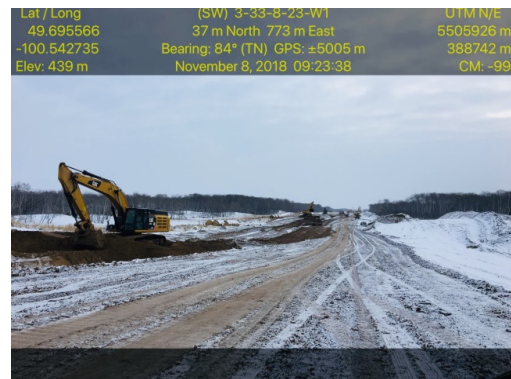
Description & Location: SSKP 844+550

Mainline Backfill crew
Backfilling and touching up trench
Crew spread out over 400 m
Facing east

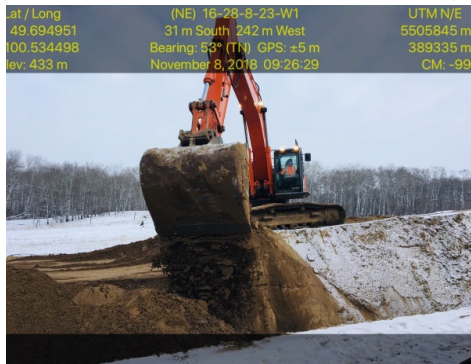
Description & Location: SSKP 844+700

Mainline Backfill crew
Excavator backfilling trench
Spotter keeps eye out for rocks
Facing north

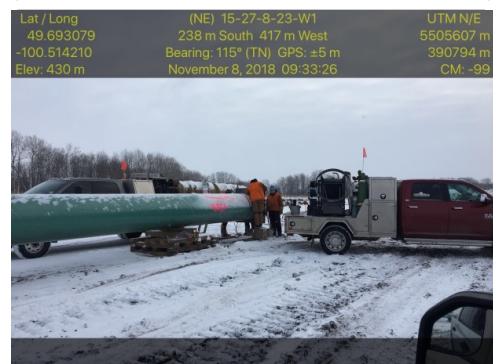
Description & Location: SSKP 846+100

Tie In welders
Welding plates on end of pipe
Used to seal pipe in wetlands trench
Facing northeast

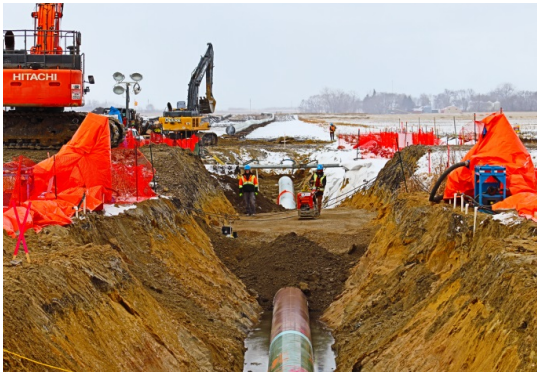
Description & Location: SSKP 808+568

Tie In Crew
They are starting backfill on road
Using a compact tamper for foundation
Facing west

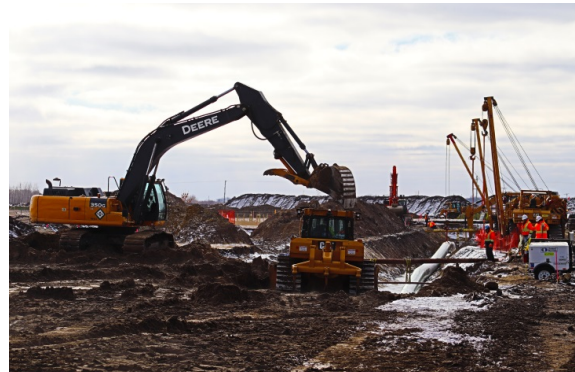
Description & Location: SSKP 824+750

Tie In Crew
Backfilling around hotline
Dozer pushing soil slowly under hotline
Facing south

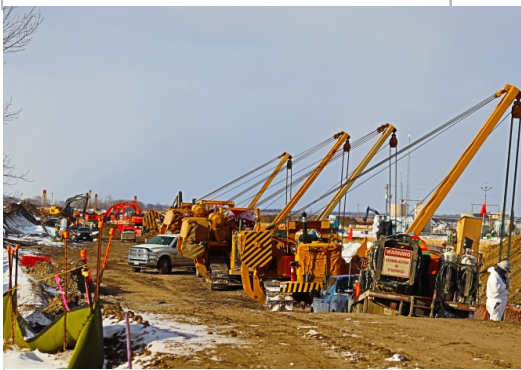
Description & Location: SSKP 826+200

Tie In, Wetland and Coating Tie In Crews
Welding pipe in trench and inspecting pipe
Inspecting welds and coating
Facing west

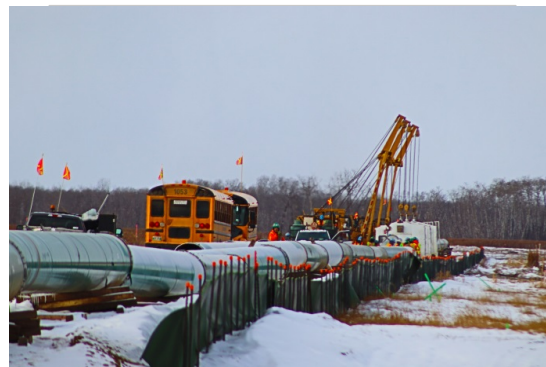
Description & Location: SSKP 840+900

Poor Boy Crew
The automatic welding shacks in wetlands
North side of wetland ramp

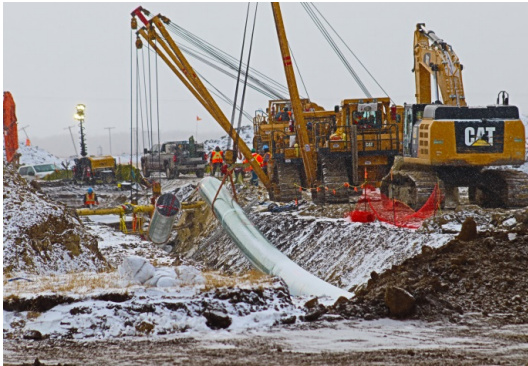
Description & Location: SSKP 824+900

Tie in Crew
Welding a Tundra P/L crossing east
Side Booms ready with pipe to get cut
Facing south

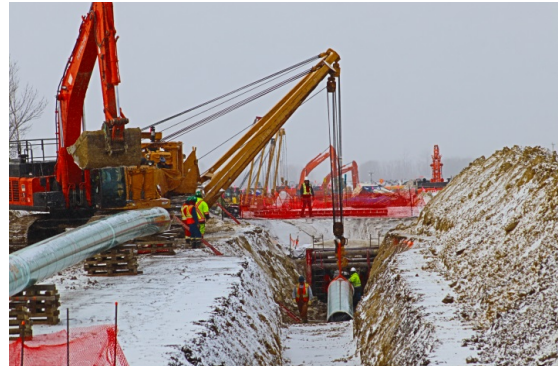
Description & Location: SSKP 826+425

Tie In Crew
Welding pipe in trench box
Congestion between Rd #19 & Rd # 20
Facing west

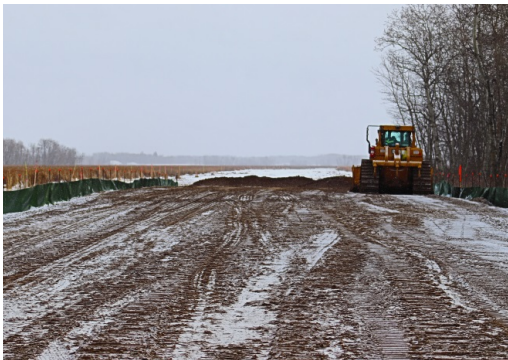
Description & Location: SSKP 838+900

Access Crew
Dozer pushing material on wetlands ramp
Also installing aqua dams in area
Facing east

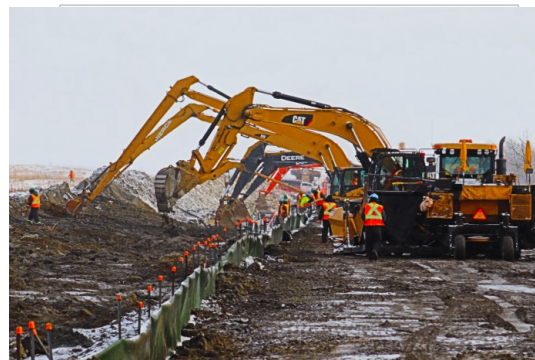
Description & Location: SSKP 847+075

Backfill, Lower In & Trenching Crews
Excavators pulling soil into trench
Trenching crew in far background digging
Facing east
