**SWAN LAKE FIRST NATION – MATRIX SOLUTIONS  
INC. PARTNERSHIP**

**INDIGENOUS CONSTRUCTION MONITORING**

**WEEKLY REPORT**

**SPREAD 7**

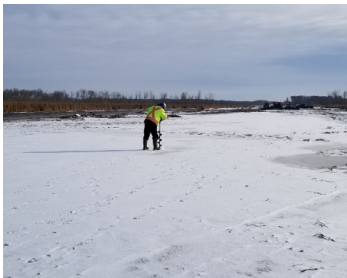
Description & Location KP-842+882

Photo taken facing west.  
Worker drilling holes in the wetlands.  
Seasonal marsh class 3 ID #SSK 842.

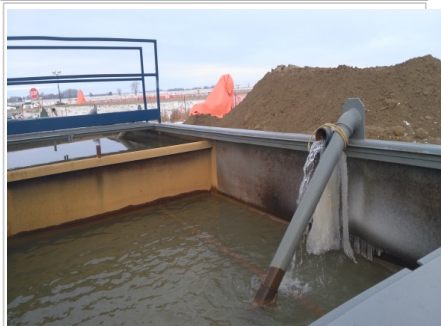
RD#1 (SSKP 808 +568)

De-watering station  
Photo taken facing west

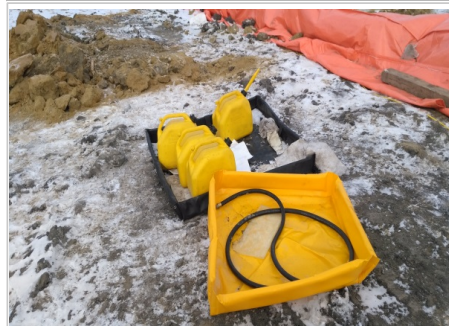
RD#1 (SSKP 808 +568)

Banister doing a good job of putting gas  
in drip trays at the de-watering station  
Photo taken facing west

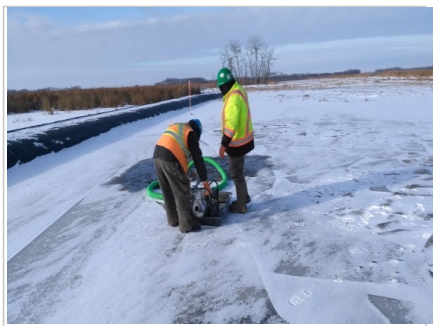
RD#28 (SSKP 840 +882 )

Banister prepping the aqua dam  
pumping water so they could get across  
the wetland  
Photo taken facing west

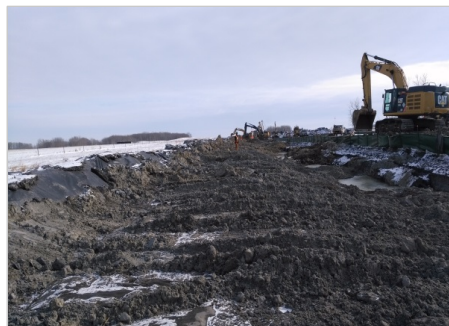
RD#28 (SSKP 847 +200)

Banister back filling at sf 28  
Banister using spotters to backfill  
Photo taken facing east

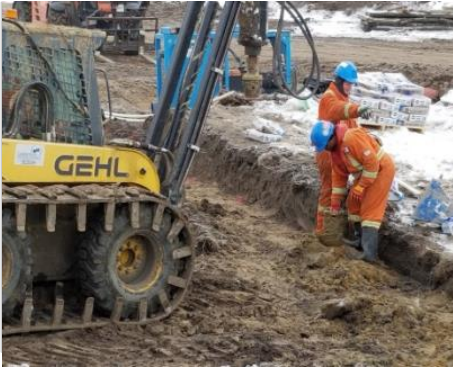
Description & Location KP-819+100

Photo taken facing east.  
Bobcat with drill attached drilling holes.  
Workers pouring the filtered sand into the holes.

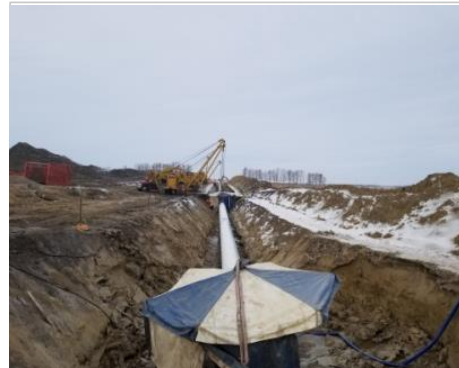
Description & Location KP-826+700

Photo taken facing west.  
Workers welding the tie-ins.

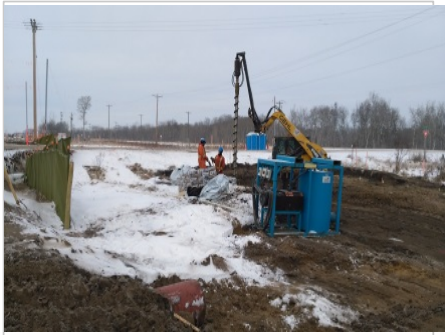
RD#12 (SSKP 819 +500 )

DE-Watering system  
The crew prepping the site for the de-watering system  
Photo taken facing west

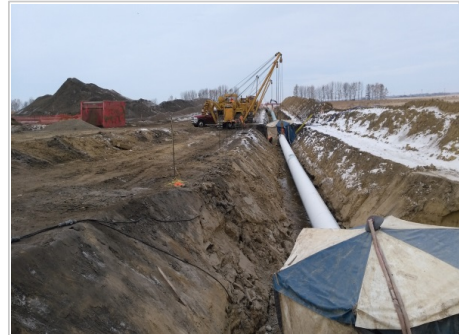
RD#20 (SSKP 826 +700 )

Banister tie-ins crew  
The site is very clean and organized  
Photo taken facing west

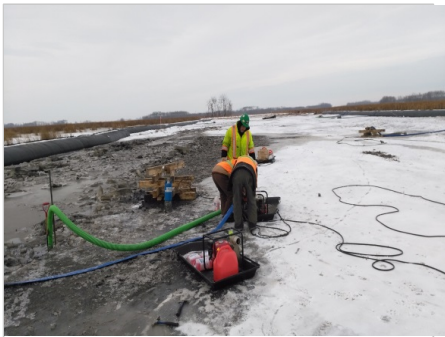
RD#28 (SSKP 840 +882)

Aqua Dam  
This is a wetland area MB-054 semi permanent marsh (class 4)  
Photo taken facing west

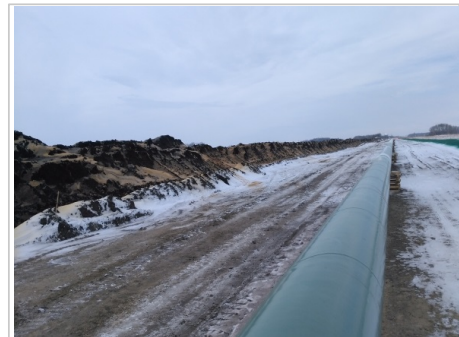
RD#37 (SSKP 861 +600 )

Banister spraying beet juice and tree sap  
To keep the topsoil from being blow away  
Photo taken facing west

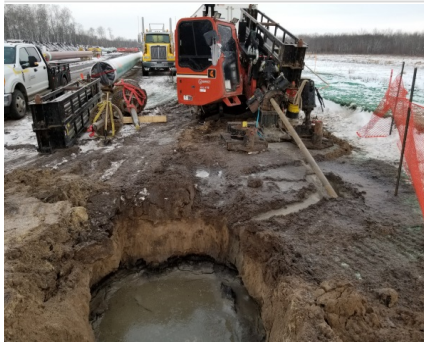
Description & Location KP-863+300

Photo taken facing east.  
Reassessing the right away. No activity.

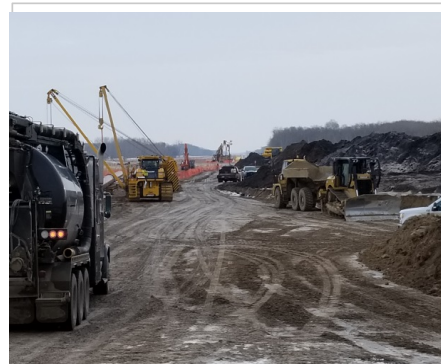
Description & Location KP-853+560

Photo taken facing east  
Hydro vac truck parked  
Lower In crew on left side of picture

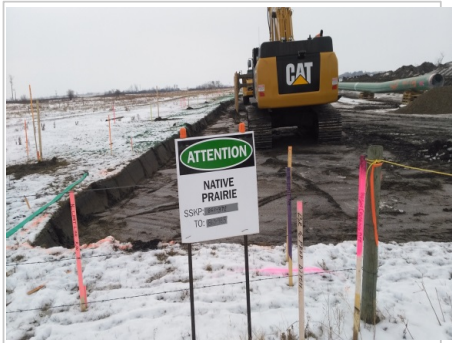
RD# 38 (SSKP 863 +371 to 863 +983 )

This area is the native prairie  
Banister going to do some reaming 38"  
and installing the trench box  
Photo taken facing east

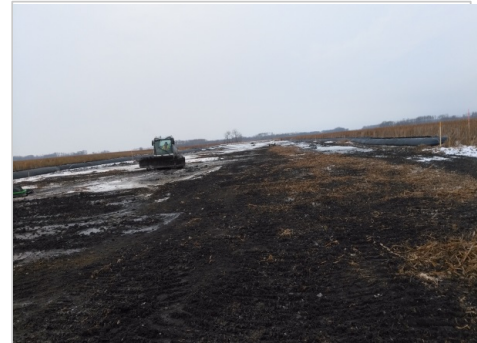
RD#28 (SSKP 840 +882 )

Aqua dam sf 28  
Banister pretty much done pumping  
water  
They will be laying down geo-tech and

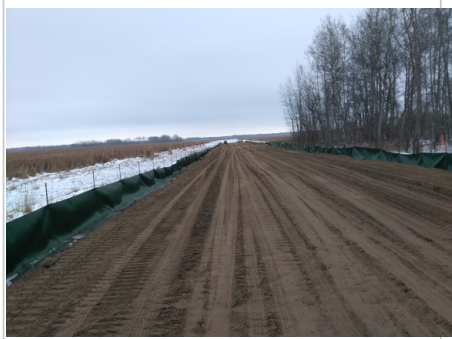
RD#27 (SSKP 839 +200 )

Aqua dam sf 27 going east  
Banister prepping the site to pump water  
Photo taken facing east

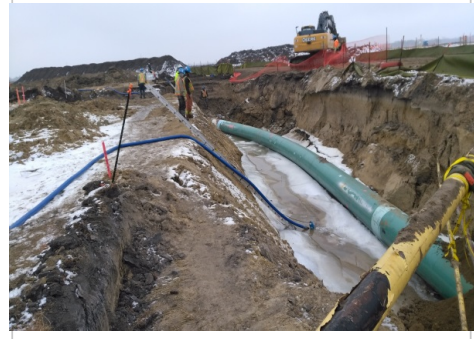
RD# 17 (SSKP 824 +900 )

Banister cleaning the ice out of the trench  
Photo taken facing south

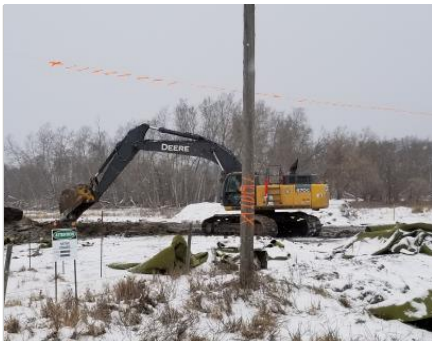
Description & Location KP-821+183 51 N

Photo taken facing north.  
Excavator digging up the frozen sand.

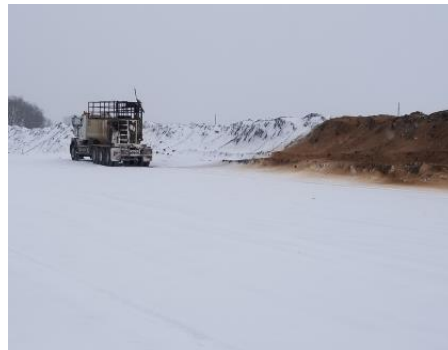
Description & Location KP-813+200

Photo taken facing west.  
Workers waiting to get more beet juice mixed with tree sap to continue on with the spraying .

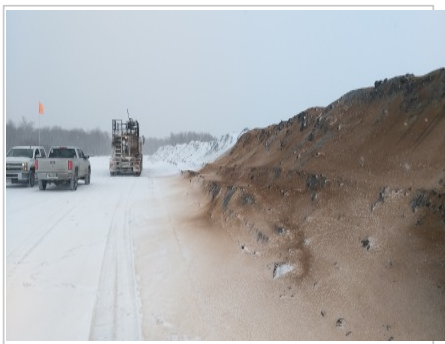
RD#5 (SSKP 816 +200 )

This is the tackifier crew  
This where they spray beet juice and tree sap. To keep the topsoil from being blown away. Photo taken facing east

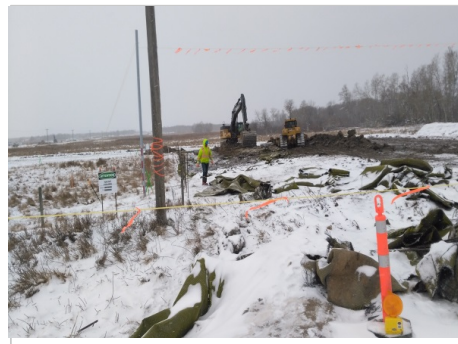
RD# 14 (SSKP 821+100 )

Banister clean up crew at sf 14  
Crew is doing a very good job of cleaning  
Photo taken facing west

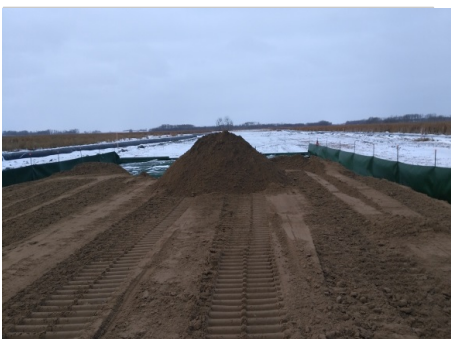
RD#28 (SSKP 840 +882)

Banister at sf 28  
Banister hauling sand across the wetland  
MB-054 semi permanent marsh (class 4)  
Photo taken facing west

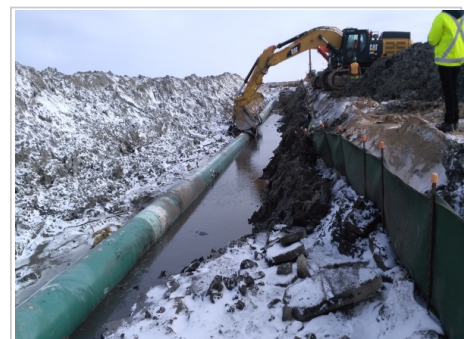
RD#28 (SSKP 848 +400 )

Banister doing some back filling at sf 28.  
They are using eco bags on top of the pipe as a anchor they use these in wetland area. Photo taken facing east

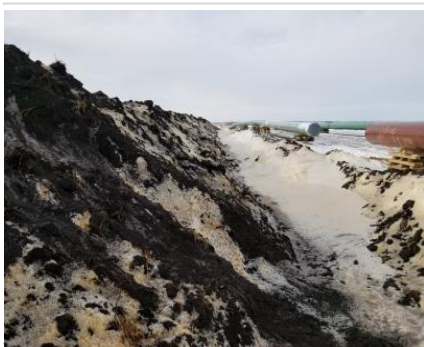
Description & Location KP-903+400

Photo taken facing north.  
Workers finished spraying the beet juice to the top soil.

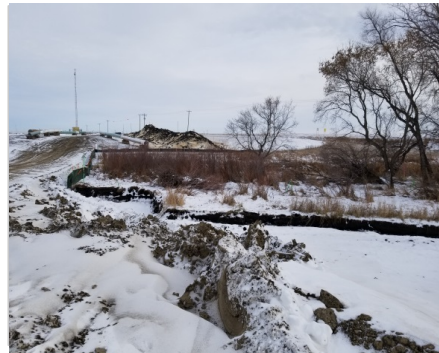
Photo taken facing east.  
Workers went around the water course crossing. MB-WC-31. ID # Drainage SSKP 903.09

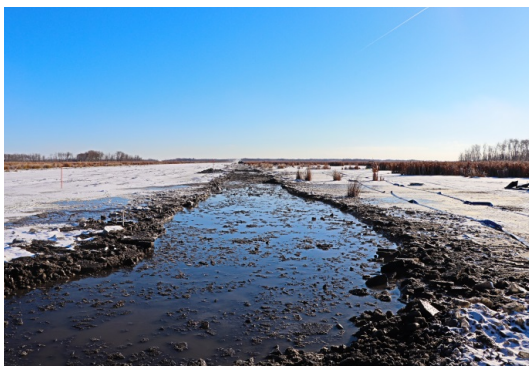
Description & Location: SSKP 839+000

Access Crew  
Snow Cat far ahead breaking ice in a row  
Workers will be installing aqua dams  
Facing east

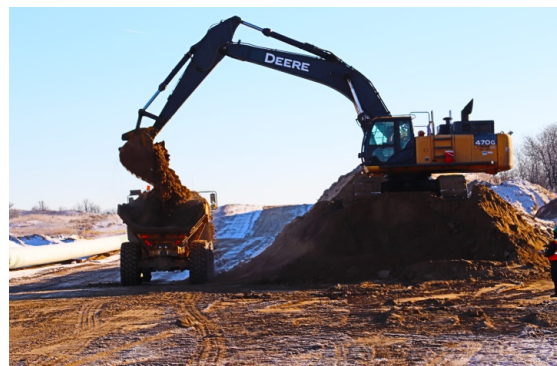
Description & Location: SSKP 843+000

Access Crew  
Excavator loading Rock truck with sand  
Rock Truck takes load to wetlands ramp  
Facing east

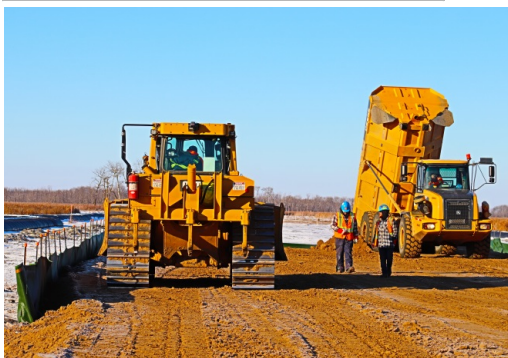
Description & Location: SSKP 840+575

Access Crew  
Rock Truck dumps sand  
Dozer pushes it on wetland ramp  
Facing west

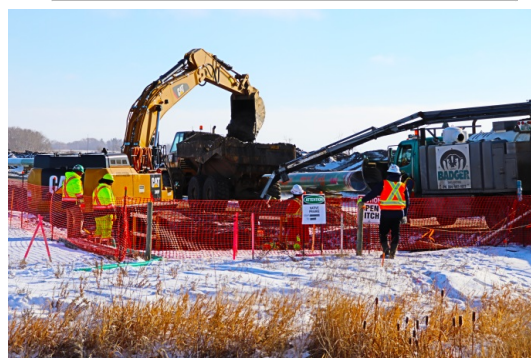
Description & Location: SSKP 863+385

C86:BT109 HD Bore Crew # 1  
Digging wet soil out of trench box  
Hydro-vac sucking up water in trench box  
Facing southeast
