**SWAN LAKE FIRST NATION – MATRIX SOLUTIONS  
INC. PARTNERSHIP**

**INDIGENOUS CONSTRUCTION MONITORING**

**WEEKLY REPORT**

**SPREAD 7**

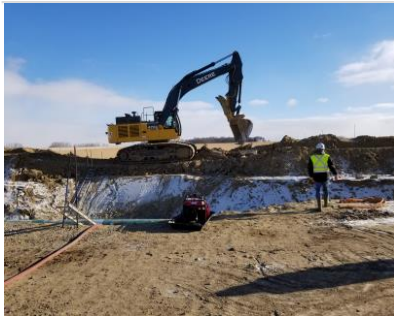
Description & Location KP- 827+332.7

Photo taken facing east.  
Excavator back filling the pipe in the open ditch.

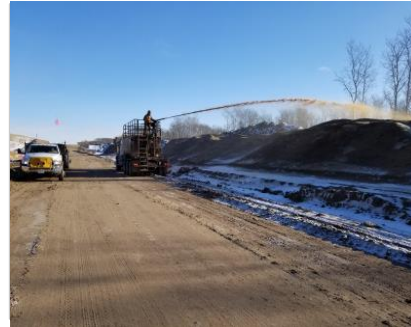
Description & Location KP-843.75+843.91

Photo taken facing east.  
Workers spraying the beet juice onto the topsoil.

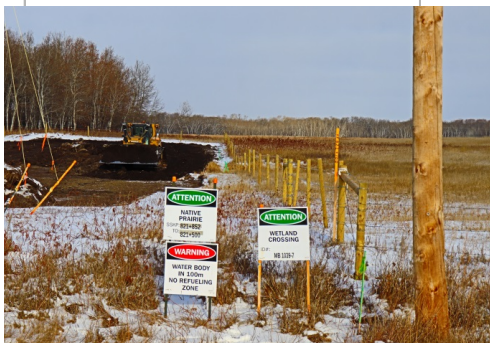
Description & Location: SSKP 822+050

SSKP 822+050 Clean Up crew working in Native Prairie at SSKP 821+852 and wetland MB-1039 Semi-Permanent Marsh Class 4 Wetland Complex SSKP 822+050 They are removing wetland ramps and replacing organics between Rd #14 and Rd #15.

Clean Up Crew  
Dozer replacing organics and touching up  
Working in Native Prairie and Wetlands  
Facing north

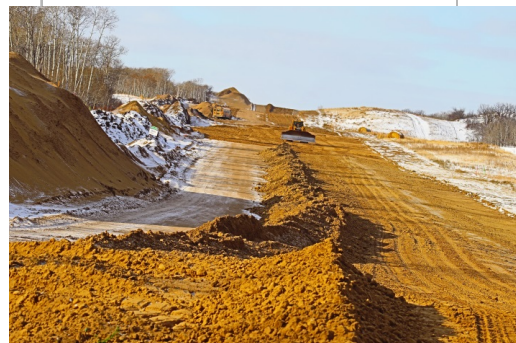
Description & Location: SSKP 844+550

SSKP 844+550 Clean Up crew levelling subsoil and replacing cuts east of Rd # 28. They are working through wetlands MB-064 Ephemeral/Temporary Marsh Class 1 & 2 SSKP 844+450.

Clean Up Crew  
Dozer Leveling subsoil & replacing cuts  
Conditions on ROW are dry and frozen  
Facing west

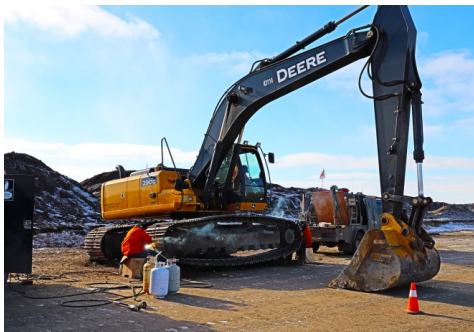
Description & Location: SSKP 849+100

SSKP 850+100 Welders welding corks on Excavator tracks for better traction as areas on our ROW have become hard packed snow and heavy equipment can slide especially on slopes and uneven grade. There also working in wetlands MB-073 Seasonal Marsh Class 3 Wetland Complex SSKP 850+100.

Buffer Crumb Crew  
Excavator get corks welded on  
They need them for traction in winter  
Facing southwest

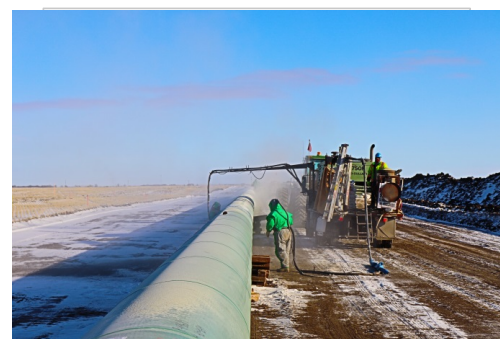
Description & Location: SSKP 896+100

SSKP 896+100 Coating Mainline had good conditions to blast and coat as there was no snow or heavy winds, they worked through wetlands including MB-123 Seasonal Marsh Class 3 Wetland Complex SSKP 894+510, MB-124 Ephemeral/Temporary Marsh Class 1 & 2 SSKP 894+700, MB-125 Ephemeral/Temporary Marsh Class 1 & 2 SSKP 894+780, MB-126 Ephemeral/Temporary Marsh Class 1 & 2 SSKP 894+890 and MB-127 Ephemeral/Temporary Marsh Class 1 & 2 SSKP 895+520.

Coating Mainline Crew  
3 Blasters blasting pipe for coating  
Conditions were good for coating  
Facing east

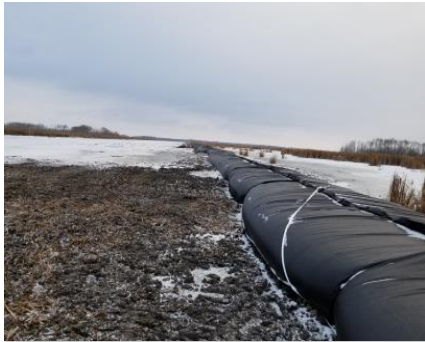
Description & Location 838+132.8

Photo taken facing east.  
Walked into the wetlands. Clean and organized. Ephemeral temporary marsh Class 1 & 2. MB-53.

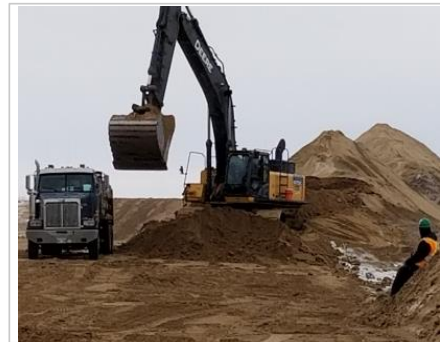
Description & Location KP-843+400

Photo taken facing east.  
Excavator loading sand into the tandem truck. Wetland crossing MB-061.

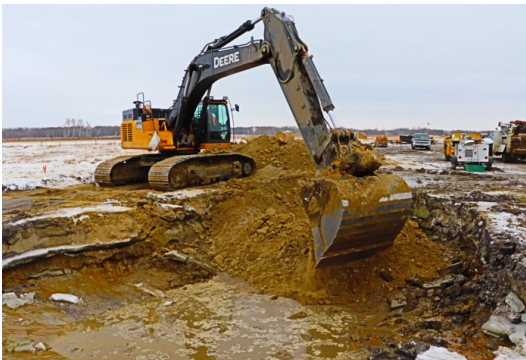
Description & Location: SSKP 836+419

SSKP 836+420 Wetlands Crew Excavator prepping RD #26 east for open cut on Thursday and they also pumped the water out. Working in wetlands MB-1049 Seasonal Marsh Class 3 SSKP 836+420. SSKP 854+060 Lots of activity in this area. HD Bores crew #1 is reaming 42" and pull bore section at Rd #32 with the "220".

Wetlands Crew  
Excavator preparing for open cut on Thursday  
They also pumped out water  
Facing northeast

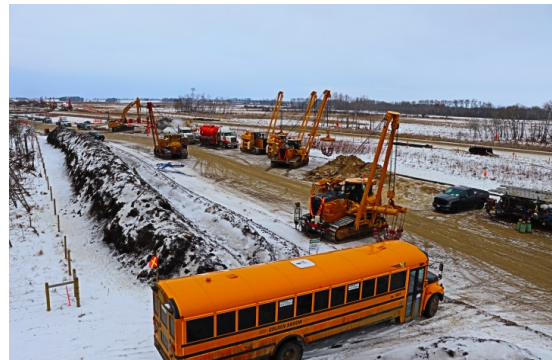
Description & Location: SSKP 854+060

HD Bores #1/Trenching/Lower In  
Trenching mobilizing at top left of picture  
Lower In waiting for trench clearance

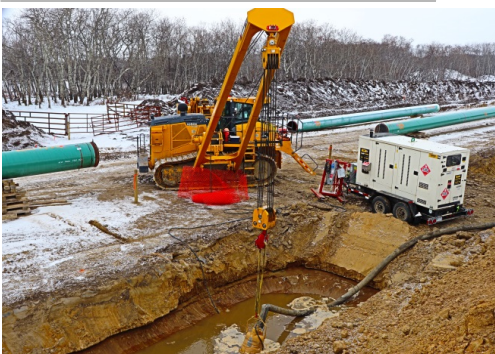
Description & Location: SSKP 854+464

a generator on sled trailer to pump water out of ditch using a 6" hose. The side Boom uses a larger water pump and lowers it in the water hooked up to a sling.

Lower In Crew  
Using larger generator to pump water  
On sling is the pump that the Boom lowers  
In wetlands photo facing southwest

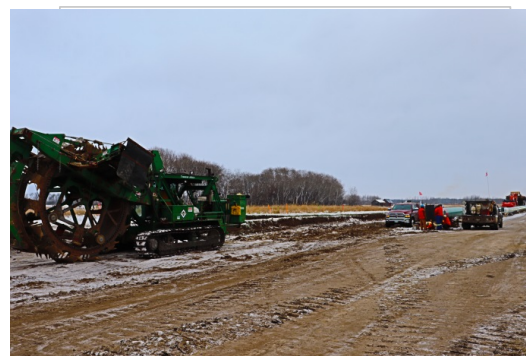
Description & Location: SSKP 855+072

SSKP 855+072 Trenching Crew working through wetlands MB-081 Broad-Leaf Treed Swamp SSKP 854+650 & MB-082 Broad-Leaf Treed Swamp SSKP 855+150.

Trenching Crew/Welders  
Excavator and Ditcher digging ditch to right  
Welders welding plate to seal pipe

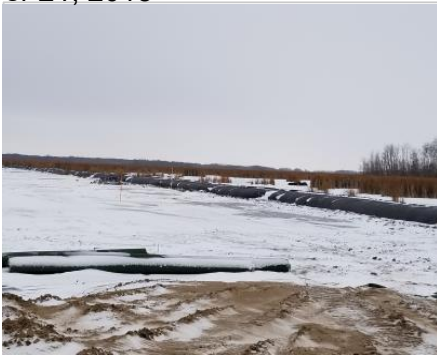
Description & Location KP-838+132.8

Photo taken facing east.  
Aqua dam frozen. Light snow cover on the wetlands. Ephemeral temporary marsh. Class 1 & 2.

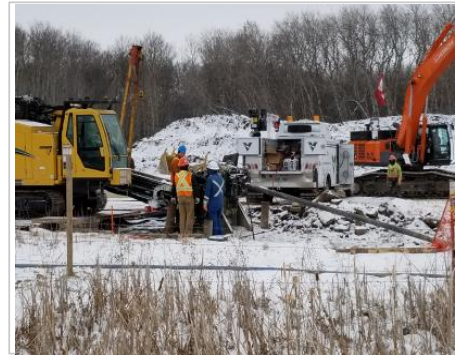
Description & Location KP- 853+629.2

Photo taken facing south.  
Horizontal drill being inspected by the workers.

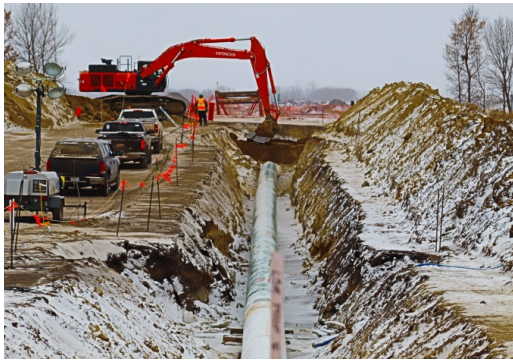
Description & Location: SSKP 826+545

SSKP 826+545 Tie In Backfill in area. Excavator filling trench and using bucket to pack soil down. Spotter with excavator to watch out for rocks which can hit pipe and sometimes require repair.

Tie In Backfill Crew  
Excavator Backfilling trench and packing  
Spotter watching for clumps/rocks  
Photo facing west

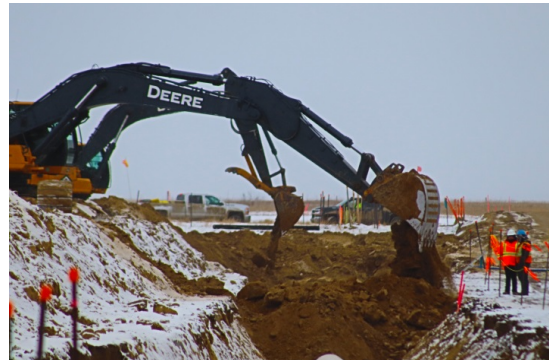
Description & Location: SSKP 827+750

SSKP 827+750 Tie In Backfill filling ditch with subsoil. Excavator mixes and breaks up soil as it freezes in colder weather making the soil come out of piles in chunks that can damage the coating on pipe. They also can cause indications that they call buckles

when they test pipe. When they use more fine soil it works more efficiently as dig ups can be costly.

Tie In Backfill Crew  
Two Excavators Backfilling trench  
The white hat (right) is Indigenous and is a Junior Inspector, facing south

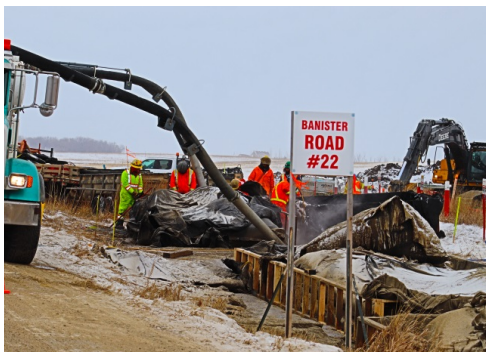
Description & Location: SSKP 829+253

SSKP 829+253 Two Hydro-vacs cleaning up overflowed pig pens that contain and filter water they pump out of trenches. Also in area is Tie In Backfill. They are also working in wetlands MB-039 Ephemeral/Temporary Marsh Class 1&2 SSKP 829+200 and MB-1039b Seasonal Marsh Class 3 SSKP 829+260.

Two Badger Hydro-vacs  
Cleaning out pig pens with suction hose  
They break it up with high pressure water  
Tie In Backfill in area, facing southwest

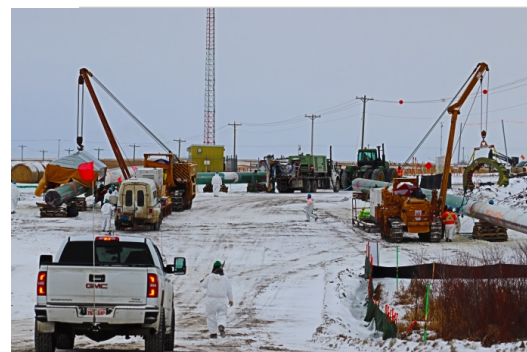
Description & Location: SSKP 902+102

SSKP 902+102 Coating Mainline working through several sensitive areas. Wetland MB-129 Seasonal Marsh Class 3 Wetland Complex SSKP 901+510. Watercourses MB-WC30 Drainage SSKP 901+970, MB-WC84 Drainage SSKP 902+530 and MB-WC31 Drainage SSKP 903+090. Buffer Mulch Crew was in the areas as well and they passed Mainline Coating today.

Coating Mainline at Rd #62 crossing  
Coating through wetland and watercourse  
Tractor pulling sandblast truck

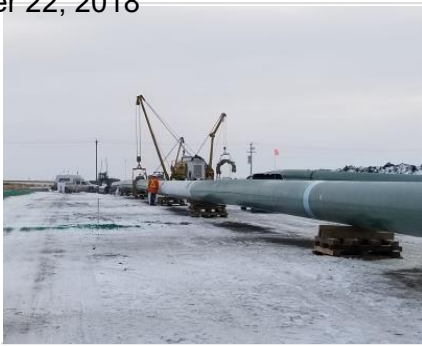
Description & Location KP-904+100

RD # 62 KP-904+100. Coating crew coating the pipe. Clean and organized. No issues.

Photo taken facing east.  
Coating crew coating the pipe .

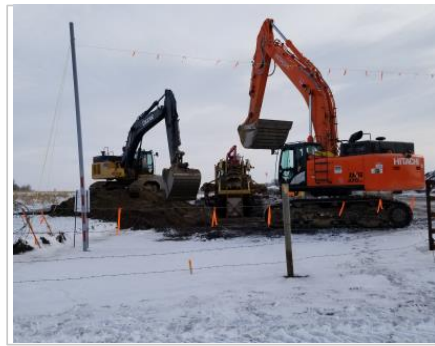
Description & Location KP-858+335.0

RD # 34 KP-858+335.0 Workers cleaning the ditch wheel scoops. Excavators removing the fallen debris from the trench. Farmer hauling manure at the cattle crossing that banister put up.

Photo taken facing east.  
Ditch wheel digging a trench. Excavator taking the sand that is falling back into the trench.

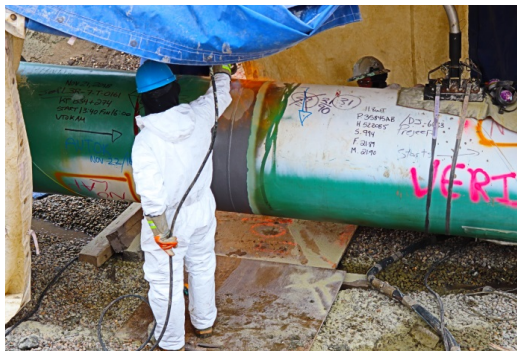
Description & Location: SSKP 834+240

SSKP 836+000 Tie In Backfill Crew is backfilling ditch. They are hauling subsoil from SSKP 835+380 as another Excavator is loading Rock Truck in HER-155 Traditional Land Use area. SSKP 834+240 Coating Tie Ins working in wetland MB-046 Open Water Pond Class 5 SSKP 834+220. The coating applicator was heating up pipe with tiger torch getting rid of moisture and to get proper temperature to apply coating.

Coating Tie Ins  
Heating the weld for applying coating  
They heat pipe to 120 degrees and apply at 90 degrees  
Working in wetlands, facing north

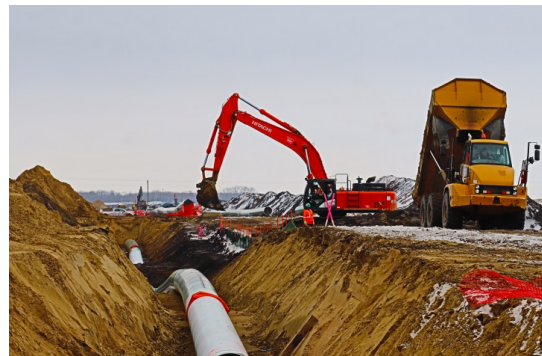
Description & Location: SSKP 836+000

Tie In Backfill, facing east  
Excavator backfilling ditch and packing soil  
Rock Truck unloading soil for backfill

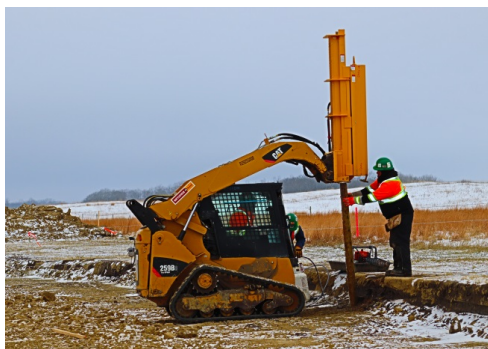
Description & Location: SSKP 849+930

SSKP 849+930 Skidsteer with post pounder attachment pounding posts making alleyway across ROW for cattle. In frozen conditions in the soil they use propane and

tiger torch to heat ground than they use an auger to start a pilot hole for the post pounder. There working through wetlands MB-072 Ephemeral/Temporary Marsh Class 1&2 SSKP 849+930. SSKP 853+629 HD Bores # 1 pulling bore section under Rd #32. There using a 42" reamer attached to 36" pipe to give it more room to pull through.

Fencing Crew  
Skidsteer with post pounder pounding post  
They heat up ground with torch first  
Than use an auger to start a pilot hole  
Facing northwest

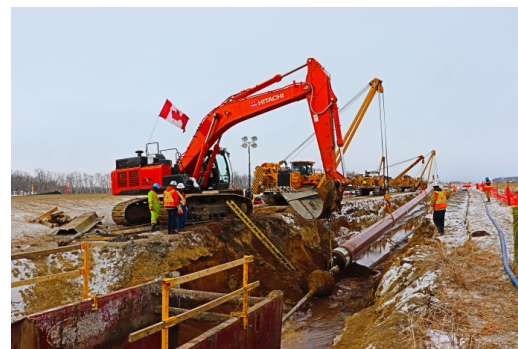
Description & Location: SSKP 853+629

HD Bores Crew #1  
Side Booms lining up pipe to pull rod  
The Reamer 42" is bigger than pipes 36" size so its easier to pull and has more room, facing northwest

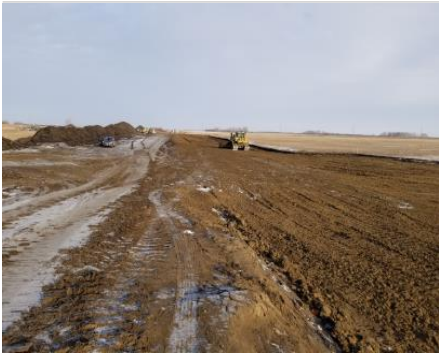
Description & Location KP-827+600

Photo taken facing north.  
Dozer leveling off the right away.

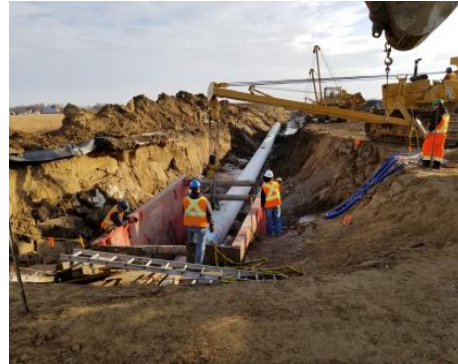
Description & Location KP-836+409.1

RD # 26 KP-836+409. Observing the excavator back filling the open cut. Lighting plant well contained. Compact test to be done as they go along. RD # 27 SSKP-839+580. Excavator loading the rock truck with sand from the borrow pit to haul to the wetlands. MB-053. Ephemeral temporary marsh. Class 1 & 2. Wetlands complex. SSKP 839+580.

Photo taken facing east.  
Workers guiding the excavator to backfill  
the pipe at the open ditch.

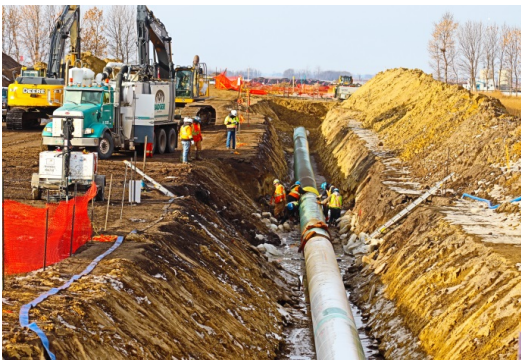
Description & Location: SSKP 826+645

SSKP 826+645 Tie In Crew cleaning out ice in ditch around pipe inside bell hole. Hydro-vac sucking out water in trench west of Rd #20.

Tie In Backfill Crew  
Cleaning out ice away from pipe  
Getting weld ready for rescan  
West of Rd #20

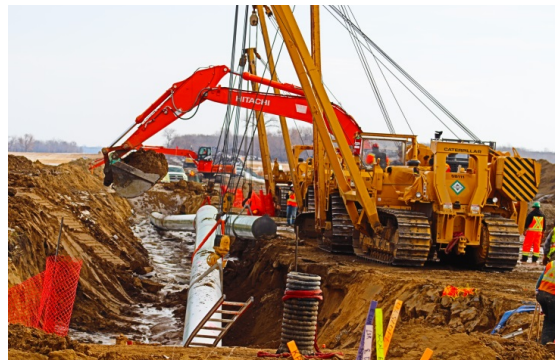
Description & Location: SSKP 829+303

SSKP 829+303 Tie In Crew Side Booms holding two ends of pipe in air with sling while the Excavator digs out soil to make room in ditch to start tie in with welders.

Tie In Crew  
Excavator digging out bell hole  
Side Booms holding pipe in slings  
Facing east

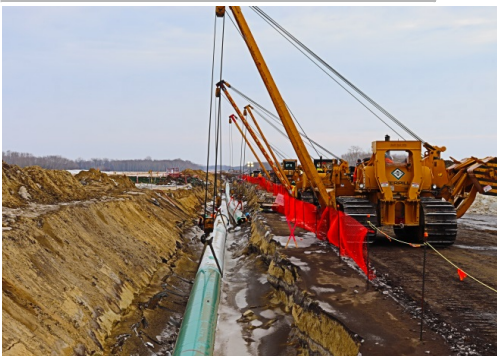
Description & Location: SSKP 832+561

SSKP 832+561 Tie In crew workers breaking ice off of pipe in bell hole. Side Booms holding pipe in slings. There getting area ready to be welded in safely.

Tie In Crew  
Workers cleaning out ice in bell hole  
Side Booms supporting pipe in slings  
Facing east

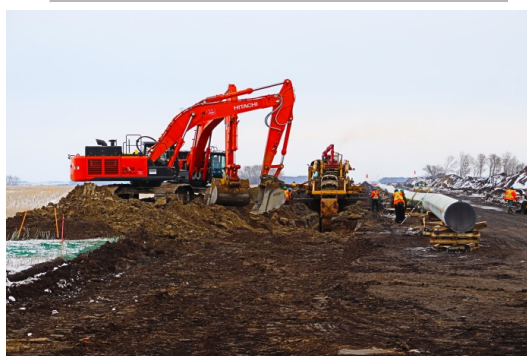
Description & Location: SSKP 860+070

SSKP 860+070 Trenching Crew digging out trench so they can lower in pipe. They are also working in wetlands MB-086 Broad-Leaf Treed swamp SSKP 859+230, MB-087 Ephemeral/Temporary Marsh Class 1&2 SSKP 859+760, MB-088 Seasonal Marsh Class 3 SSKP 859+970 and MB-089 Ephemeral/Temporary Marsh Class 1&2 SSKP 860+810. RD # 21 KP-827+600. Dozer levelling off the right of way. Clean and organized. RD # 22 east. KP829+253. Observed the workers filling in the trench. Workers doing the tie-ins. 3 side-booms holding the pipe. Clean and tidy. No concerns.

Trenching Crew  
Digging through wetlands  
Conditions starting to get muddy  
Facing east

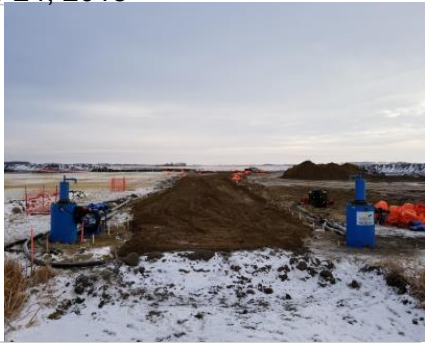
Description & Location KP-808+568.2

Photo taken facing east.  
Leveled off the right away. Clean and tidy.

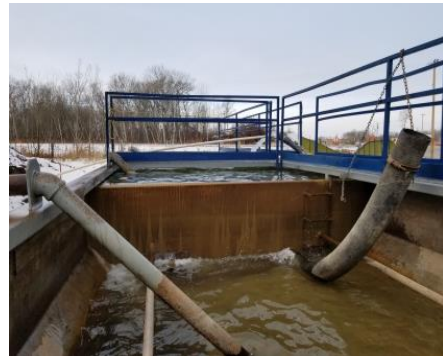
Description & Location KP-819+432.5

Water Containment Tank  
Facing east

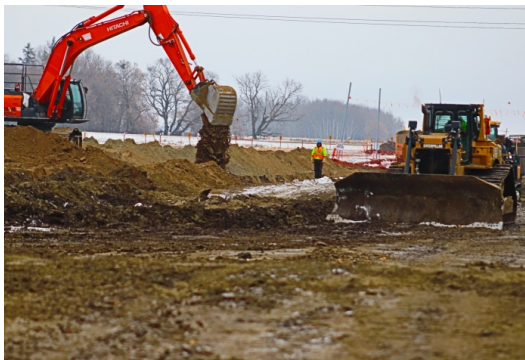
Description & Location: SSKP 858+200

SSKP 858+200 Mainline Backfill Crew in area backfilling trench. Excavator backfilling ditch while Dozer touches up ROW.

Mainline Backfill  
Excavator backfilling trench  
Dozer touching up ROW  
Facing east

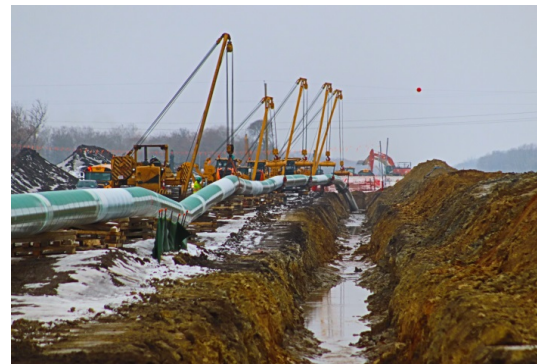
Description & Location: SSKP 859+050

SSKP 859+050 Lower In Crew waiting on water to be drained before lowering pipe. There is lost of water and they are using two large pumps to drain faster. Good job for the Lower In crew with all the water they've been dealing with.

Lower In Crew  
Waiting for water to be drained  
Backfill working in far background  
Facing west

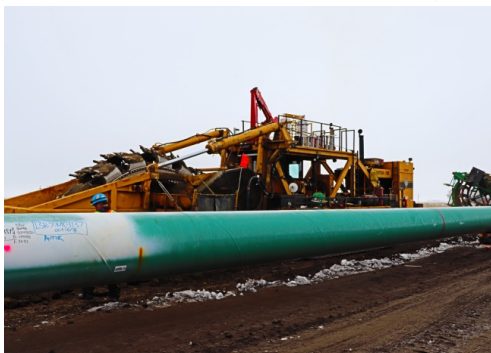
Description & Location: SSKP 860+000

SSKP 860+000 Trenching Crew Crew working through wetland MB-089 Ephemeral/Temporary Marsh Class 1&2 SSKP 860+810.

Trenching Crew  
Working through wetlands  
Ground conditions soft from warm weather  
Facing northeast

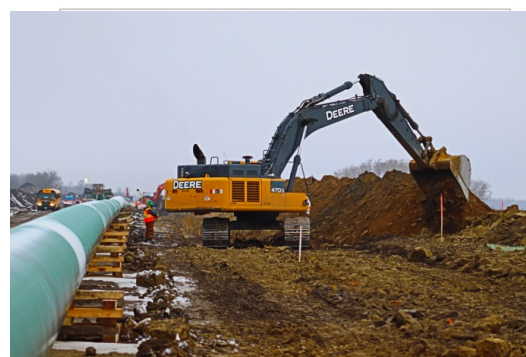
Description & Location: SSKP 861+500

Trenching Crew  
Excavator digging ditch  
Spotter measures depth to be dug  
Facing west
