**SWAN LAKE FIRST NATION – MATRIX SOLUTIONS
INC. PARTNERSHIP**

INDIGENOUS CONSTRUCTION MONITORING

WEEKLY REPORT

SEPTEMBER 24TH TO SEPTEMBER 30TH

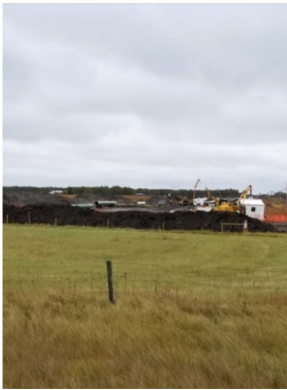
Sept 24/18 Description & Location KP- 821+006.251N
Photo taken west.
Side booms moving welding shacks.
Very congested and muddy

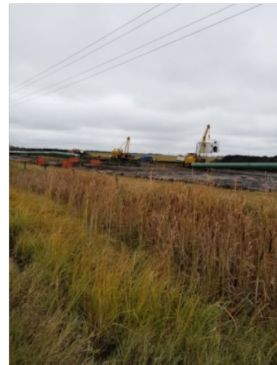
Sept 24/18 Description & Location KP-819+432.5 148 west
Photo taken facing east.
Pipe gang continuing welding

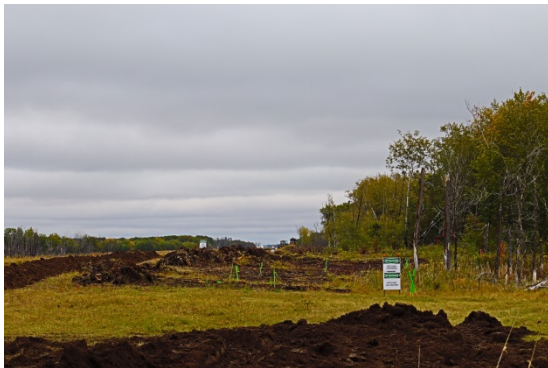
Sept 24/18 Description & Location: SSKP 855+115
Broad-Leaf Treed Swamp Wetland MB-081
Grade crew has started to strip by wetland
This area wasn't bad for rain
Facing East

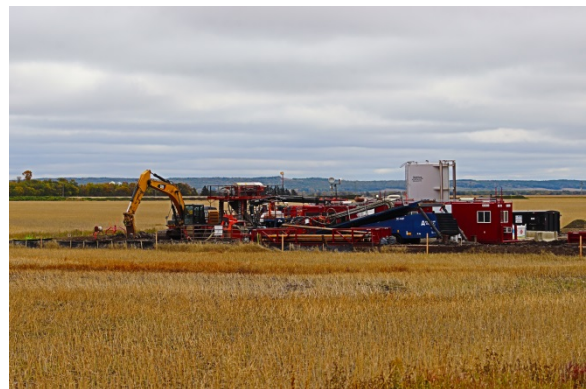
Sept 24/18 Description & Location: SSKP 899+250
Somerville HDD site on Banister ROW
Banister is prepping pipe to be pulled
Once they weld pull head on bore section they will pull it from here. Facing SE

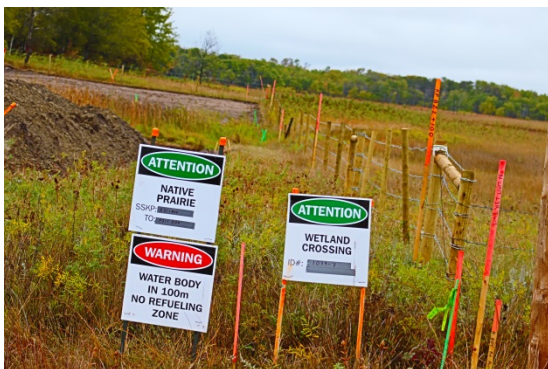
Sept 24/18 Description & Location: SSKP 821+100
Native Prairie and Wetland
Work in area is ongoing
Bore pipe installed under road- Facing North

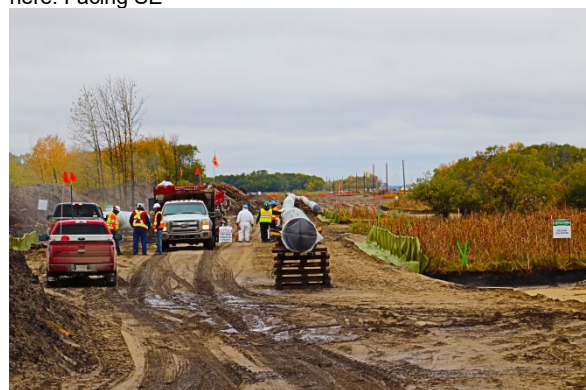
Sept 24/18 Description & Location: SSKP 817+665
Coating off sections at Rd # 6
Blasting pipe on left side
Coater in white waiting to paint – Facing West

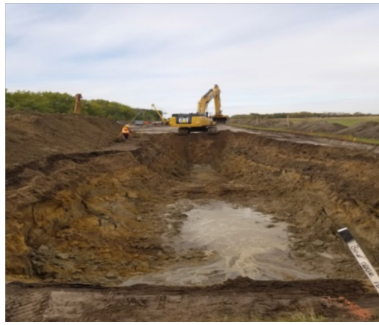
Sept 25/18 Description & Location: KP 830 + 899
Photo taken facing west
Excavator digging the open ditch ay SF # 23

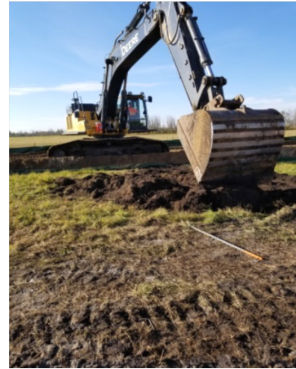
Sept 25/18 Description & Location: KP 811 + 300
Photo taken facing south.
Excavator removed the contaminated soil, than replaced it with fresh top soil at SF # 28

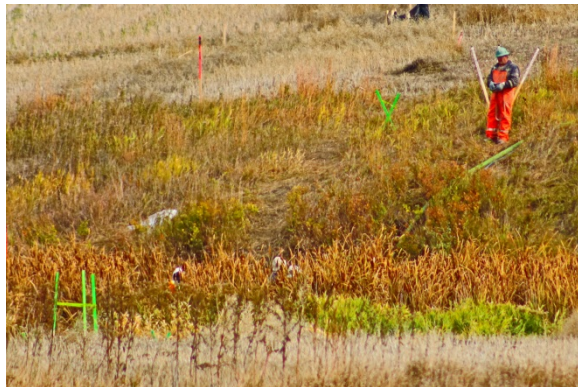
Sept 25/18 Description & Location: SSKP 899+760
Frack fluid coming through surface in Black Creek,
Environmental Inspector at left
Badger worker middle using suction & water
Operator to right, facing east

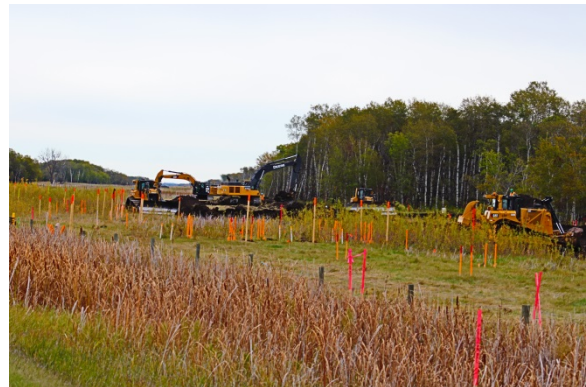
Sept 25/18 Description & Location: SSKP 835+735
Grade Crew stripping around wetlands
Dozers and Excavators Stripping soil
Lots of buried facility's mostly MTS
Facing south east

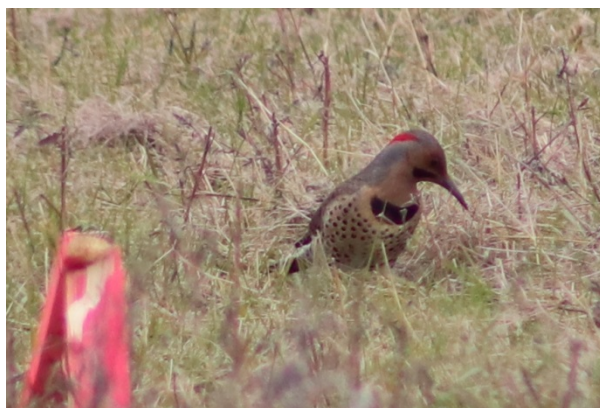
Sept 25/18 Description & Location: SSKP 863+270
Northern Flicker (Woodpecker)
Eating ants on our ROW
Pink broken stake 5 m buffer
Close to north boundary, facing west

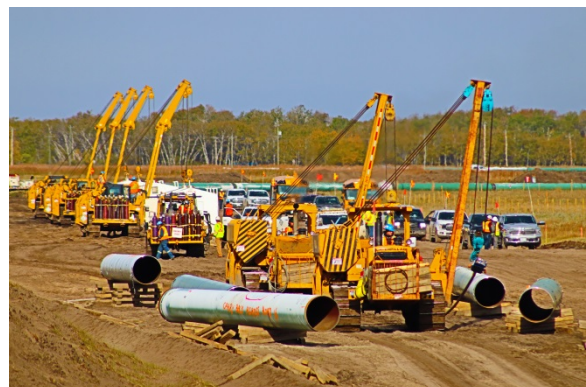
Sept 25/18 Description & Location: SSKP 823+025
Pipe Gang Welders in Wetland MB-1039
Just finishing there welding in wetland
Soil condition was starting to dry more
Facing west

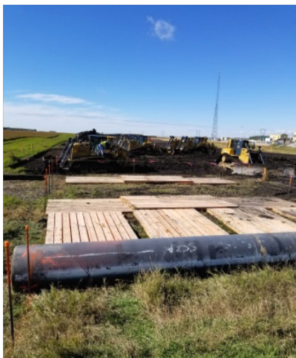
Sept 26/18
Description & Location KP-873+696.2 118 west
Photo taken facing west
Prepping to build a ramp under the road way

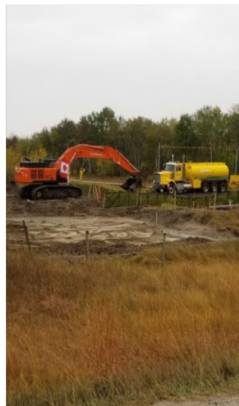
Sept 26/18
Description & Location: 819+432.5 148 west
Photo taken facing south
Excavator pulling tank truck from SF # 13 to SF # 12

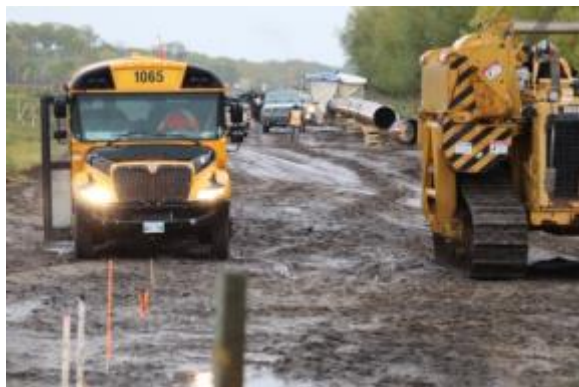
Sept 26/18 Description & Location: SSKP 841+750
Welding a bore section in wetland
Bus parked close to crossing as ROW is wet
Side Boom waiting to be loaded Facing east

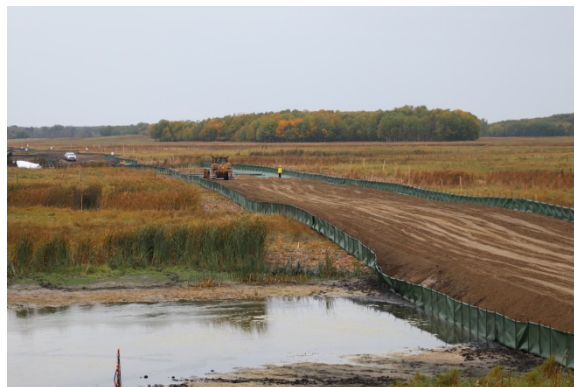
Sept 26/18 Description & Location: SSKP 848+ 750
Semi-Permanent Marsh Class 4 MB-071
A small pond south of wetland ramp
Facing north west

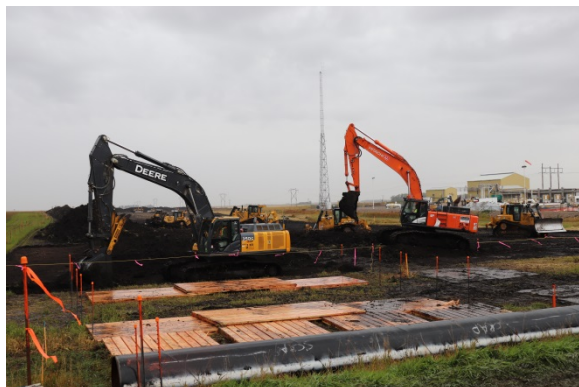
Sept 26/18 Description & Location: SSKP 873+800
Grade crew stripping by road crossing
Flume pipe ready for road approach
Enbridge Souris Station in upper right
Facing north west

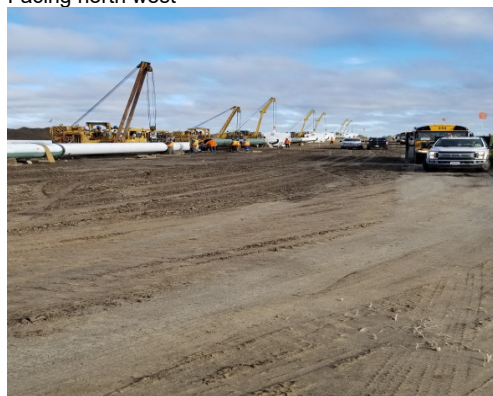
Sept 27/18 Description & Location KP-821-200
Photo taken facing west.
Prep gang preping the pipe for the welders
Main gang welding the pipe.

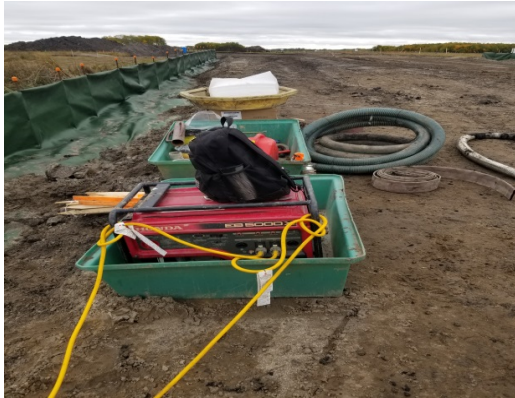
Sept 27/18 Description & Location KP-848+350
Photo taken facing west.
Generator and fuel jugs are well contained.
At SF # 29 wetlands complex MB 0571.
Semi permanent class four.

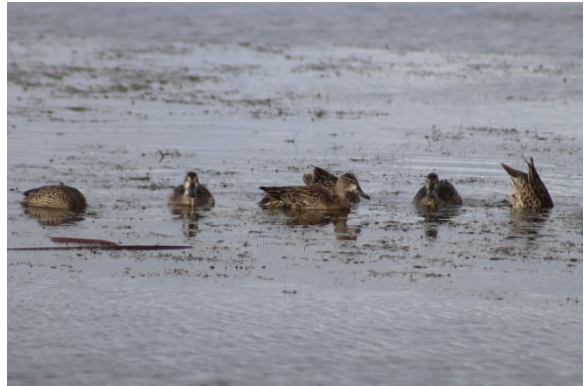
Sept 27/18 Description & Location: SSKP 848+400
6 Mallard ducks on ROW
Eating was easier due to lowered water
These ducks left once water drained
Facing west

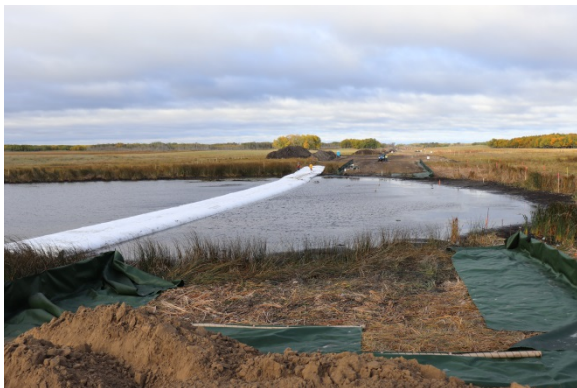
Sept 27/18 Description & Location: SSKP 848+400
Aqua Dam just completed
Draining water to left of dam
If you zoom in you can see 6 ducks to right
Facing west

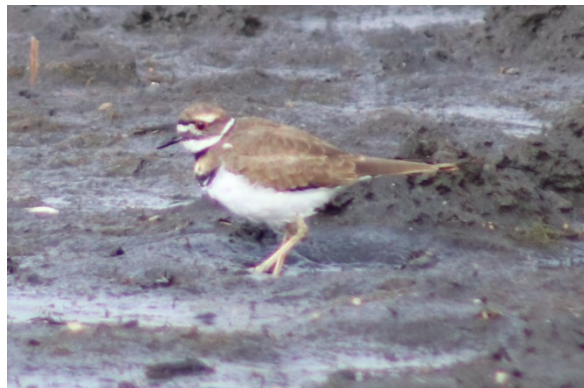
Sept 27/18
Killdeer bird on ROW
Water was drained attracted wildlife
This bird was eating snails
Facing west

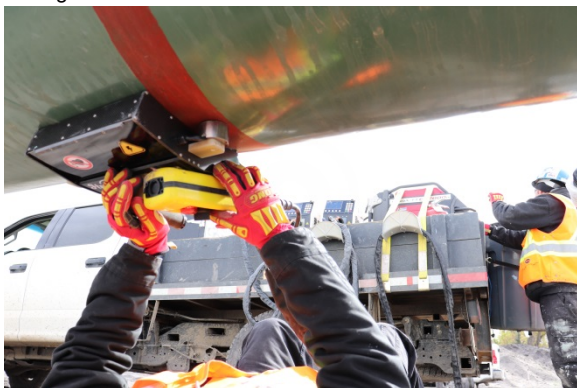
Monitored the mainline coating crew and they did good as they welded over 40 today the most done so far on this job for one day. Only concern I had I addressed it, the repair crew for coating missed a repair and I reminded the contractor worker for banister who is also my friend of 9 years to make sure you double check before going forward. 10 minutes later the foreman called them back about 150 m to fix a repair they missed. It's day one for coating and they will get better as they go along. Also noticed they designated a worker to pick up any coating on the ground that was missed by spill board that was caused by mainline paints, as it was windy today the coating can blow away from spill board and unto the ground. The repair crew was using a new device called the Isolated Induction heat. It's like the mainline coil used for induction hit but this new device is smaller and made for repairs and is a lot more efficient than using a torch, as a torch can burn coating and make it brittle. SF # 5 Water pump and fuel jugs are well contained. Crew workers cleaning up west side of SF # 5. No concerns SF # 21 Welding gang near the entrance of SF # 21. Prep crew are at SF # 21 entrance. SF # 28 West side clean and tidy. No concerns. SF # 29 Workers at the aqua dam pumping water out of north side of the wetlands of SF # 29 to the south side of the wetlands of SF # 29. MB 071.

Sept 27/18 Description & Location: SSKP 812+700
Isolated Induction Coil for repairs
This device is much more safe for repairs
Worker heating repair at 6'o clock, Device in hands on pipe

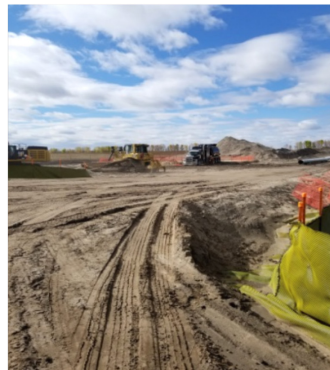
Sept 28/18 Description & Location KP-826 + 745
Photo taken facing west.
Worker spraying down his truck.
Dozer parked

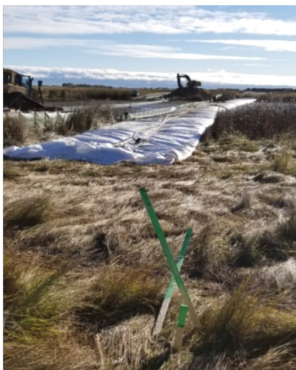
Sept 28/18 Description & Location KP- 848 + 400
Workers putting up the fence
Clean and tidy
MB 071. Wetlands complex. Class 4

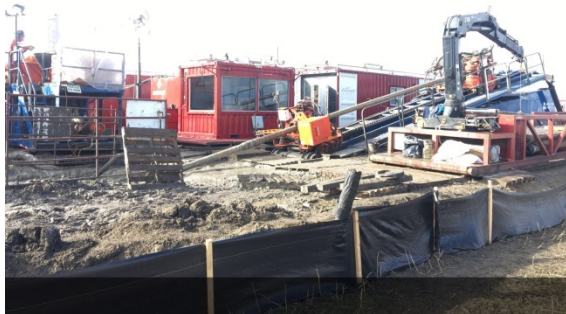
Sept 28/18 Description & Location: SSKP 899+350
HDD Bore site Black Creek
Currently reaming with 42" bit
Operator in dog house with windows - Facing SW

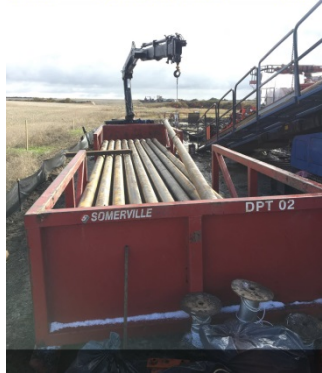
Sept 28/18 Description & Location: SSKP 899+350
HDD Bore site Black Creek
This is where they store rods for bore
They use hoist for hooking up and
dismantling rods, facing east

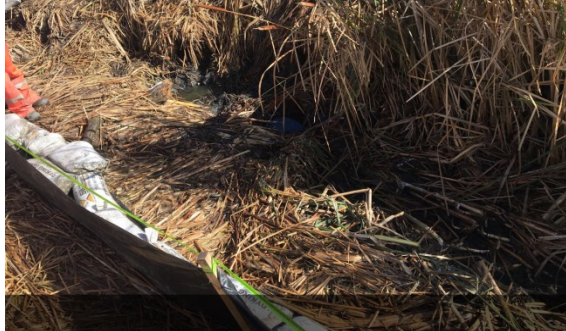
Sept 28/18 Description & Location: SSKP 899+650
Location in Black Creek
Frack fluid came through surface here
They did a good job containing it
Very good work by Enbridge & Badger

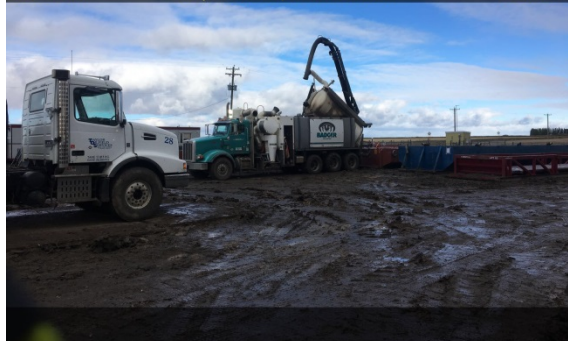
Sept 28/18 Description & Location: SSKP 899+350
HDD Bore site Black Creek
Badger hydro-vac dumping bad soil in bin
Conditions on site still slippery

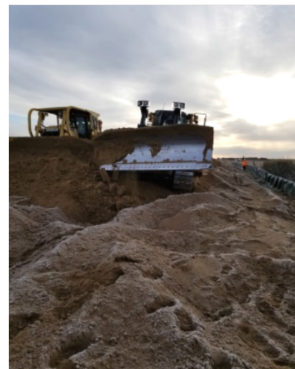
Sept 29/18 Description & Location MB-071
Photo taken facing east
Dozers pushing sand onto the wetlands
ramp at SF # 29 west.

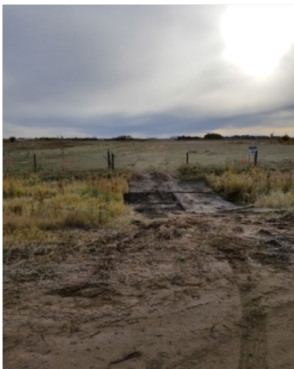
Sept 29/18 Description & Location 863+300)(864+000 Her-160
Photo taken facing east.
Archaeologist found old traditional (heritage site) 5000 years old.
Workers roping off the sensitive area off west

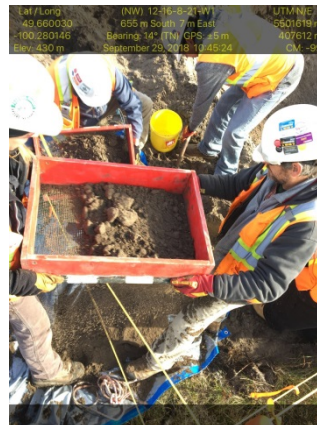
Sept 29/18 Description & Location: SSKP 863+371
Archeologists Screening for artifacts
Tarp on ground to keep soil off topsoil
Found several items while screening Facing north

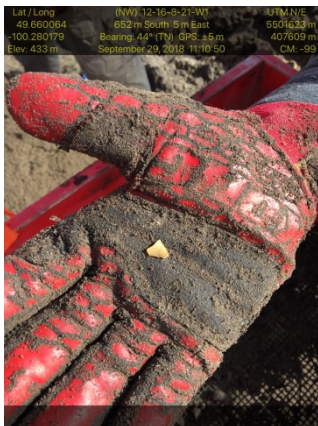
Sept 29/18 Description & Location: SSKP 863+371
Archeologist displaying the found flake
Was piece of a rock used to shape tools
Found Bones, flakes and burnt wood
Facing north

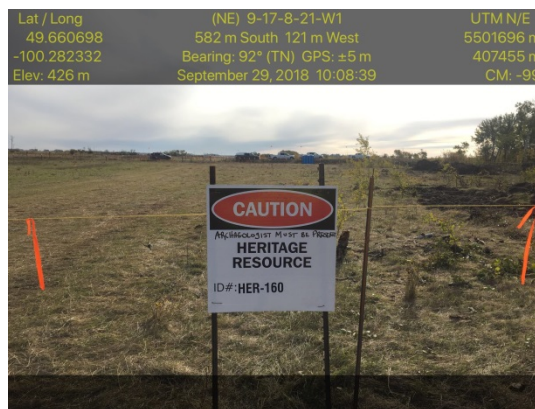
Sept 29/18 Description & Location: SSKP 863+050
Heritage Resource area
Only can strip soil with Archeologist present
Some already stripped to the right - Facing East

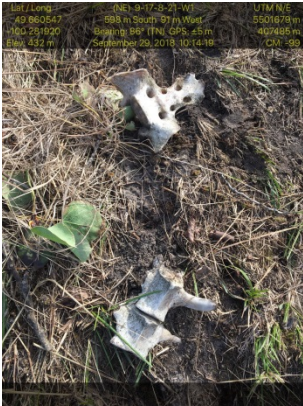
Sept 29/18 Description & Location: SSKP 863+300
In Heritage area found Deer bones
They were scattered over our ROW
I let the archeologists know their location
