**SWAN LAKE FIRST NATION – MATRIX SOLUTIONS  
INC. PARTNERSHIP**

**INDIGENOUS CONSTRUCTION MONITORING**

**WEEKLY REPORT**

**SPREAD 7**

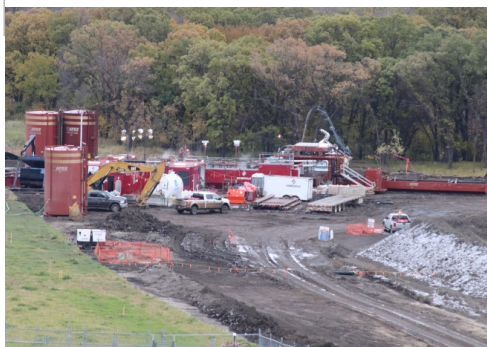
Description & Location: SSKP 907+000

Souris River HDD ( Somerville )  
Site wasn't too muddy starting to dry  
Swept the area was clean  
Facing east

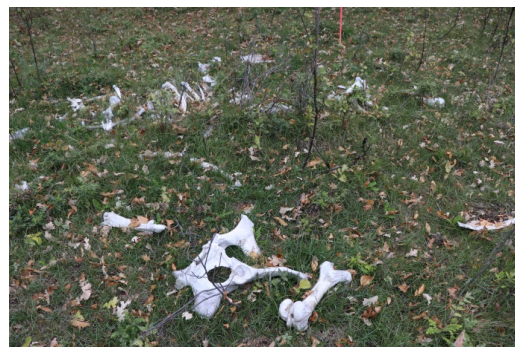
Description & Location: SSKP 907+150

Bones on ROW ( Cattle )  
Pink north boundary picture top of  
photo  
Was taken close to Souris River

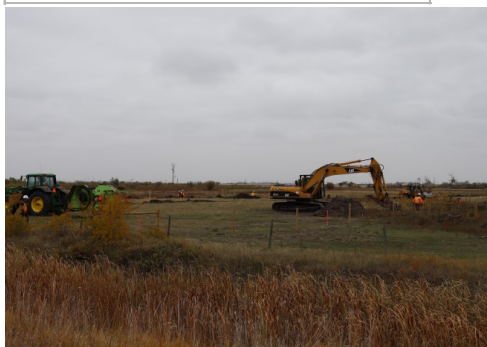
Description & Location: SSKP 863+600

Excavator back filling slurry pit  
Disking on the left  
Archeologist in middle  
Facing north east

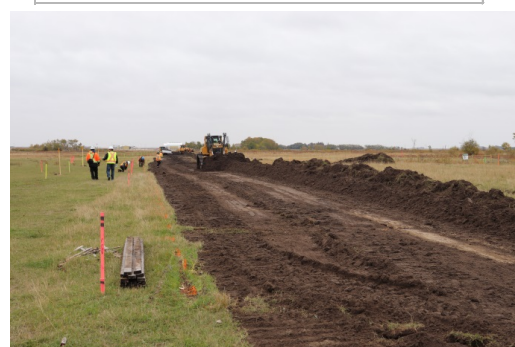
Description & Location: SSKP 864+210

Dozer stripping topsoil  
Archeologists in left side in picture  
Helped them scan the area  
Photo facing east

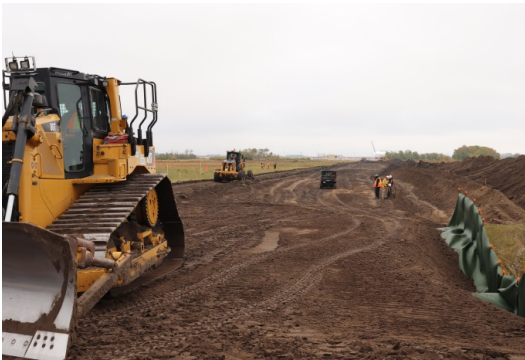
Description & Location: SSKP 863+400

Heritage and Wetland site  
Dozer on left back blading ROW  
Archeologists assessing ROW  
Photo facing east

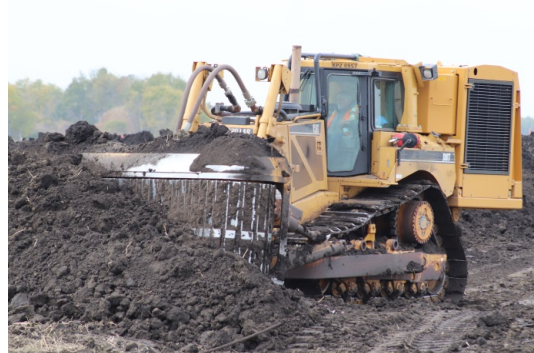
Description & Location: SSKP 877+780

Power Dozer pushing topsoil on ROW  
Pushing soil in Wildlife Feature  
The Northern Leopard Frog not in area  
Facing south west

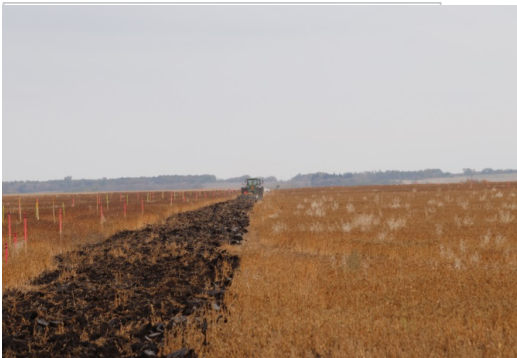
Description & Location: SSKP 879+610

Traditional Land Use Area (Moose)  
Tractor using disc to loosen topsoil  
Stakes to the left indicate north boundary  
Photo facing east

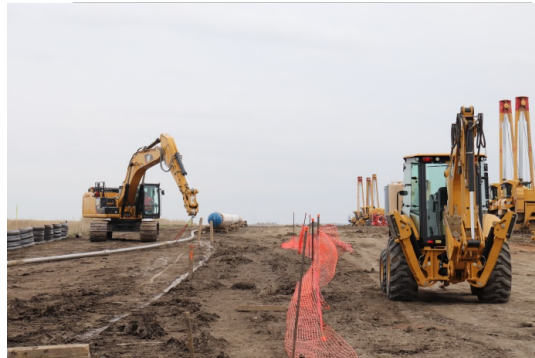
Description & Location: SSKP 899+760

East of Black Creek & the HDD section  
Excavator on left lining up pipe  
Pull Head (blue on pipe) welded  
Facing east

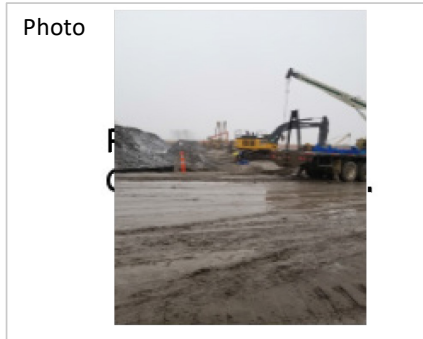
Description & Location KP-813 +200.0 Bone

Photo taken facing west.  
Workers picking up steel and loading it on the truck.

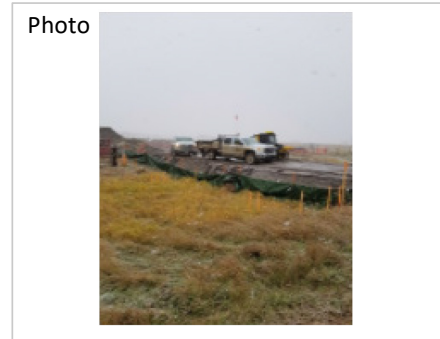
Description & Location KP-830+923.0

Photo taken facing west.  
Banisters workers waiting for the semi truck.

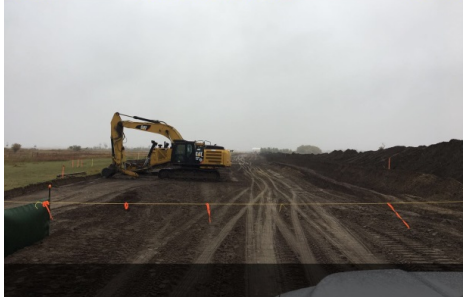
Description & Location: SSKP 838+500

Rd # 38 where the archeologists are  
Before snow 10am  
Facing east

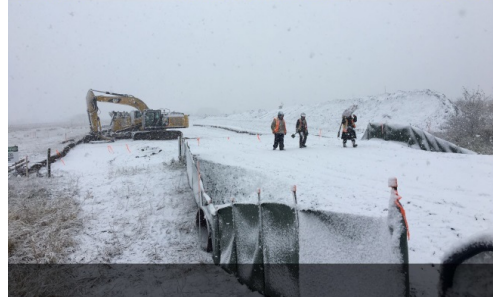
Description & Location: SSKP 838+500

Rd # 38 where the archeologists are  
Before after snow 11am  
Facing east

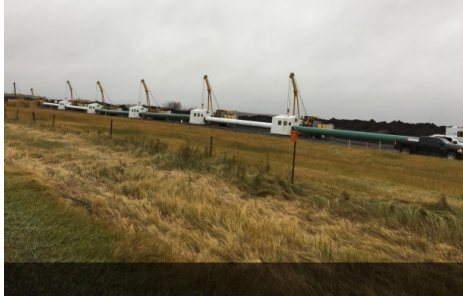
Description & Location: SSKP 838+500

Pipegang shut down  
Working through wetlands  
Facing Southeast

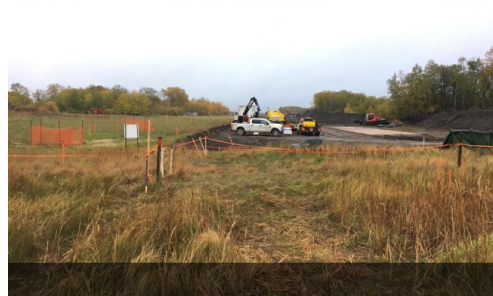
Description & Location: SSKP 838+220

HD Bore crew at Rd # 27  
Also shutdown from wet conditions  
Facing east

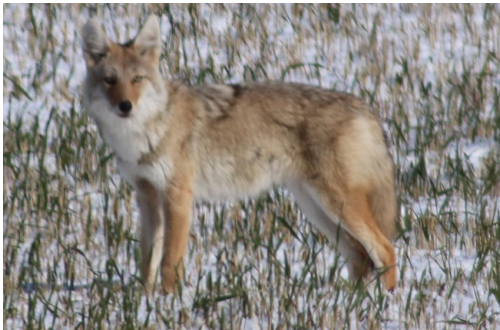
Description & Location: SSKP 847+500

Coyote just north of ROW  
There was 2 of them on ROW  
Lots of wildlife in this area  
Facing north

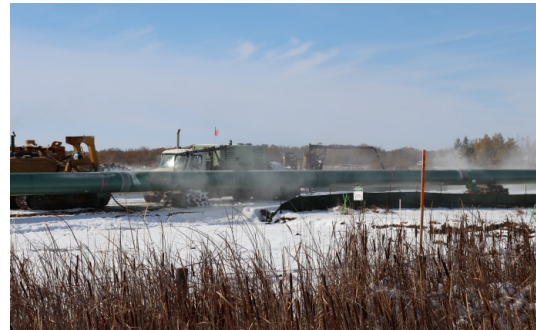
Description & Location: SSKP 820+400

Semi-Permanent Marsh Class 4 Wetland  
MB-1039 Blasting the weld  
2 Blasters on north and south of pipe  
Facing south

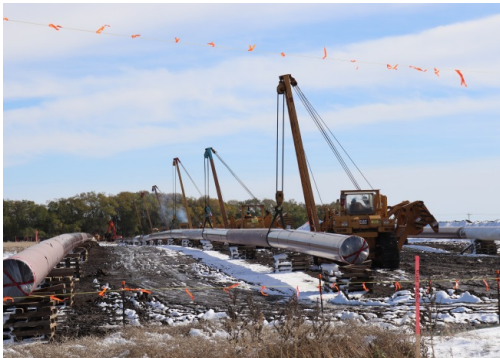
Description & Location: SSKP 907+900

Souris River HDD section  
6 Side-Booms holding pipe  
Being held and welded in middle (smoke)  
Facing east

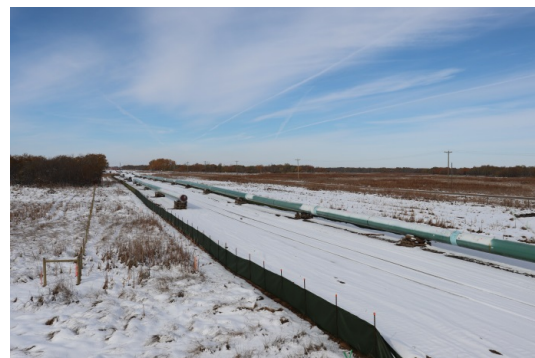
Description & Location: SSKP 819+150

Semi-Permanent Marsh Class 4 Wetland  
MB-1039 Wetland access ramp  
Coating completed welds  
Facing West

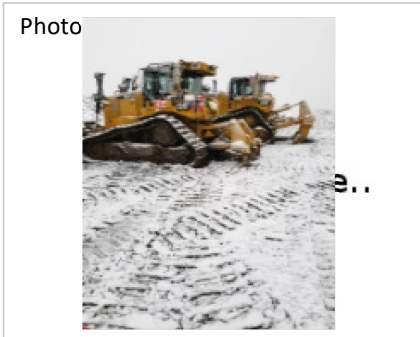
Description & Location KP-861+702.9

Photo taken facing west  
Parked dozers. Neat and tidy, No concerns

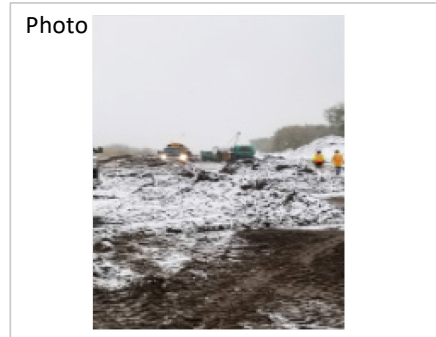
Description & Location KP-861+702

Photo taken facing east.  
Workers waiting for the go ahead to start work.

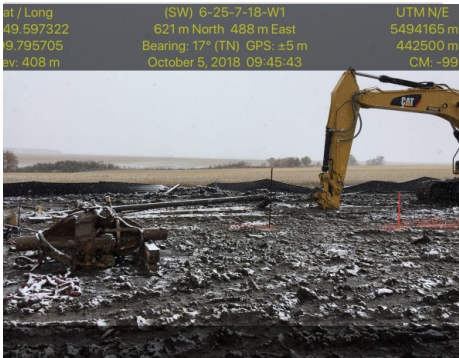
Description & Location: SSKP 899+750

Black Creek Bore exit  
Drill pipe ready to hook up  
42"inch reamer to left  
Facing north

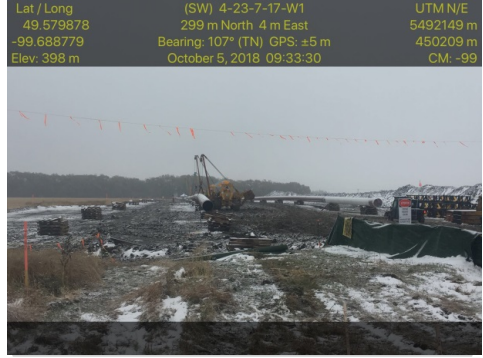
Description & Location: SSKP 900+100

Souris River second bore section  
Being welded for HDD pull  
Conditions are slippery  
Facing east

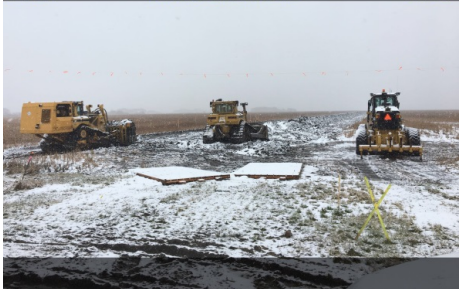
Description & Location: SSKP 840+750

Grade crew is shut down  
Conditions are very wet on ROW  
Power Dozer's and Grader in picture  
Facing east

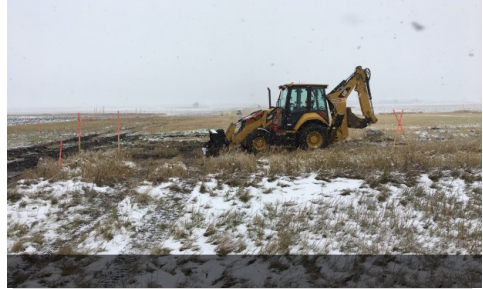
Description & Location: SSKP 890+850

Hydro vac crew starting to work  
Daylighting the Clipper line  
Facing east

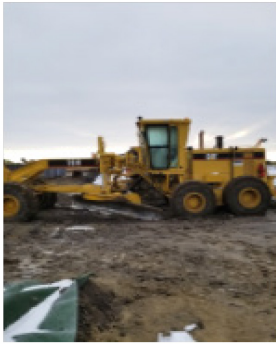
Description & Location KP-877+058.7

Photo taken facing east  
Checked parked equipment for leaks or  
spills.  
No concerns. Neat and tidy

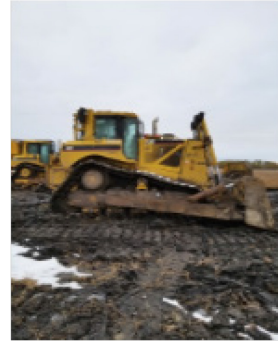
Description & Location KP-878+739.1

Photo taken facing east.  
Equipment parked safely. No concerns.  
Checked parked equipment for leaks,  
spills, garbage.

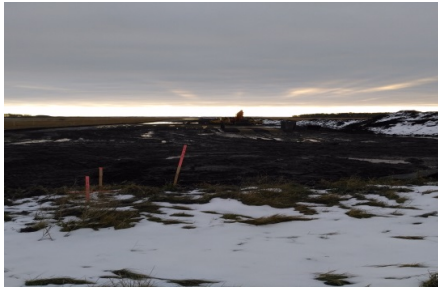
SF46(KP877+000)

Banister have started to strip the topsoil  
but had to stop because of the weather.  
PHOTO TAKEN FACING EAST

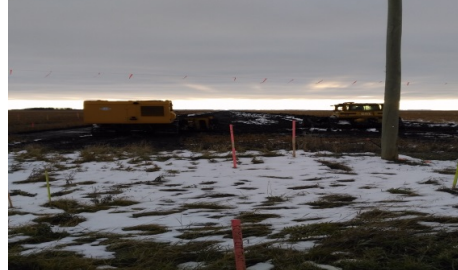
SF47 (KP878+800)

Banister had to stop stripping because of  
poor weather conditions.  
PHOTO TAKEN FACING EAST
