**MANITOBA METIS FEDERATION – MATRIX
SOLUTIONS INC. PARTNERSHIP**

INDIGENOUS CONSTRUCTION MONITORING

WEEKLY REPORT

SPREAD 7

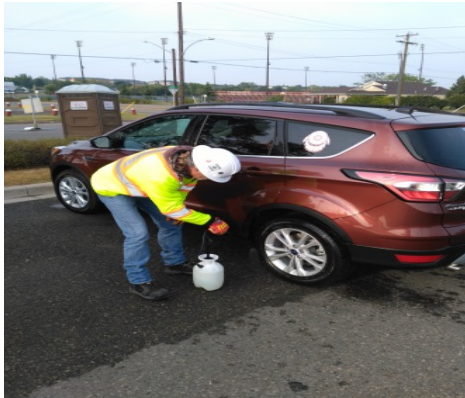
SF15 - Cleaning after sandblasting and coating - Brandon Coop Carwash

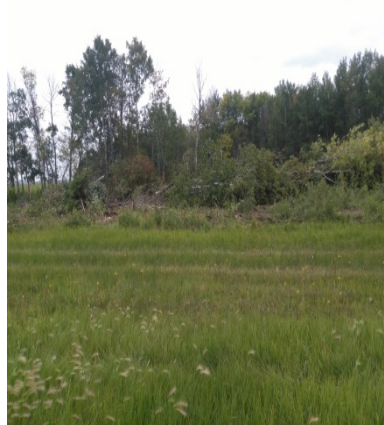
KP 831+200-831+300
Wetland habitat, facing south

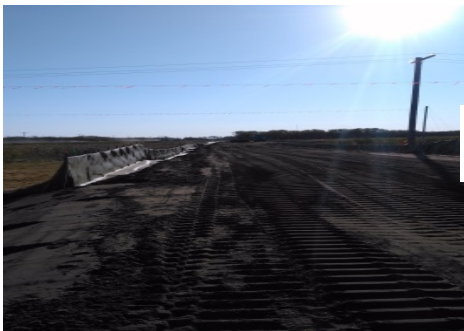
SF9 (KP818-500) SF9 (KP818-500)

September 1st, slips, trips, falls, wildlife, farm equipment on roadways; Weather forecast, +26, overcast; SF8 (KP800+900) the bore pipe was coated and sandblasted ready to be installed under roadway, site nice and clean; SF9 (KP818+500) geotech has been put down on wetlands; SF21 (KP818+500) semi on the ROW waiting to be unloaded with the bore pipe. Sideboom crossing the roadway to go and be unloaded. Badger trucks watering down all work site's dust control. Banister was moving an excavator on the roadway using all safety precautions. Pilot vehicles were being used while going down the roadway; Work forecast; return to monitor site's on Tuesday morning.

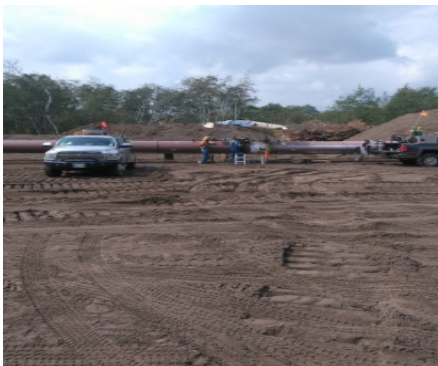
On August 28th, Housing keeping, uneven ground on ROW, drive slow when meeting vehicles, good communication with the guys on the line, wildlife are on the move this time of year. Weather forecast, +18, UV index 5, moderate risk of a thunderstorm, fog patches. SF15 – Welding is complete on the bore section; Semi unloading sideboom. Direct drilling mobilizing equipment. KP 822+500; SF16 – Signage is up (Caution KIDS AT PLAY), welding is complete on the bore (823+500); SF 17 – bore welding is complete on section KP 824+500); SF21 – equipment stripping the top soil going east (KP 827+340). Work forecast: return to monitor the line

SF15 Complete weld - Inspection pass

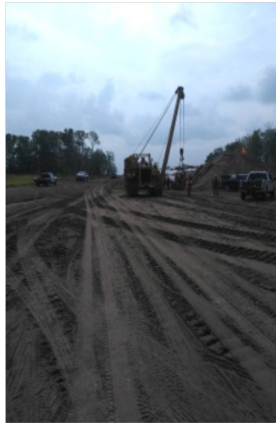
Side boom crossing roadway to unload truck

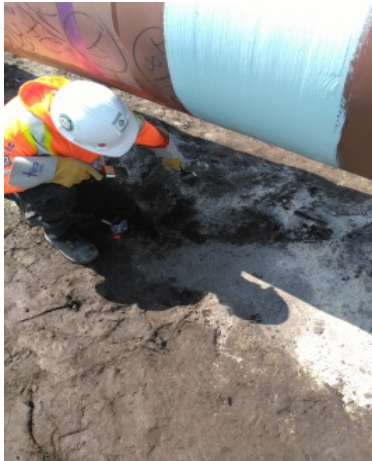
KP 845+900
Gardener Snake on ROW
