**SWAN LAKE FIRST NATION – MATRIX SOLUTIONS
INC. PARTNERSHIP**

INDIGENOUS CONSTRUCTION MONITORING

WEEKLY REPORT

SPREAD 7

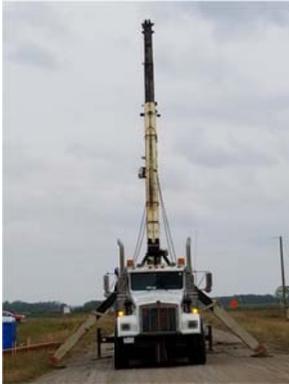
Description & Location KP826+745
Photo facing east
Picker truck unloading

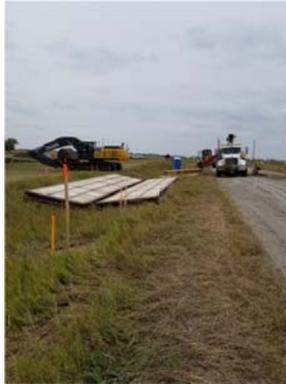
Description & Location KP 327+340
Photo facing east
Back Hoe just unloaded

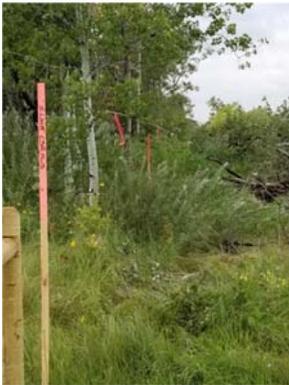
August 27, 2018
Description & Location KP 831-200
Photo facing east
of the disturbed area

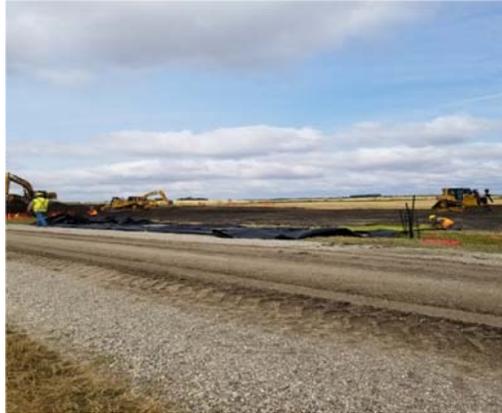
August 28, 2018
Description & Location: SF35 facing North East

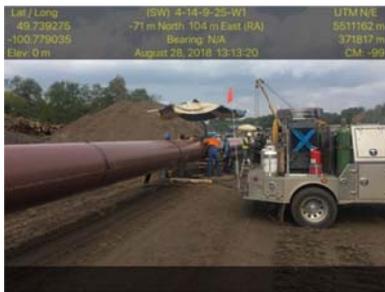
August 28, 2018
Description & Location: SSKP 824+350
Bore section
Welders doing the cap on their weld
Facing NE

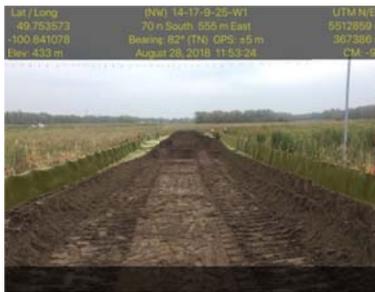
August 28, 2018
Description & Location: SSKP 816+650
Protective barrier for wetlands

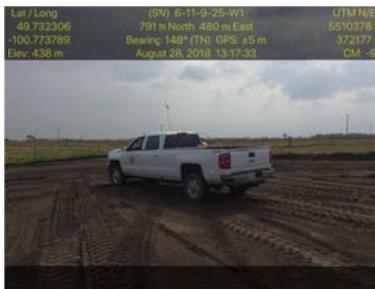
Discussed daily objectives with monitors after toolbox meeting, all of us would go to Rd#15 KP 822+125 to monitor the coating crew coat a weld. Had to tell foreman to put his flag up on truck as he was on ROW, also seen the same foreman walk backwards in ruts and mud while spotting picker truck (picture below). The truck got stuck in the mud and they decided to try and reach with the boom that was holding an induction coil used to heat the pipe. The operator extended the boom out to max and the 2 workers had to push and force the coil over the weld. They were rushing and it ended up taking them longer and was unsafe. I let the safety people at Enbridge know of what I observed and they will be addressed. During their coating application I received a call from the archaeologist letting me know I could come take a look at the arrowhead that was found at Souris River at SSKP 904+320. So I headed there and took a picture of the discovery, the archaeologist estimates its roughly 3500 years old (picture below).

August 28, 2018
Description & Location: SSKP 825+310
Banister truck on ROW with flag down

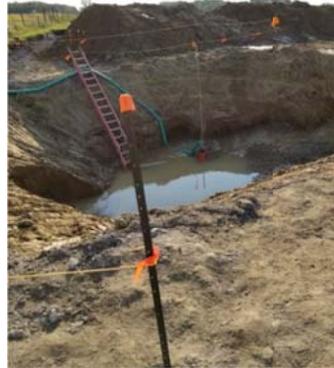
August 30, 2018
Description & Location KP 832+300
Open Pit - Photo taken facing south

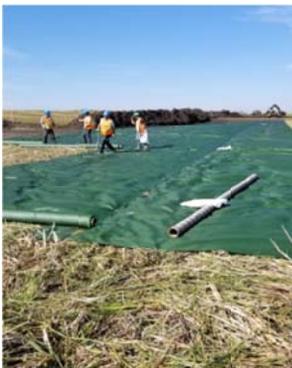
August 30, 2018
Description & Location KP 829+253
Workers laying G.T.O
Facing North

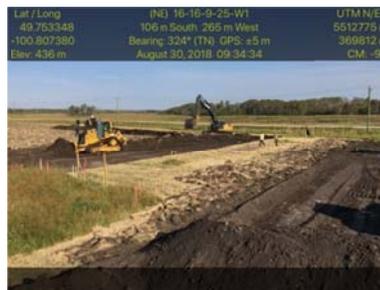
August 30, 2018
Description & Location: SSKP 820+842
Dozer/Hoe stripping topsoil
Workers getting ramp set up to protect hotline
Photo taken facing north

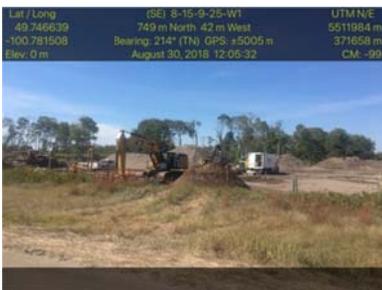
August 30, 2018
Description & Location: SSKP 823+430
Excavator digging entry pit for road bore
Facing NW

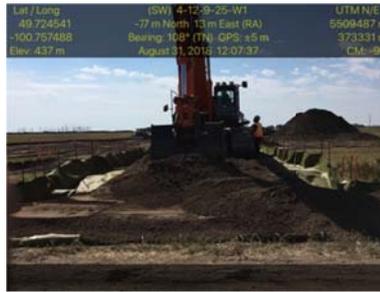
August 31, 2018
Description & Location: SSKP 827+400
Excavator finishing road ramp to access Rd # 21

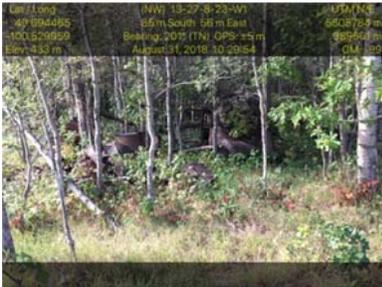
August 31, 2018
Description & Location: SSKP 844+950
Old car in our ROW in trees

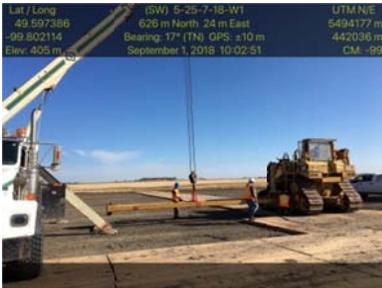
September 1, 2018
Description & Location: SSKP 899+125
Picker truck helping set up of side boom
Worker by boom tracks installing pin
Facing North East

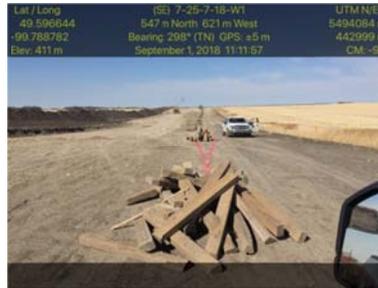
September 1, 2018
Description & Location: SSKP 900+300
Skid piles left by low bed truck
Used to crotch pipe securely
Piles are 20m apart 2 crotches per pipe
Facing West

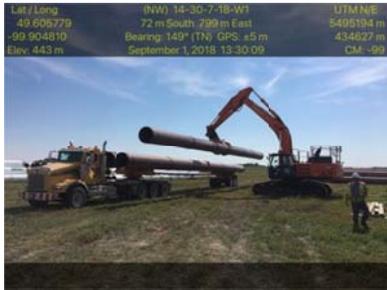
September 1, 2108
Description & Location: Nesbitt Stockpile Yard
Excavator with pipe claw attachment
This way is safer before it was suction grip
Loading Heavy wall 19.1mm pipe
Facing South

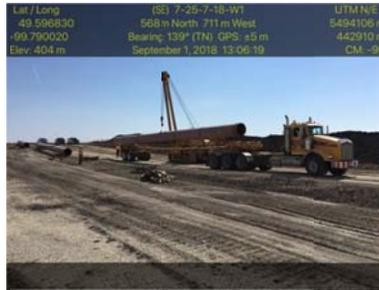
September 1, 2018
Description & Location: SSKP 900+300
Side Boom unloading Premay truck
Side Boom lifts pipe on last one and pulls ahead
then its lowered into crotch
Facing South East
