**MANITOBA METIS FEDERATION – MATRIX
SOLUTIONS INC. PARTNERSHIP**

INDIGENOUS CONSTRUCTION MONITORING

WEEKLY REPORT

SPREAD 7

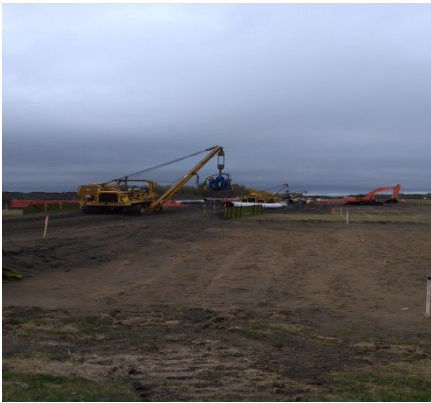
SF8(KP817+900)

Dozer moving the prep machine to
bevel the pipe

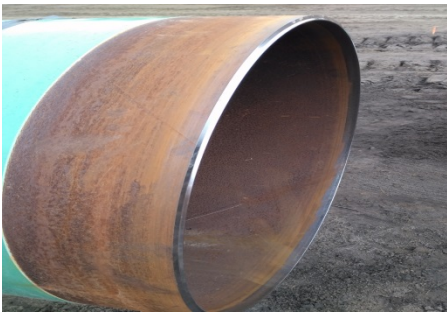
SF8(817+900)

This is what a bevel pipe looks like after the
prep machine is done.

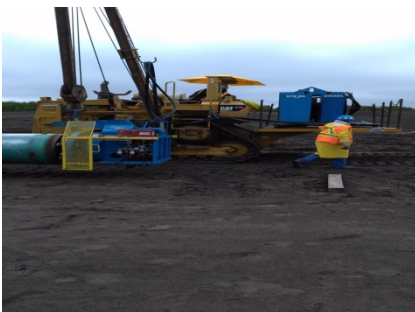
SF8(KP817+900)

The operator is prepping to bevel the pipe.
Photo taken facing east

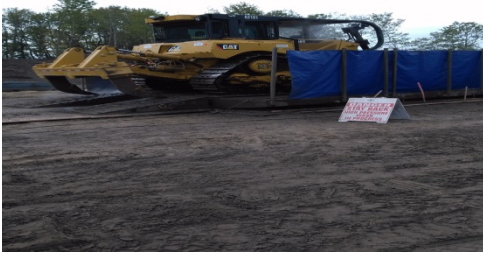
SF27(KP838+200)

The Big Dirty Truck Wash. Clean and disinfect the dozer. Photo taken facing east

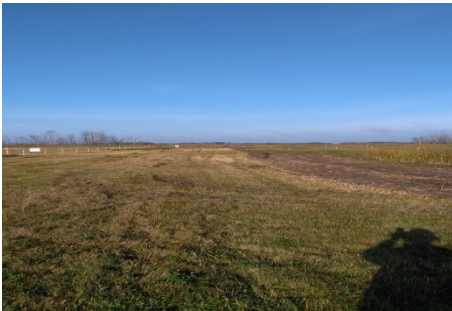
SF28(KP841+300)

Banister putting down 3kms of geo-tech on the wetlands going west. Photo taken facing west.

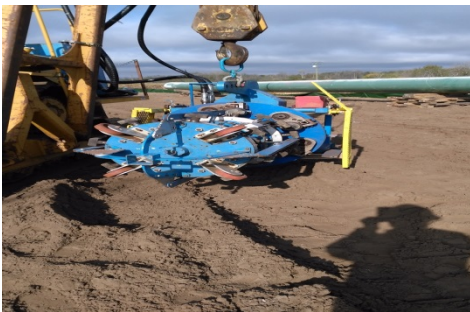
SF11(KP819+100)

This is a prep machine use for beveling pipe. They prep the pipe for the welder's. Photo taken facing west.

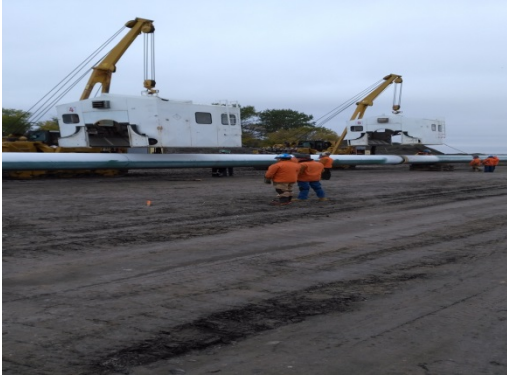
SF4(KP812+000)

The welder's are welding NW of SF4.
Those are the welding shacks that they put
over the pipe to stay out of bad weather.
Photo taken facing NW

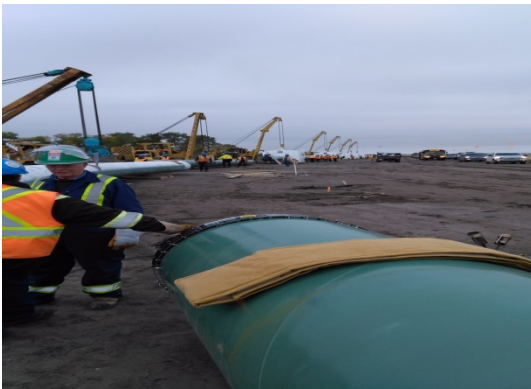
SF4(KP812+000)

Banister prepping the pipe ahead of the
welder's. Photo taken facing NW of SF4

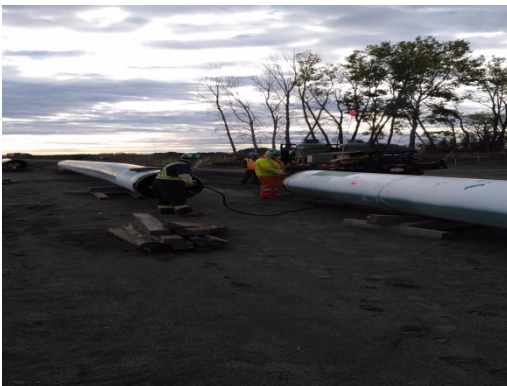
SF4(812+700)

Banister is preheating the pipe at 120 degree.

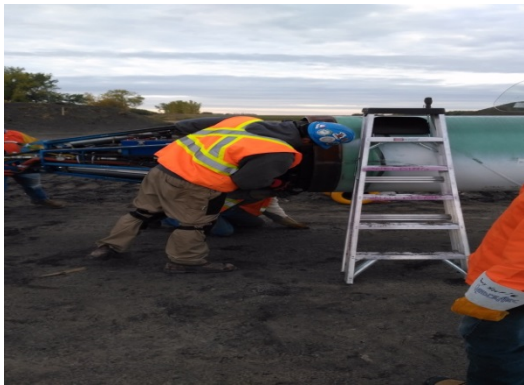
SF4(812+700)

Banister internal welding machine this machine weld's the pipe on the inside of the pipe. Photo taken facing south.

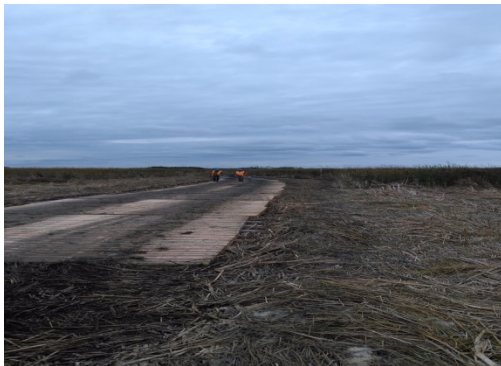
SF28(KP841+400)

sure the weld is all good; SF28 (KP841+400) Reassess the wetlands. Banister started to lay down the geo-tech on the wetland. The purpose of geo-tech on the wetlands is to protect the wetland. Once the geo-tech is laid down then they put sand on top of it acting like a ramp to get across the wetland. It looks very good after all done; Work forecast: Go back and monitor the welder's at SF 4 going east.

Banister laying down the geo-tech on the wetlands going west. Photo taken facing west.

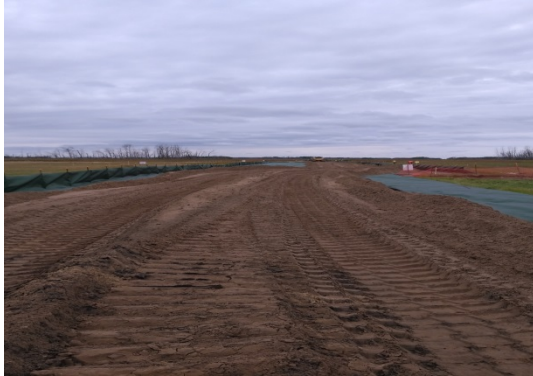
SF28(KP841+400)

Banister laying down sand on the geo-tech going west on wetlands. Photo taken facing west.

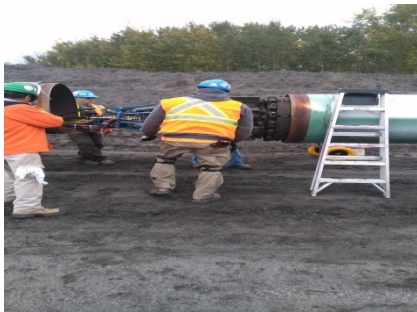
SF4(KP 814+900)

This is what they call an internal welder
Photo taken facing south

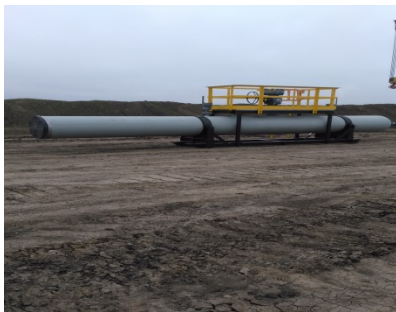
SF(KP899+800)

This is the test head that going to be weld on the pipe. Photo taken facing south

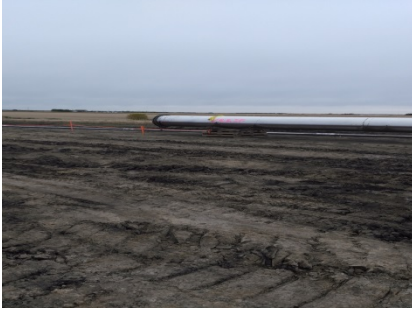
SF60(KP 899+800)

This is where the test head going to be attached at the end of this pipe. Photo taken facing south

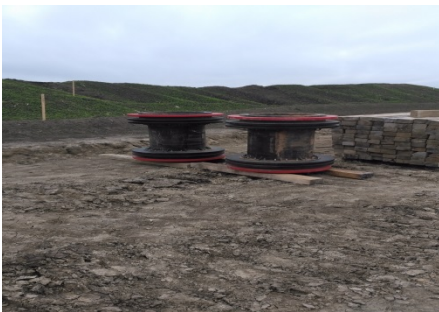
SF60(KP899+800)

This is what they call a pig .The pig is used to clean out the pipe they fill the pipe with water and push the pig through it. Photo taken facing west.

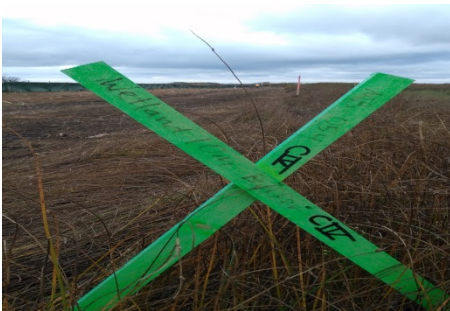
SF28 (KP 841+000)

This is where the geo-tech is being laid on the wetland. Photo taken facing west

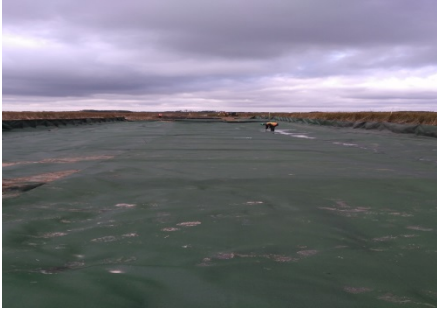
SF28 (KP841+000)

This is what geo-tech looks like on the wetland.
They have to lay 3kms of geo to protect the
wetland. Photo taken facing west.

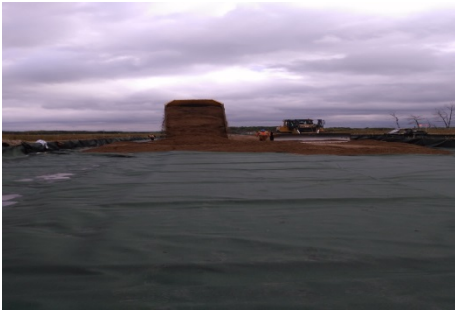
SF28(KP841+000)

Rock truck unloading sand on the geo-tech.
Building a ramp to get across the wetland.
Photo taken facing west

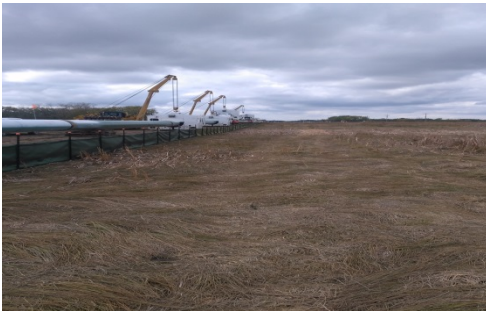
SF10 (KP818+800)

The welder's crossing 1039 wetland semi-
permanent marsh class 4 wetland complex.
Photo taken facing west.

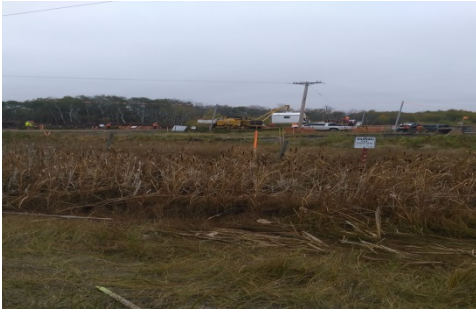
SF12(KP819+400)

Banister crossing the road under the power lines. They had spotters when crossing.

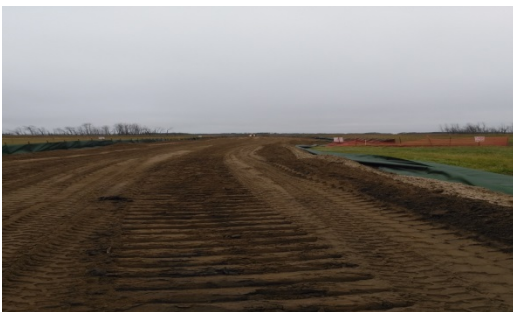
SF28(KP841+300)

Ephemeral/Temporary Marsh Class 1 & 2
This is where banister is laying down the geo-tech and sand .Geo-Tech is to protect the wetland. Photo taken facing west.
