**SWAN LAKE FIRST NATION – MATRIX SOLUTIONS  
INC. PARTNERSHIP**

**INDIGENOUS CONSTRUCTION MONITORING**

**WEEKLY REPORT**

**SEPTEMBER 17<sup>TH</sup> TO SEPTEMBER 22<sup>ND</sup>**

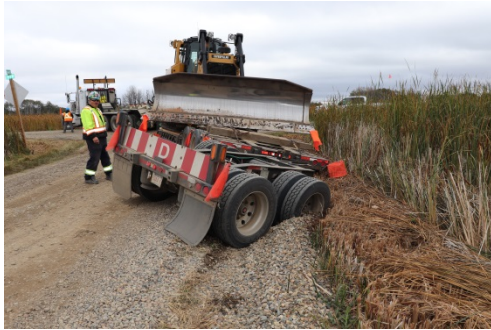
Description & Location: 137W + 41N  
Truck end sunk from soft road edge  
Scene frozen and help sent to help get out  
Heavy weight a factor/Facing east  
Good job with following procedures

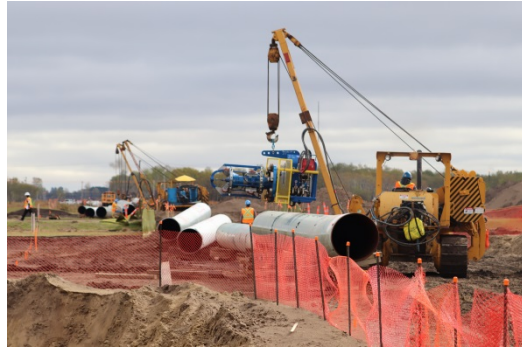
Description & Location: SSKP 818+050  
End Prep crew beveling pipe ends  
Facing east

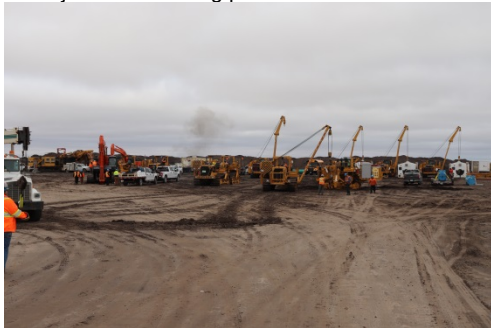
Description & Location: Bone Yard-Facing North  
Very congested area  
Unloading side booms and automatic welders  
Pipe Gang getting prepared

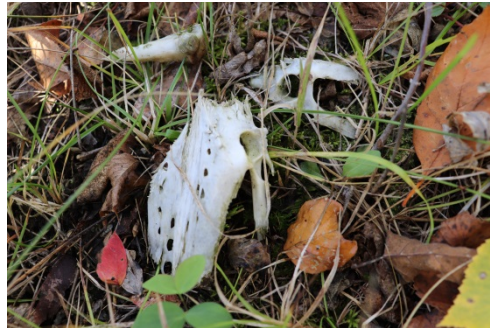
Field Observation	# of occurrences	Description and Mitigation Measures	Mitigation Status	Further Action Required (Yes/No)
Traditional Use Area (hunting, fishing, gathering, trapping)	N/A			
Rock Formations (rocks of significance, tipi rings, etc.)	N/A			
Artifacts	N/A			
Bones	1	Souris River SSKP 907+325 status unidentified reported to environmental coordinator	unkown	yes
Potential Gravesites	N/A

Description & Location: SSKP 907+325  
Unidentified bones on ROW-Possibly a bird  
Near Souris River

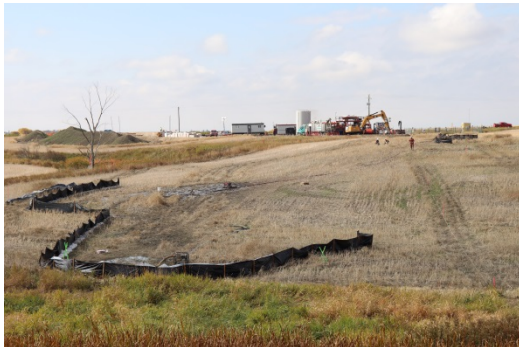
Description & Location: SSKP 899+450-Facing west  
Black Creek boring crew  
Some fluid released through cracks  
Clean up crew doing good job containing it

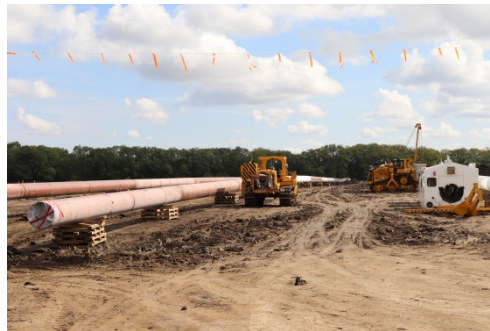
Description & Location: SSKP 908+000-Facing east  
Section for Bore crossing for Souris River  
Will be set up for Test

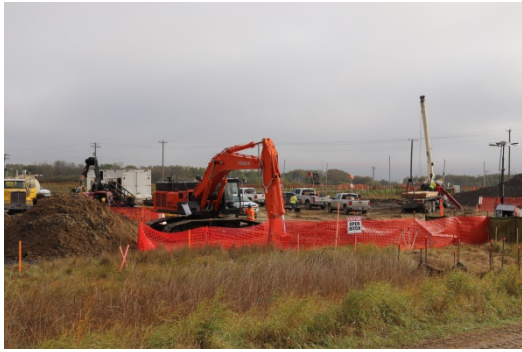
Description & Location: SSKP 821+100-Facing NE  
Road bore at Rd # 13  
Excavator digging on north  
Picker truck unloading matts in background

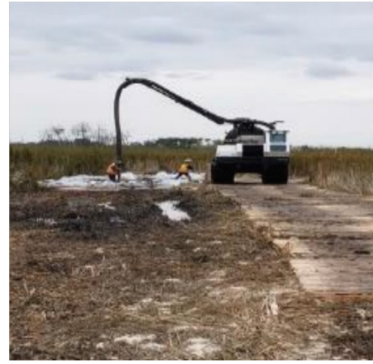
Description & Location KP-841+100- Facing E  
Worker's cleaning swamp with hydro-vac

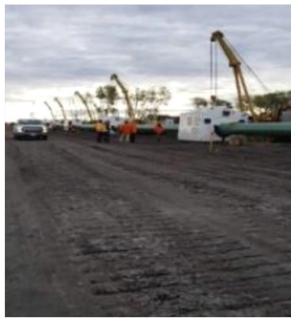
Description & Location KP-813+200.  
Photo taken facing east.  
Welder's getting ready to weld.

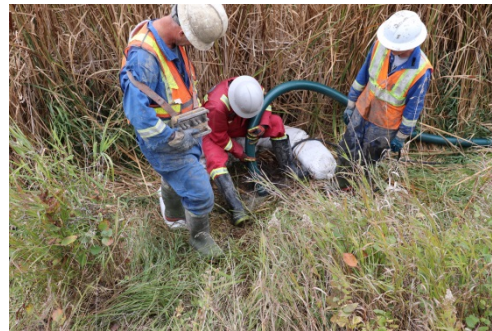
Sept 19/18 Description & Location: SSKP 899+550  
Workers with SA Energy and Badger  
Cleaning the seeping fluid on surface  
Using water and suction hose to clean  
Picture taken in Black Creek

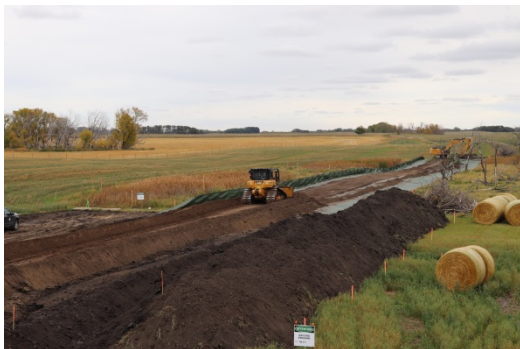
Wetland: 1 Seasonal Marsh Class 3 Wetland MB-073 SSKP 850+100 status work in progress

Sept 19/18 Description & Location: SSKP 850+100  
Seasonal Marsh Class 3 Wetland MB-073  
Dozer and Excavator building ramp through wetland complex  
photo facing NE

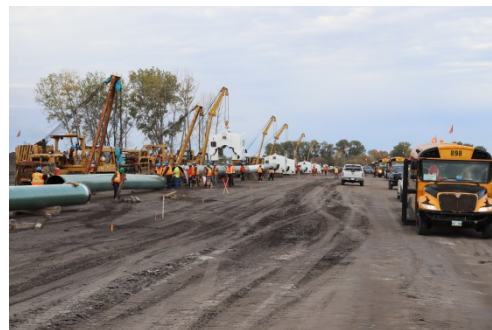
Sept 19/18 Description & Location: SSKP 812+700  
Main gang welding mainline facing west  
Very congested biggest crew on job  
Preheaters, Automated Welders Root pass, Hot pass, Cap  
and Rotoscan

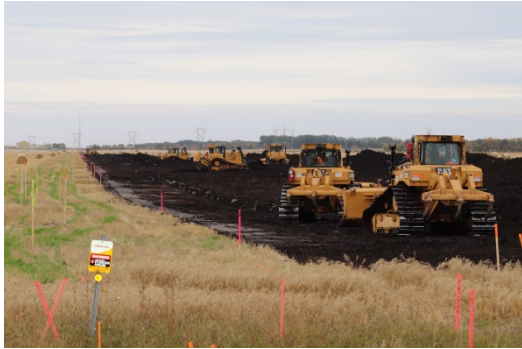
Sept 19/18 Description & Location: SSKP 870+550  
Grade crew stripping and piling soil  
Dozers pushing soil and Power dozer  
Pink stakes beside dozers are 5 m buffer  
Photo facing east

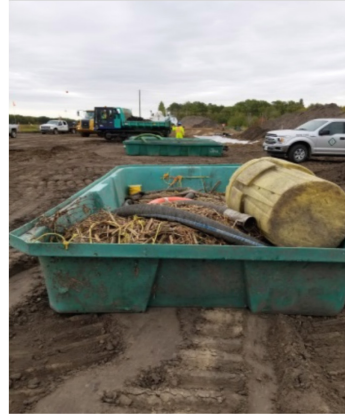
Sept 20/18 Description & Location KP-841+553 137 west  
Nodwell machine hauling contaminated bulrush  
out of the wetlands at SF # 28 west and  
disposing it in the plastic trays.  
Photo taken facing east

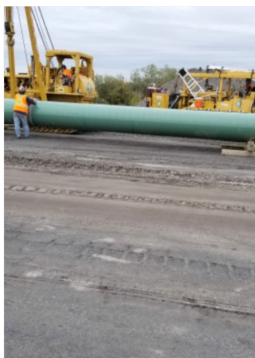
Sept 20/18 Description & Location KP-815-100 bone yard  
Side boom moving the pipe for the welders to start welding  
Photo taken facing south.

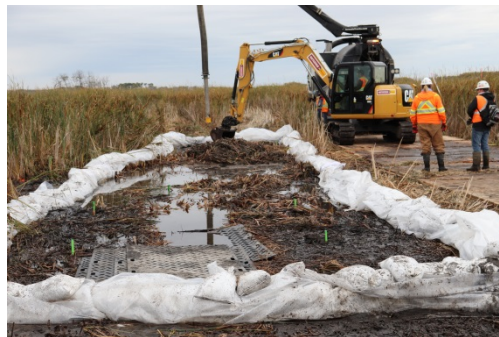
Weekly activity included attending daily tailgate meetings and continue to check access points on the ROW on Spread 7. Monitored the spill at SSKP 840+727 in a Semi-Permanent marsh Class 4 Wetland Habitat.

Sept 20/18 Description & Location: SSKP 840+727  
Environmental Clean-up  
Mini Excavator digging contaminated soil  
Hydro-Vac in background facing west  
Sandbags used to contain spill

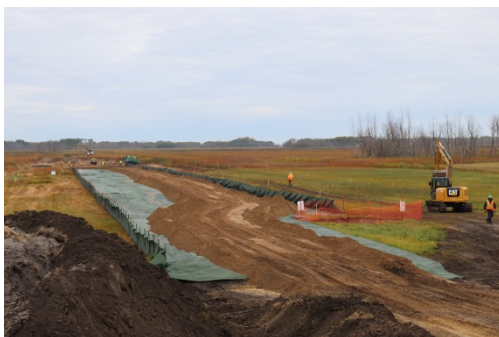
Sept 20/18 Description & Location: SSKP 841+050  
Semi-Permanent Marsh Class 4 Wetland  
Wetland ID MB-054  
Building Wetland ramp facing west

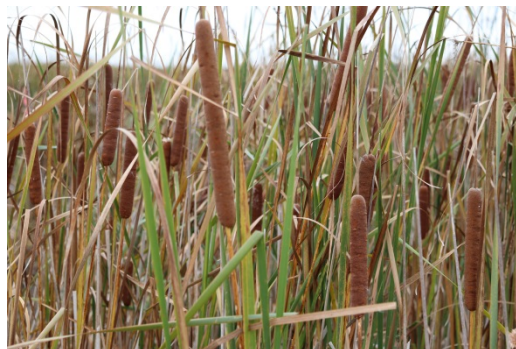
many Bulrushes that are used by indigenous peoples for medicinal, food and crafting. The people who helped with the containment of the spill did an excellent job. From Enbridge, Banister and Badger the teamwork was great and everyone came together to make sure the job was done properly. Just east of the spill site the Access crew was building a Wetland ramp. SSKP 899+850 At Black Creek they are welding test onto bore section for the HDD. Also, in area I assessed the clean-up around Black Creek and it looks a lot better now as they've been using water to mix with clay on the surface than using Hydro-vac to get rid of it. Wetland: 1 Semi-Permanent Marsh Class 4 Wetland ID MB-054 SSKP 840+727 Status spill being contained and monitored. Ongoing Indigenous Medicinal Plant: 1 Bulrushes in Wetland MB-054 SSKP 840+727 Status being mitigated with wetland ramp and work ongoing.

Sept 20/18 Description & Location: SSKP 840+727  
Indigenous Medicinal plant Bulrush  
used for multiple purposes including Medicinal, Food and Craft  
Facing North

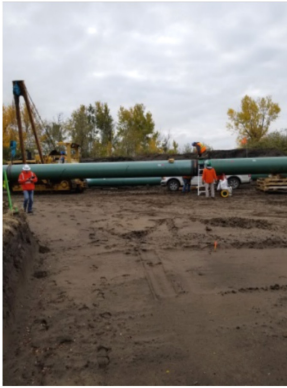
Sept 21/18 Description & Location KP- 817+789  
Photo taken facing north  
Workers pre heating the pipe for the internal welding

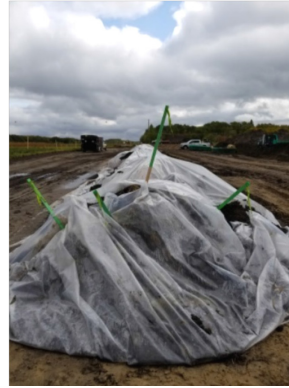
Sept 21/18 Description & Location KP-841 + 553  
Soil wrapped and covered with poly from  
the wetlands west of SF # 28.  
Photo facing west

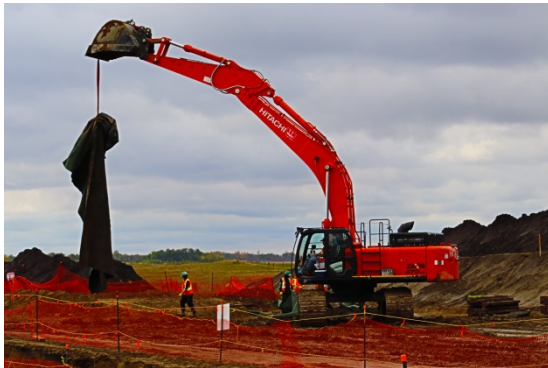
Sept 21/18  
Crews were disassembling the cleaning station  
as it is no longer required in that area  
Excavator removing Caepla carpet

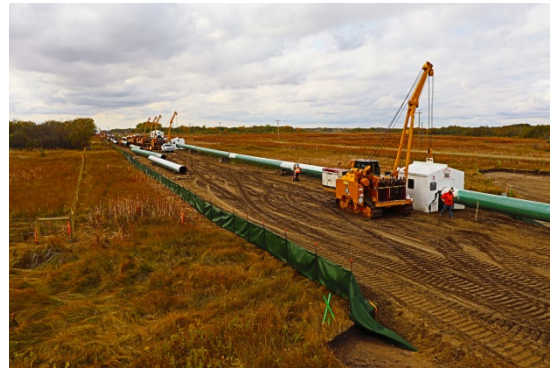
Sept 21/18  
Pipe Gang and Poor Boy Welding crews  
working in a Semi-Permanent Marsh Class 4  
Wetland Complex MB-1039  
Phot facing NW

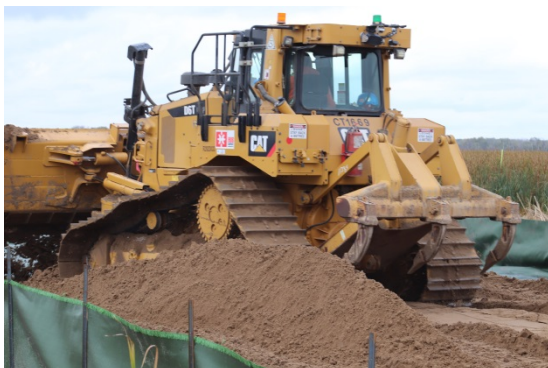
Sept 21/18  
Semi-Permanent Marsh Class 4 Wetland  
D6 Dozer pushing sand on wetland ramp  
Close to environmental spill site  
Photo facing NW

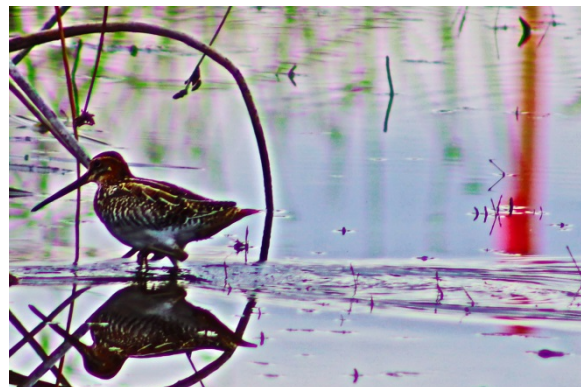
Animal Observations: 1 Sandpipers in our ROW, status be careful of wildlife and work is ongoing

Sept 21/18  
Sandpiper feeding on ROW  
Reflection of south boundary stake  
Active on the ROW  
Photo facing south

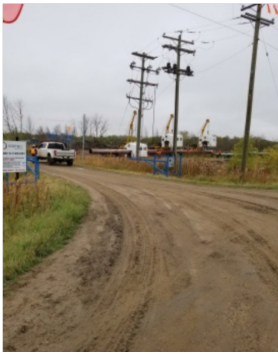
Sept 22/18  
Description & Location KP-819+400 148 west  
Side booms moving the welders shacks to SF # 13 east.  
Photo taken facing south

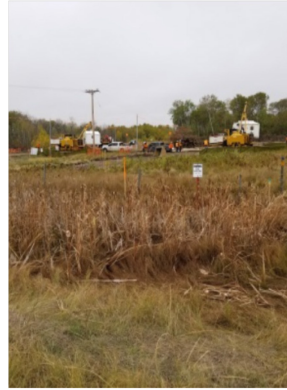
Sept 22/18  
Description & Location KP-818-500  
Welders finished welding side booms  
moving shacks to SF # 10.  
Photo taken facing east

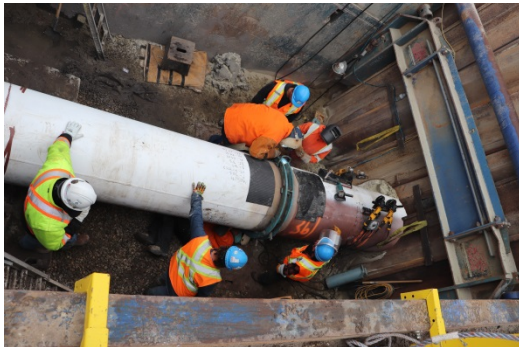
Wetland: 1 Seasonal Marsh Class 3 Wetland Complex MB-1051b.

Sept 22/18 Description & Location: SSKP 825+490  
Seasonal Marsh Class 3  
Wetland Complex MB-1051b  
Tundra Bore/Trench Box/Welders  
Pipe clamps used to line up pipe (blue)

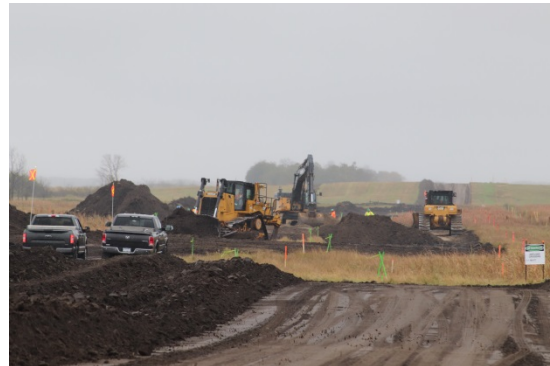
Wetland: 1 Semi-Permanent Marsh Class 4 Wetland Complex MB-077.

Sept 22/18 Description & Location: SSKP 853+000  
Semi-Permanent Marsh Class 4  
Wetland Complex MB-077  
Grade crew stripping soil by Wetland  
Photo facing west

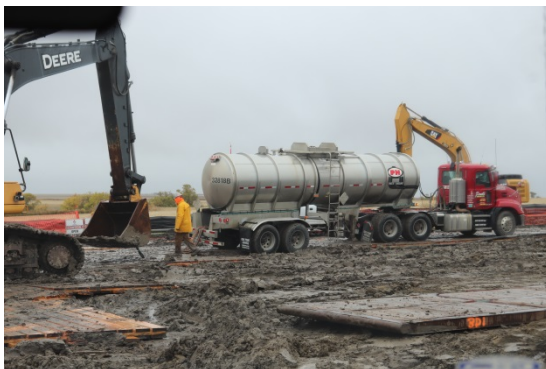
Sept 22/18 Description & Location: SSKP 899+800  
Truck stuck from slippery conditions  
Excavator hooked up to pull it out  
Started raining more made conditions worse  
Photo facing north

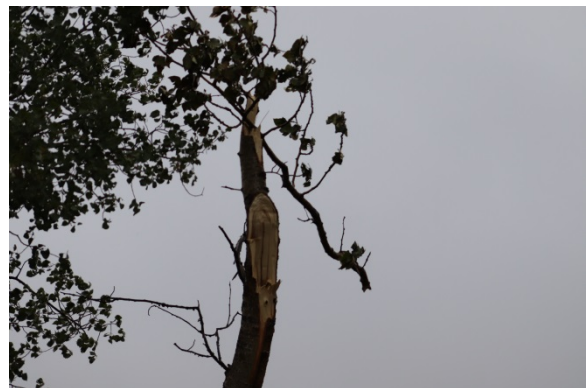
Rd # 36 on north side of crossing about 200 m west on south boundary there is a tree that's broken in half that could of been caused by clearing crew it also has a widow maker on top of it and is a hazard as it can fall close or within our work space. Tree is about 2 feet off our ROW work space. Also at Rd # 36 another tree broke in half where clearing was done, it's on the south side of road and is 200 m west on south boundary.

Sept 21/18 Description & Location: SSKP 860+550  
Damaged Tree close to our boundary  
Looks bad and is dangerous with branch hanging off top  
hanging off top (widow maker)  
Photo facing north

Trees: 2 Poplar trees damaged from clearing crew, broken in half just outside our boundary. Status need to be removed or replaced.
