**MANITOBA METIS FEDERATION – MATRIX  
SOLUTIONS INC. PARTNERSHIP**

**INDIGENOUS CONSTRUCTION MONITORING**

**WEEKLY REPORT**

**SPREAD 8**

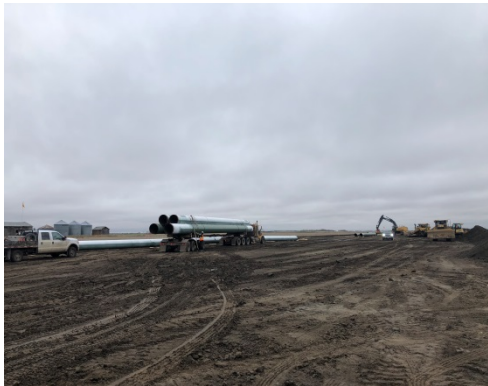
SF 14, photo facing east, stringing pipe taking place.

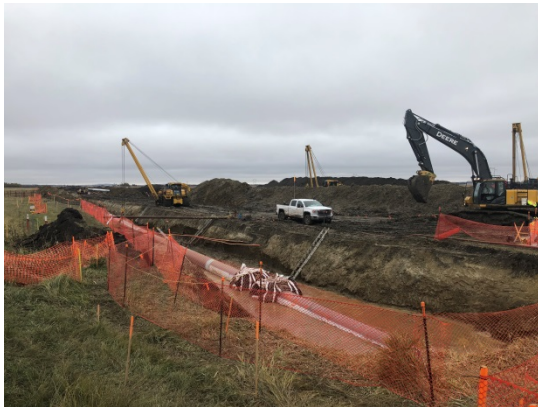
SF 22, photo facing south east, crews pumping water, lowering pipe in.

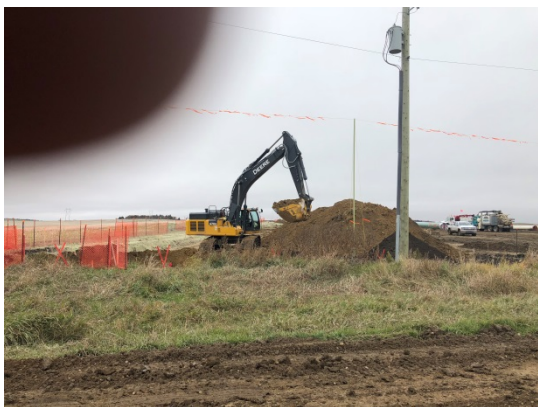
SF 28, photo facing east, excavator digging hole for where pipe will go under the road.

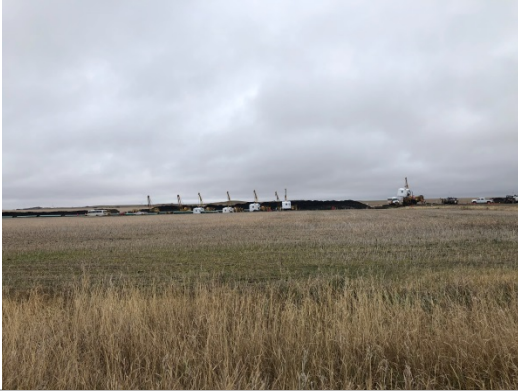
SF 43, photo facing south, pipe gang welding the pipe together.

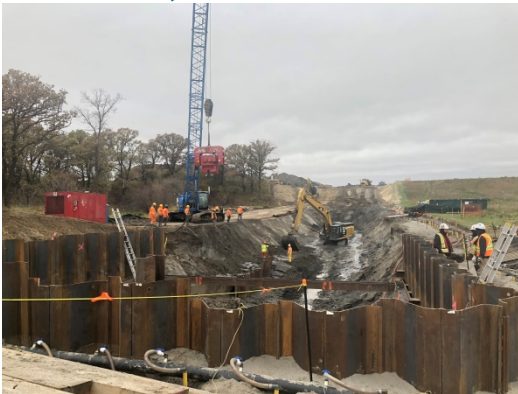
SF 8, photo facing west, oak creek crossing, crews pumping water out of pit, excavator moving mud out of pit.

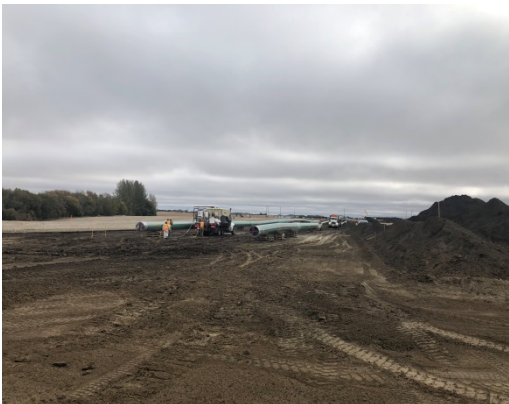
SF 38, photo facing east, coating crews coating the welds on the pipe.

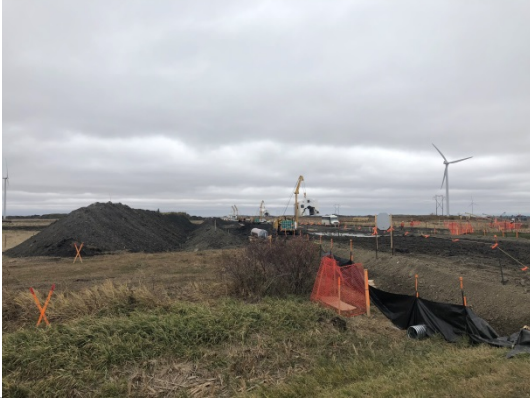
SF 47, photo facing west, pipe gang getting ready to move across the road.

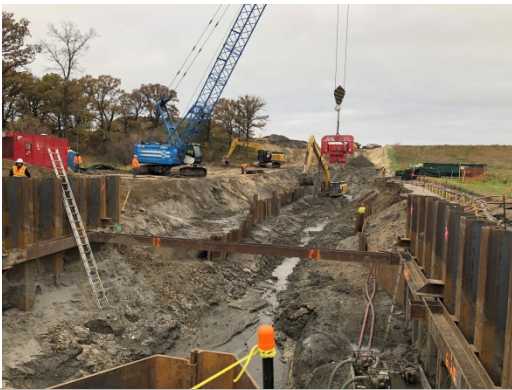
SF 8, photo facing west, oak creek crossing, excavator digging mud out of the trench, crews pumping water, machine tamping down steel support walls.

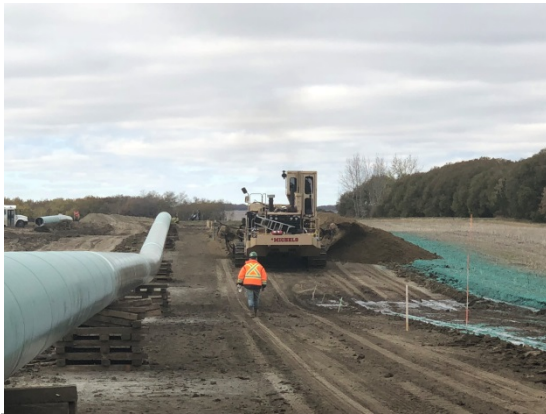
SF 39. photo facing west, trencher on sight  
trenching the ROW from west to east.

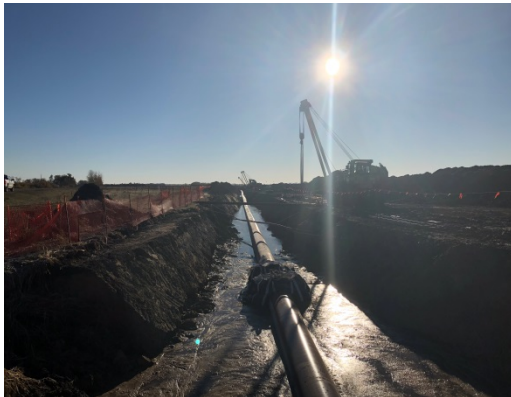
SF 22, photo facing south east, lowering in  
crew lowering in pipe, three side booms  
lowering in the pipe.

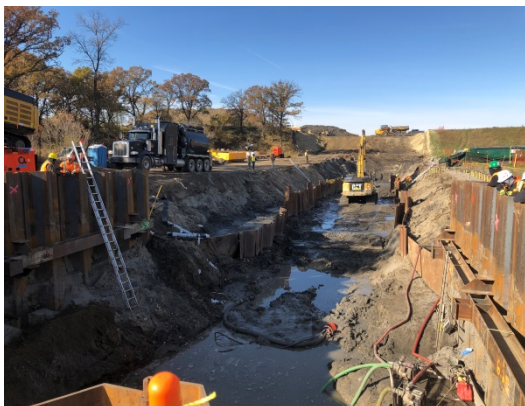
SF 8, oak creek crossing, photo facing west, not  
much has changed since yesterday, crews  
pumping water, hydrovac is on sight.

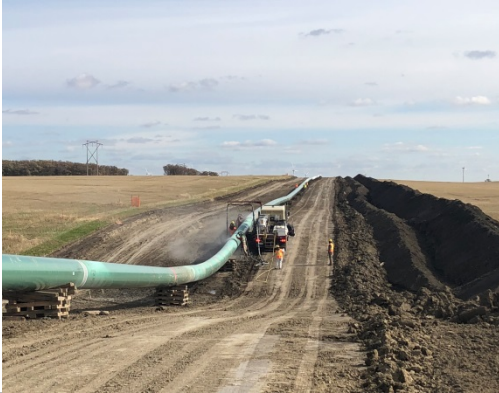
SF 44, photo facing east, coating crew sandblasting the welds on the pipe.

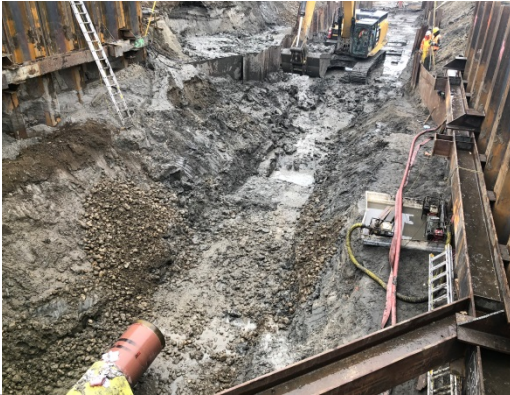
SF 8, oak creek crossing, most of the water is pumped out, pipe is visible.

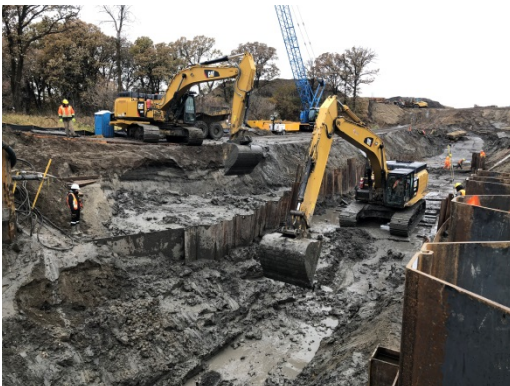
SF 8, oak creek crossing, two excavators and one rock truck working together to clear the mud out of the trench.

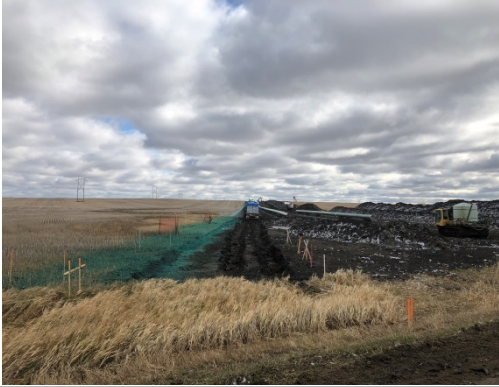
SF 43A, photo facing east, green mulch being sprayed.

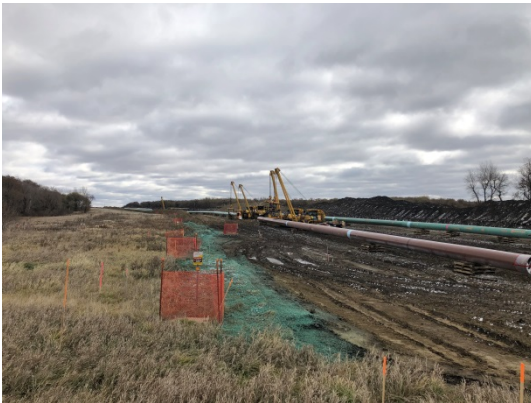
SF 38, photo facing south east, lowering in crew lowering the pipe into the trench.
