**MANITOBA METIS FEDERATION – MATRIX
SOLUTIONS INC. PARTNERSHIP**

INDIGENOUS CONSTRUCTION MONITORING

WEEKLY REPORT

SPREAD 8

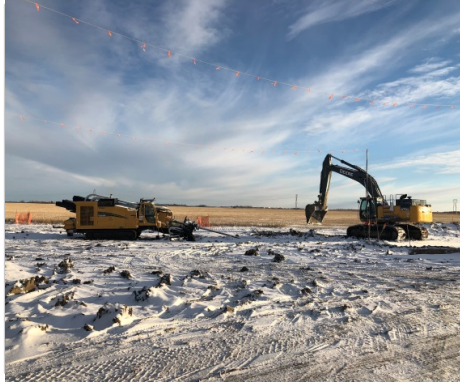
SF 24, photo facing north, road drilling machine on sight drilling under road.

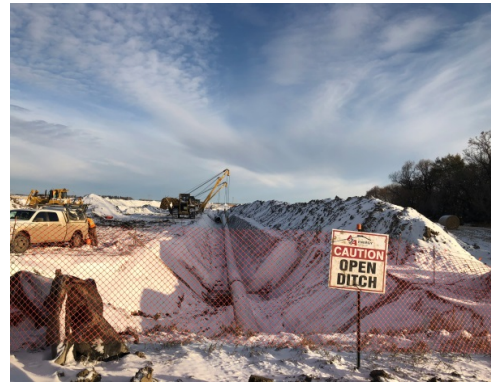
SF 26, photo facing north, lowering in crew lowering in pipe.

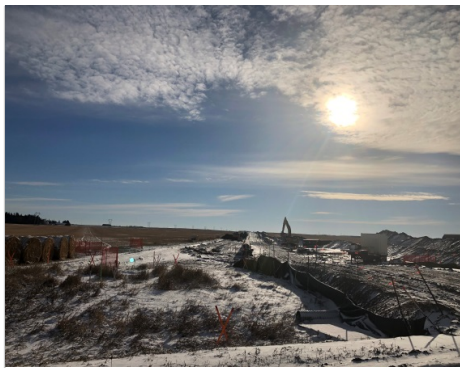
SF 41A, photo facing east, trencher trenching the ditch, one excavator moving dirt out of the trench.

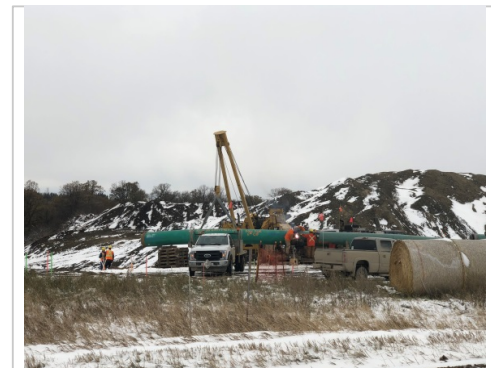
SF 35, photo facing south, crews welding the pipe.

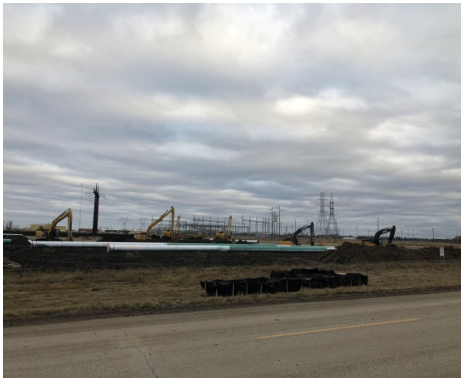
SF 21, photo facing north west, multiple pieces of equipment moving dirt.

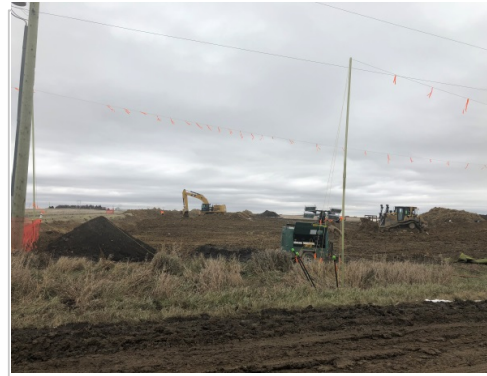
SF 28, photo facing east, one excavator backfilling trench, one dozer pushing dirt onto the ROW.

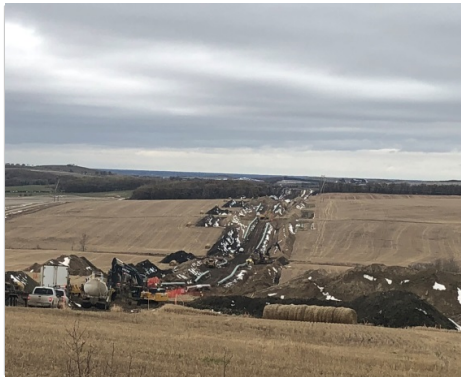
SF 32, photo facing north, two hydrovacs on sight and multiple pieces of equipment moving dirt.

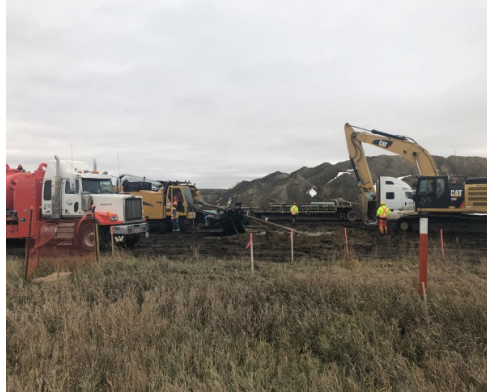
SF 35, photo facing south, boaring machine boaring under the road.

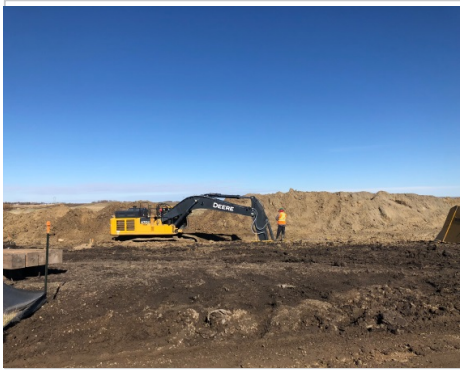
SF 35, photo facing north, excavator digging hole for where pipe will go under the road.

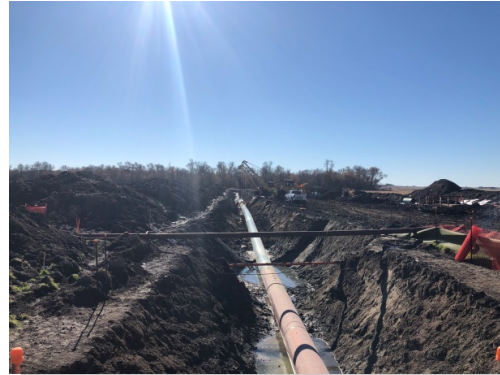
SF 26, photo facing south, lowering in crew holding onto the pipe while welders weld it.

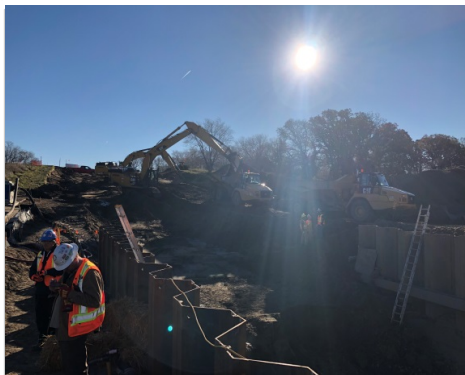
SF 8, oak creek crossing, photo facing east, excavator digging down path that pipe will come up.

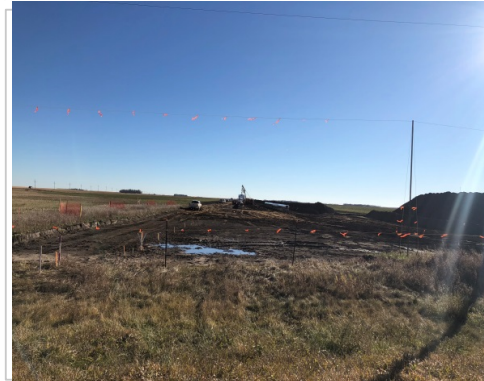
SF 10, photo facing west, pipe gang welding the pipe.

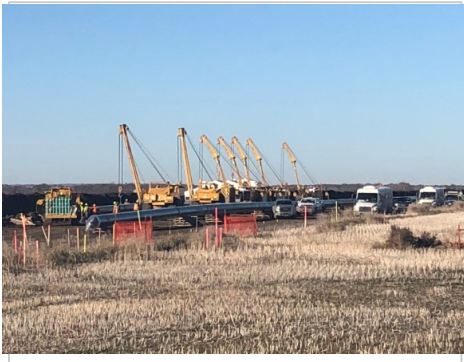
SF 12, photo facing west, pipe gang welding the pipe together.

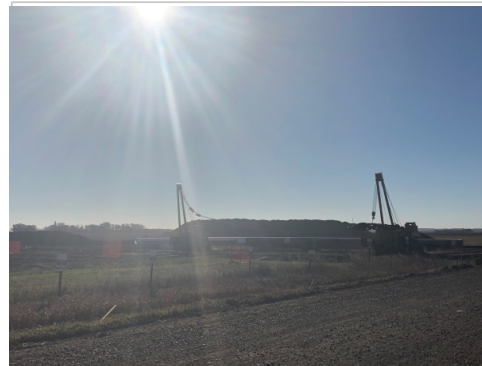
SF 12, photo facing south, two side booms transferring long welding device across the road.

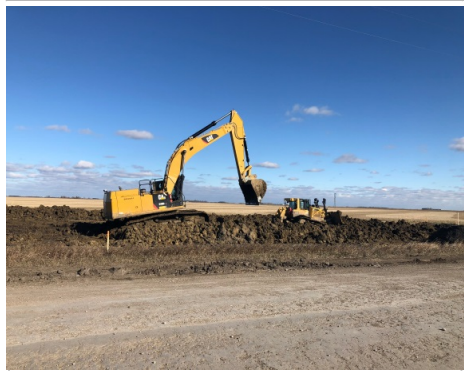
SF 24, photo facing north, one excavator and one dozer pushing dirt on top of the pipe.

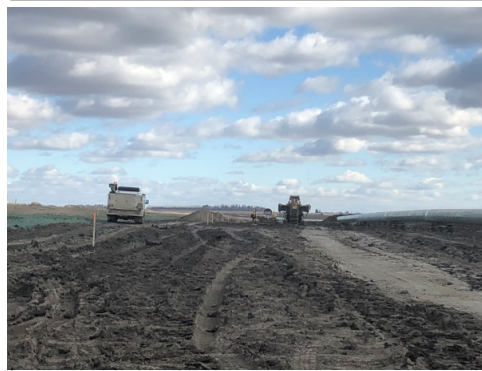
SF 49, photo facing east, trencher on sight preparing to start trenching.
