**MANITOBA METIS FEDERATION – MATRIX  
SOLUTIONS INC. PARTNERSHIP**

**INDIGENOUS CONSTRUCTION MONITORING**

**WEEKLY REPORT**

**SPREAD 8**

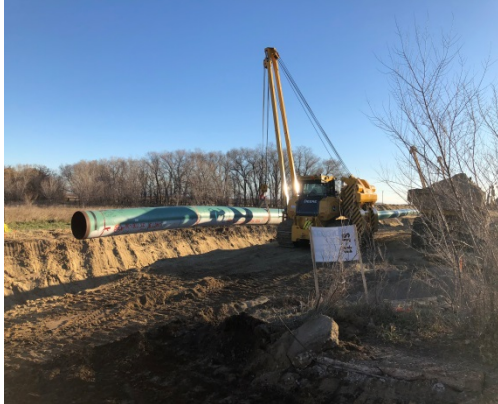
SF 8, oak creek crossing, photo facing north east, pipe being lowered into the trench.

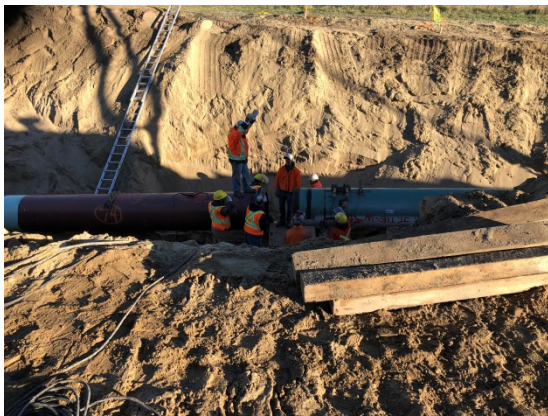
SF 8, oak creek crossing, one crew member giving signals to the boom operators to line the pipe up with the pipe that's already in the trench.

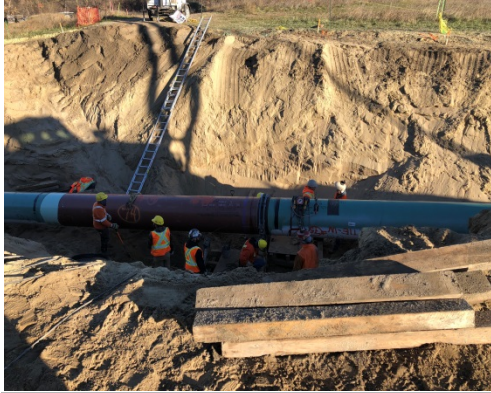
SF 8, oak creek, pipe lined up, two crew members heating up the pipe with tiger torches to prepare for the welding.

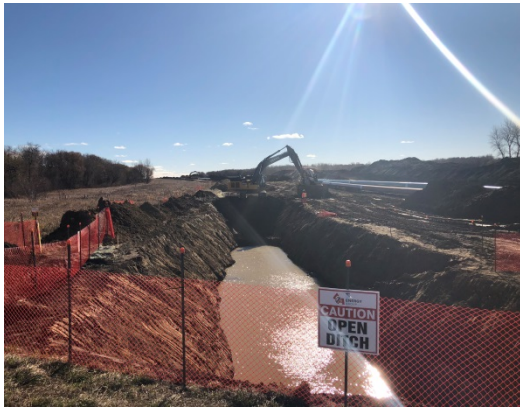
SF 38, photo facing east, excavator digging dirt out of trench, one dozer pushing that dirt to the side of the row. Lots of water in the trench.

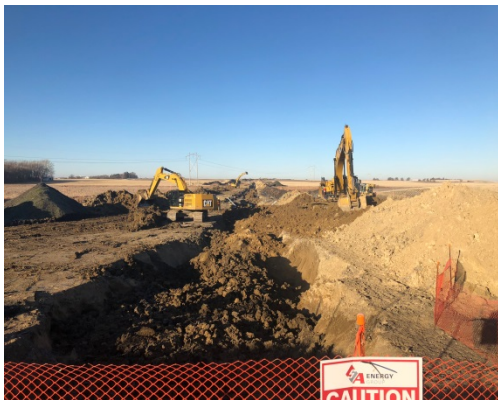
SF 30, photo facing east, backfilling taking place.

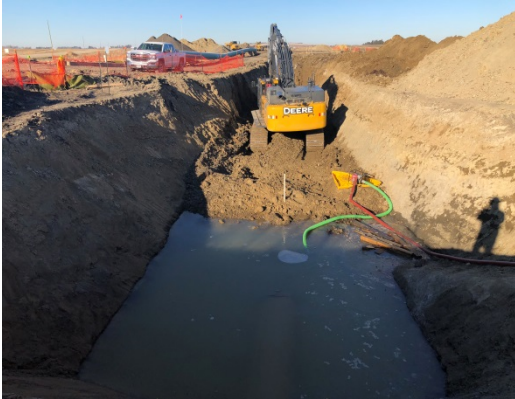
SF 35, photo facing west, excavator moving out dirt, crews attempting to pump out water.

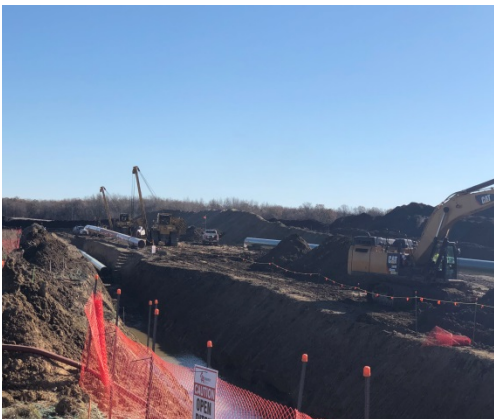
SF 38, photo facing south east, excavator moving soil, side booms moving pipe closer to trench.

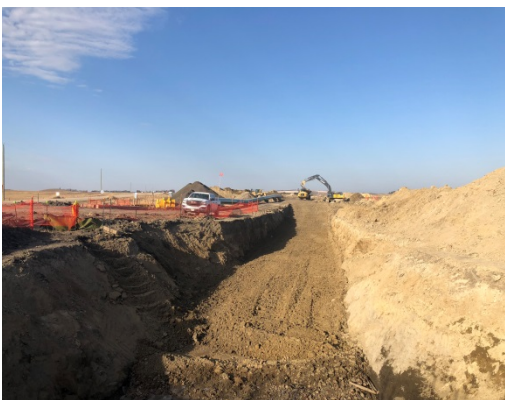
SF 35, photo facing west, excavator loading dirt from the trench into the back of a rock truck.

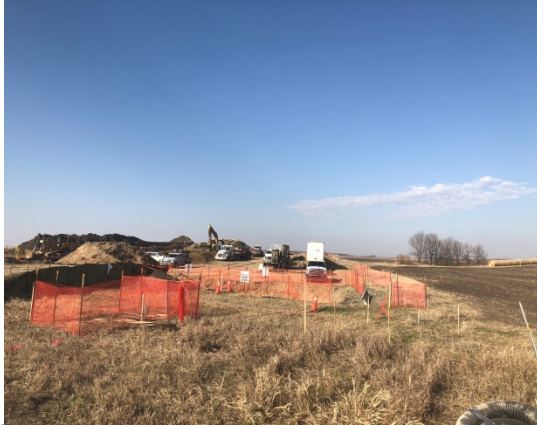
SF 38, photo facing north west, boring taking place.

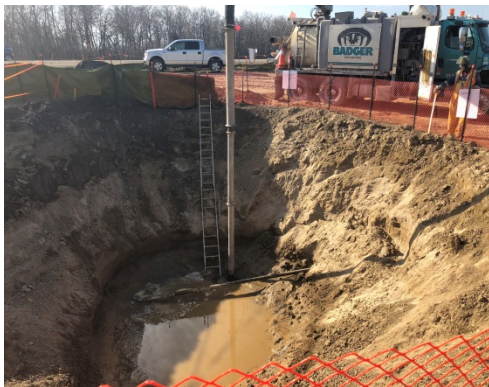
SF 38, hydro vac pumping out water from open ditch, you can also see the boring drill bit just above the water.

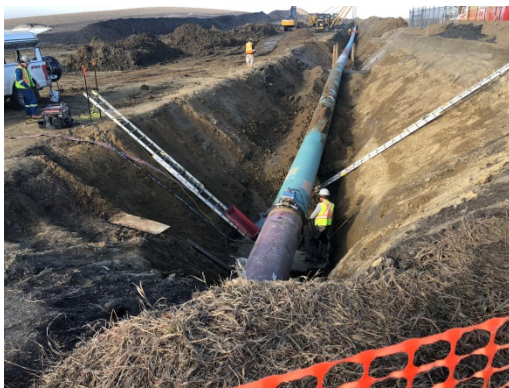
SF 28, photo facing west, lowering in crew lowering in pipe, APPlus doing ultra sounds on the pipe.

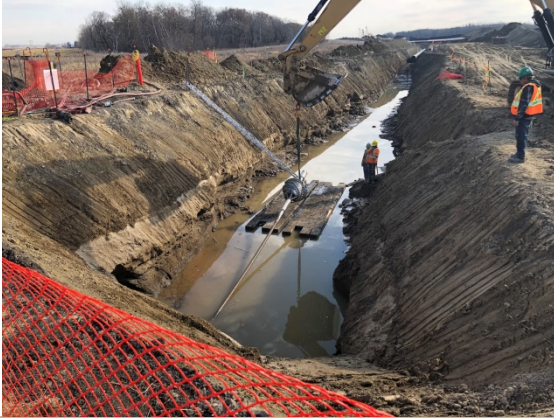
SF 38, photo facing south east, a picture of the drill bit that was used to boar under the road with the pipe attached.

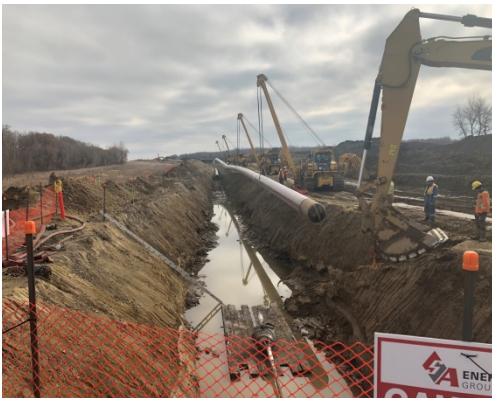
SF 38, photo facing south, lowering in crew getting ready to lower in pipe and attach it to the drill bit.

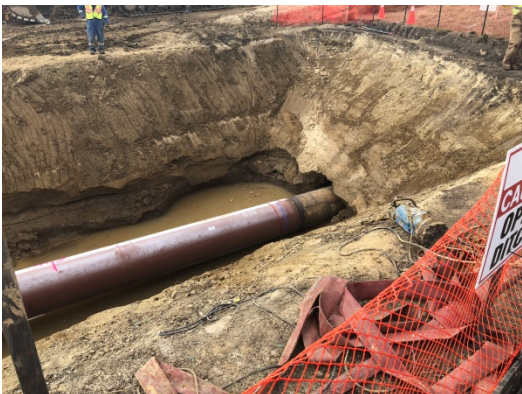
SF 38, photo facing west, pipe is under the road being pulled by the directional driller.

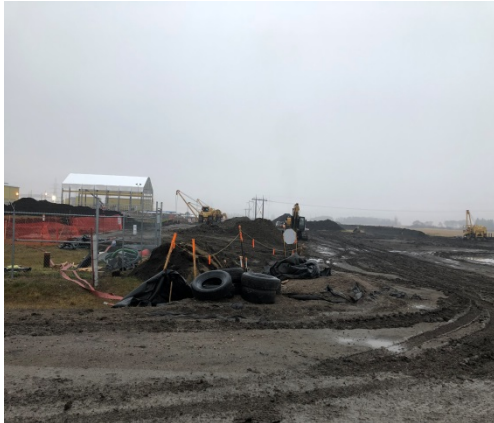
SF 20, photo facing east, lowering in crew lowering in pipe, ROW is very muddy and wet.

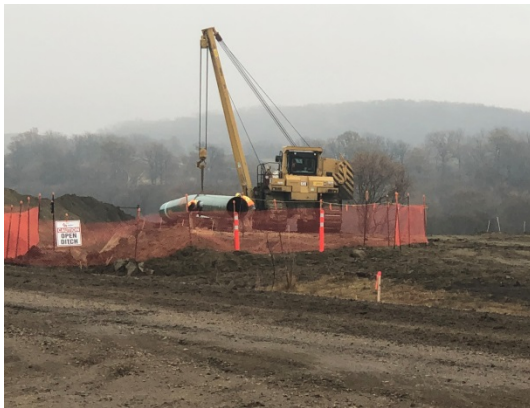
out of the trench, loading that mud into the back of a rock truck; SF 35, south side, one side boom lifted the end of the pipe that is welded together and crew members built up the skid pile underneath it so the pipe is raised higher; SF 41A, west side, boring machine on sight boring underneath the road to east side; SF 43, south side, one excavator digging dirt out of the trench and putting it on the ROW, another excavator is then moving that dirt to the south side of the ROW;

SF 35, photo facing south east, side boom raised pipe and crew members built up skid pile higher.

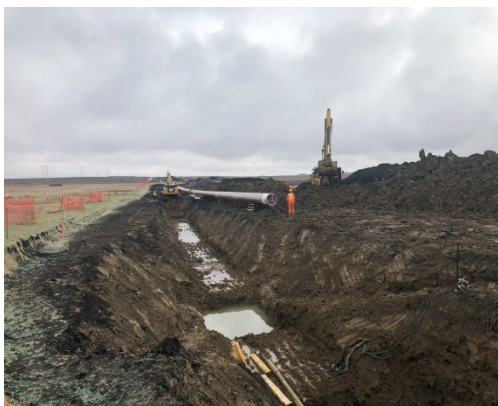
SF 43, photo facing east, excavators moving dirt out of the trench to the side of the ROW.

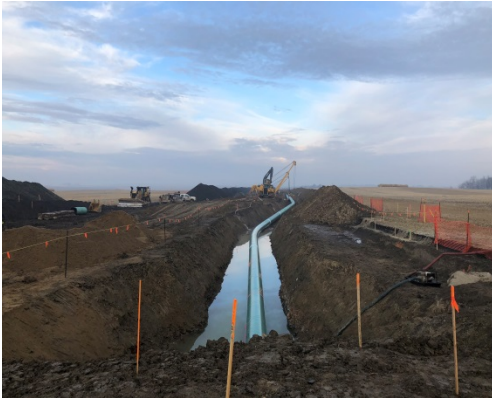
SF 34, photo facing west, tie In crew tying in the pipe.

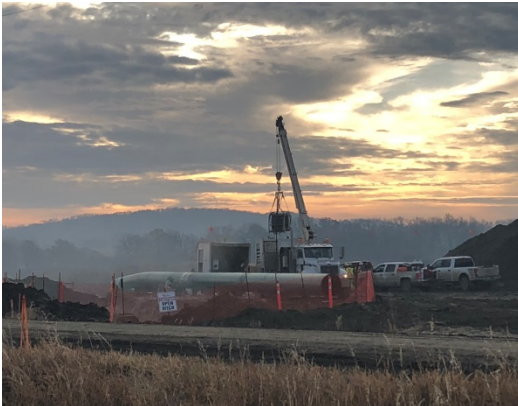
SF 35, photo facing south east, sand blasters sand blasting the pipe, coaters came shortly after.

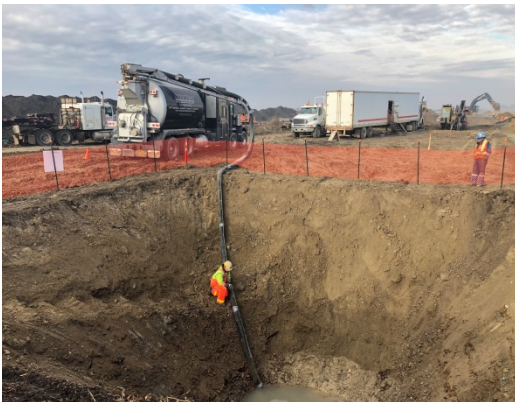
SF 41A, photo facing west, hydro vac pumping out water while directional drill drills.

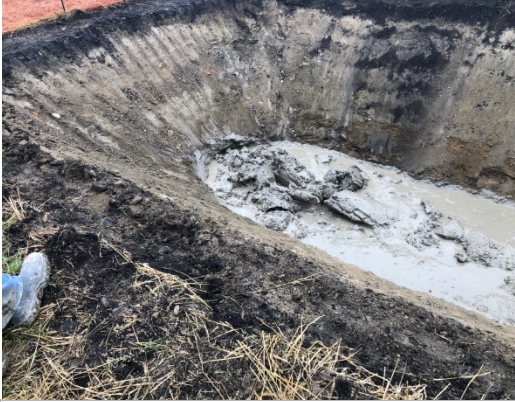
SF 41A, photo facing north west, drill bit coming out on the east side of the road.
