**MANITOBA METIS FEDERATION – MATRIX
SOLUTIONS INC. PARTNERSHIP**

INDIGENOUS CONSTRUCTION MONITORING

WEEKLY REPORT

SPREAD 8

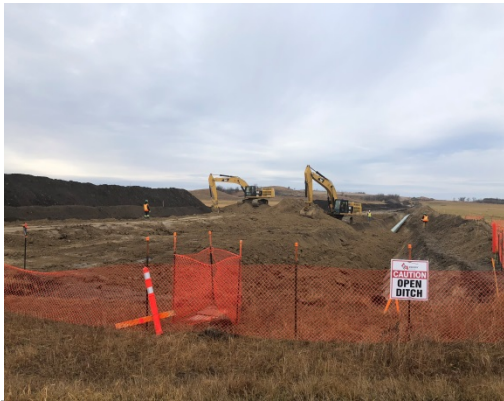
SF 33, photo facing west, excavators backfilling pipe.

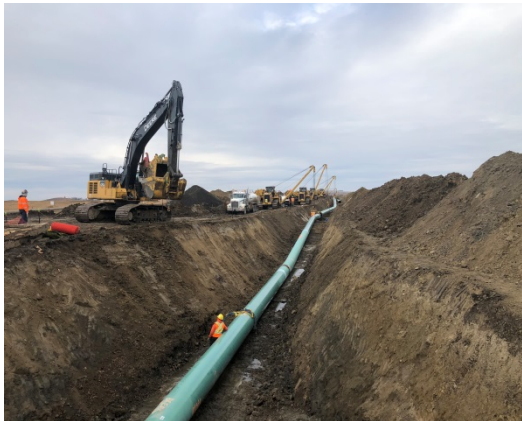
SF 35, photo facing west, crews tying in the pipe.

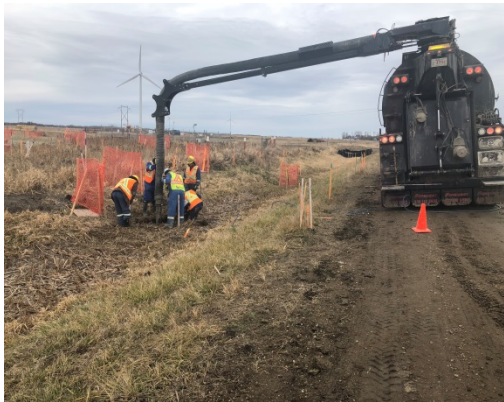
SF 47, photo facing north, crews hydrovacating to locate the drillers drill bit.

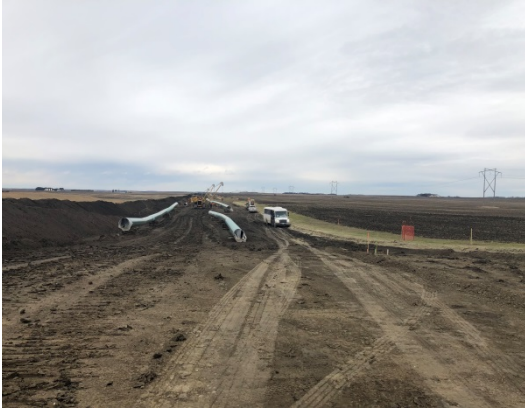
SF 44, photo facing west, side booms moving pipe closer to the trench.

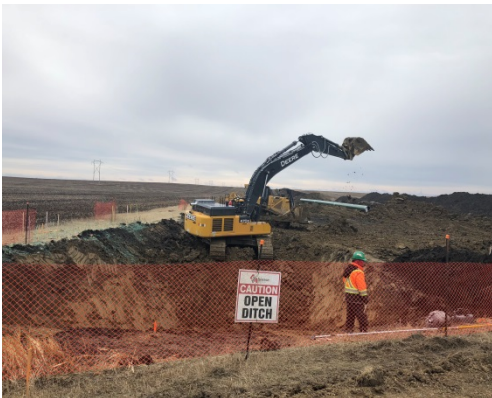
SF 43A, photo facing east, excavator digging hole for where pipe will go under the road.

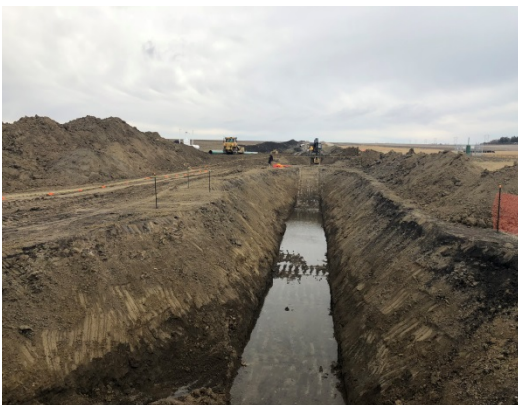
SF 42, photo facing west, excavator moving dirt out of the trench onto the ROW, one dozer then moving that dirt to the side of the ROW.

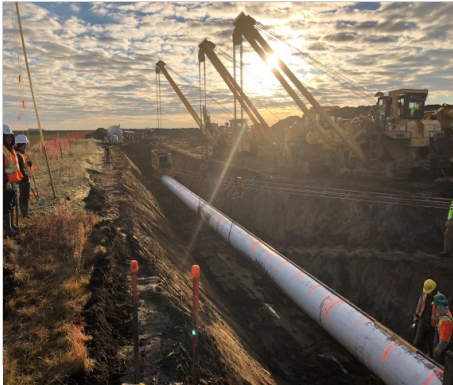
SF 10, photo facing east, crews pulling pipe under the road.

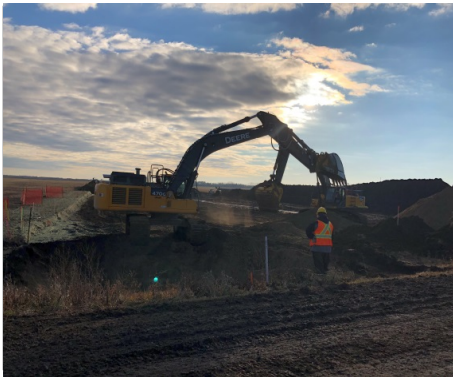
SF 14, photo facing east, excavator digging bell hole.

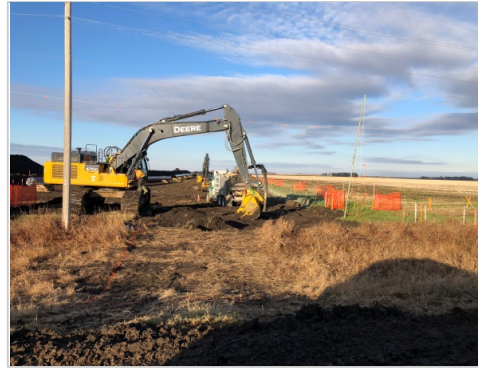
SF 14, photo facing west, excavator digging bell hole, hydrovac looking for any buried lines.

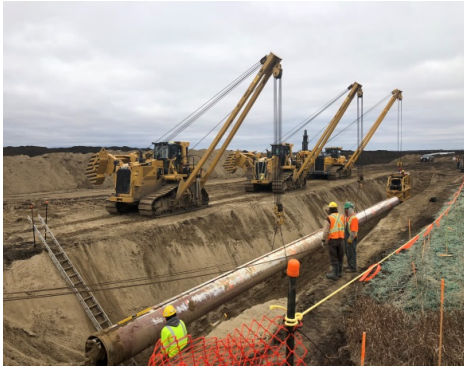
SF 12, photo facing south west, side booms sliding the pipe into the bored hole under the road.

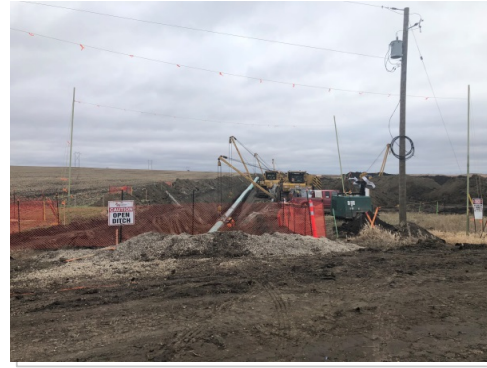
SF 42, photo facing east, side booms lowered pipe into the ground, welders on sight welding the pipe together, tying in.

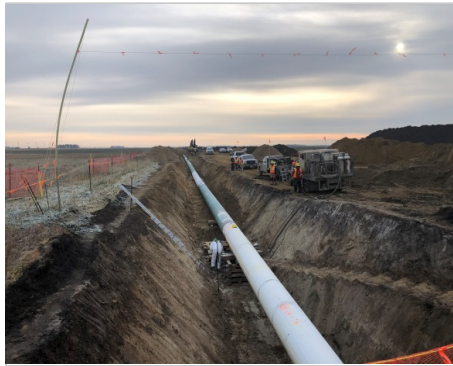
SF 10, photo facing east, one worker getting ready to heat the pipe.

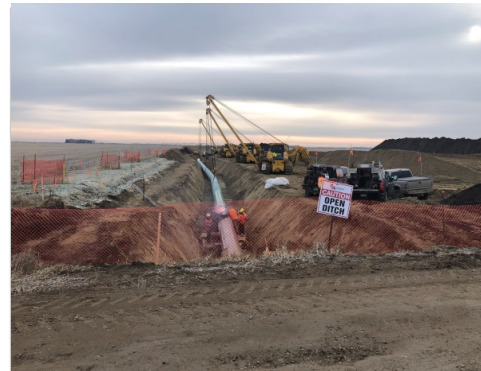
SF 11, photo facing east, crews welding the pipe together.

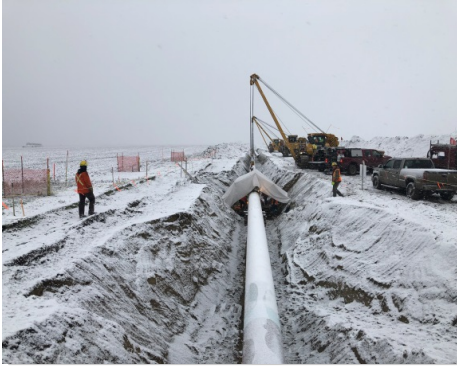
SF 12, photo facing east, crews tying in pipe.

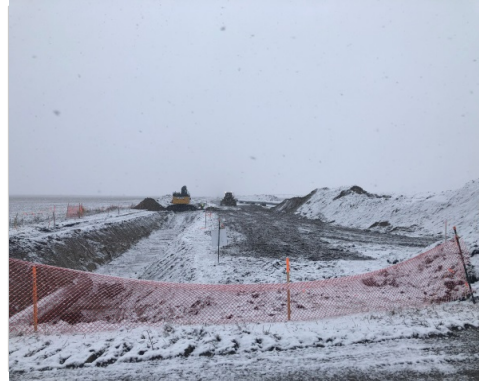
SF 15, photo facing east, one excavator digging down trench, dozer pushing dirt to the side of the ROW.

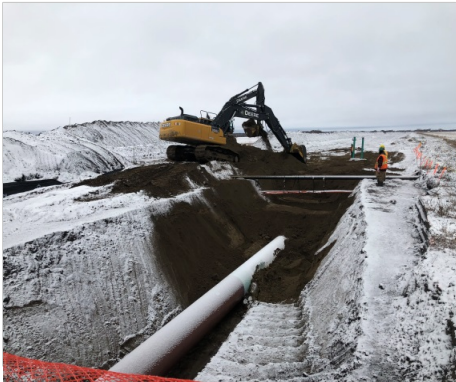
SF 11, photo facing west, two excavators back filling the pipe.

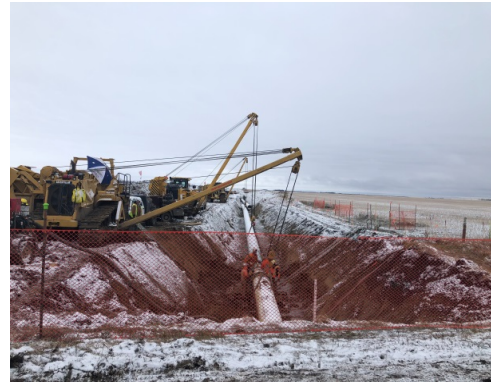
SF 16, photo facing west, tie in crew tying in the pipe.

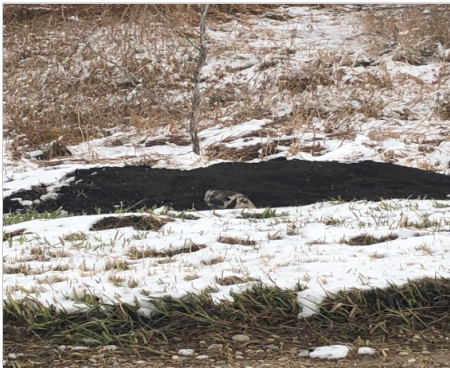
Saw this badger about 100 feet north of the SF 6 access on the east side of the gravel road, I decided to name him frank.

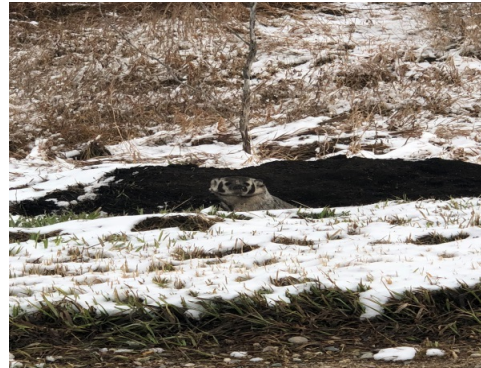
Here's another picture of frank, we saw him cross the road as we were monitoring SF 6, he is very big and fast, I would not mess with frank.
