**MANITOBA METIS FEDERATION – MATRIX
SOLUTIONS INC. PARTNERSHIP**

INDIGENOUS CONSTRUCTION MONITORING

WEEKLY REPORT

SPREAD 8

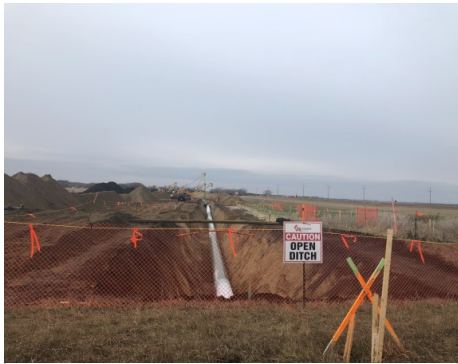
SF 10, photo facing west, lowering in/tie in crew.

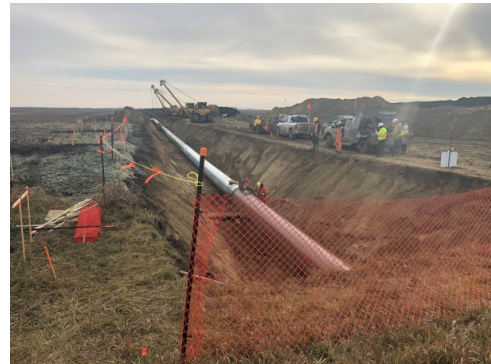
SF 15, photo facing east, tie in crew, welders welding the pipe together.

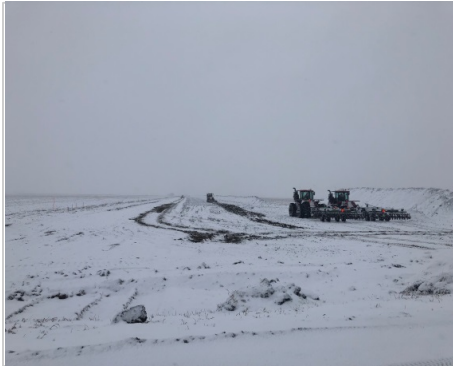
SF 12, photo facing east, three quad tracks
discing the ROW.

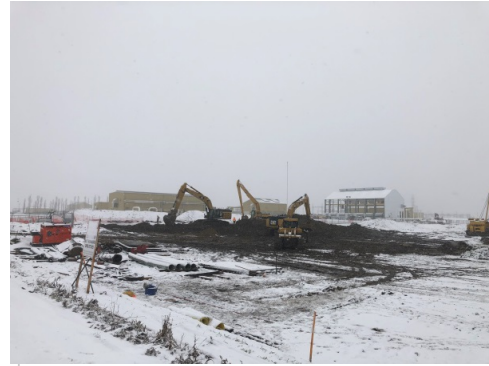
SF 20, photo facing north east, crews
backfilling the pipe.

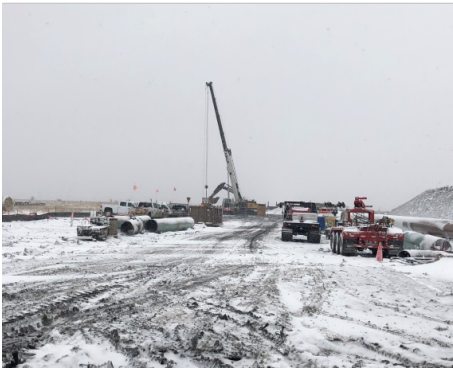
SF 22B, photo facing east, crews installing
sheet metal piles.

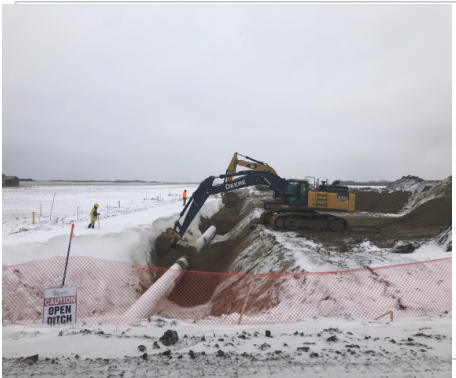
SF 14, photo facing east, two excavators back filling.

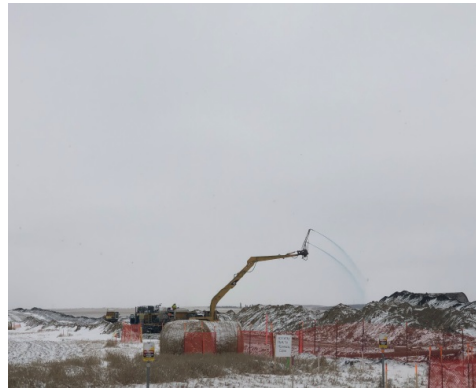
SF 41A, photo facing east, long arm excavator spraying tackifier on the top soil.

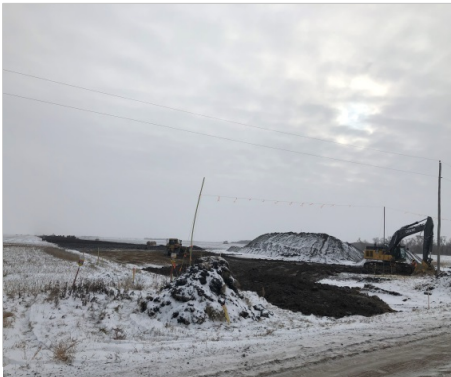
SF 10, photo facing south east, crews pushing dirt, multiple dozers in the far backround pushing back topsoil.

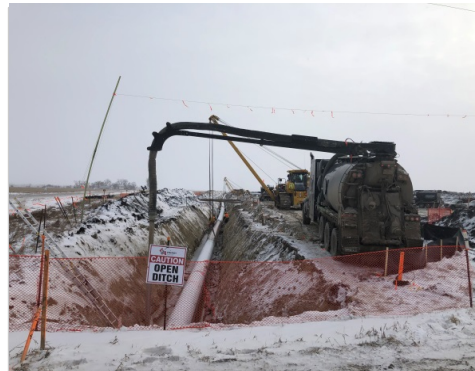
SF 17A, photo facing east, lowering in/tieing in crew.

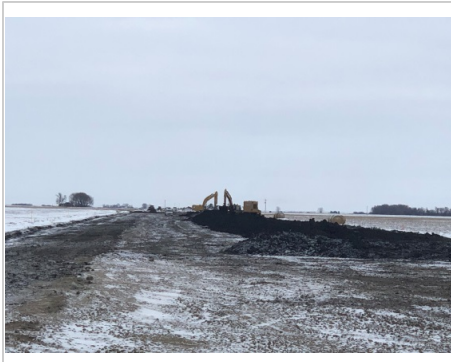
SF 12, photo facing east, multiple dozers and excavators putting topsoil back on the ROW.

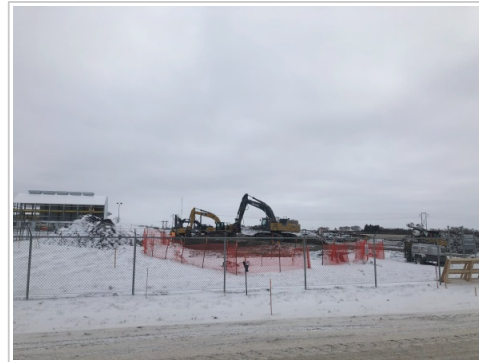
SF 20, photo facing east, excavators burying pipe.

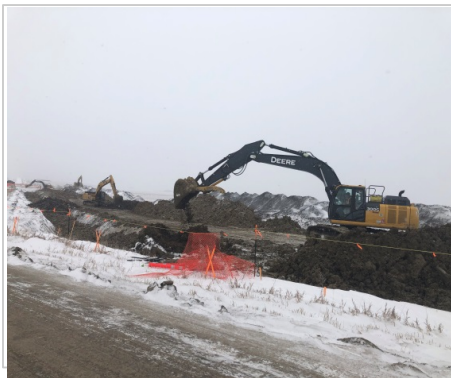
SF 43, photo facing south east, four excavators backfilling the pipe.

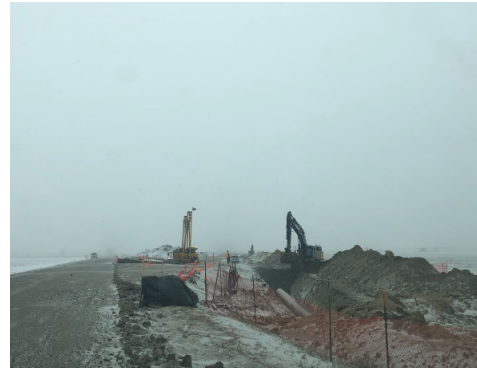
SF 17, photo facing west, two excavators backfilling the pipe.
