**MANITOBA METIS FEDERATION – MATRIX
SOLUTIONS INC. PARTNERSHIP**

INDIGENOUS CONSTRUCTION MONITORING

WEEKLY REPORT

SPREAD 8

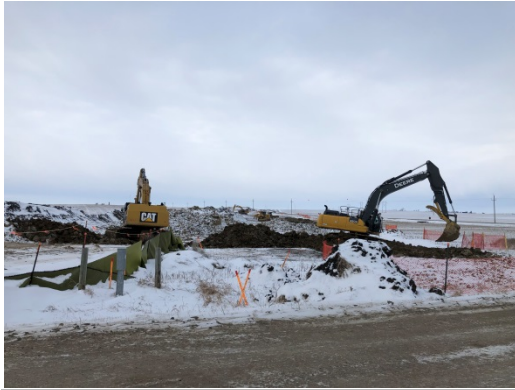
SF 43A, photo facing west, excavators and one dozer moving dirt.

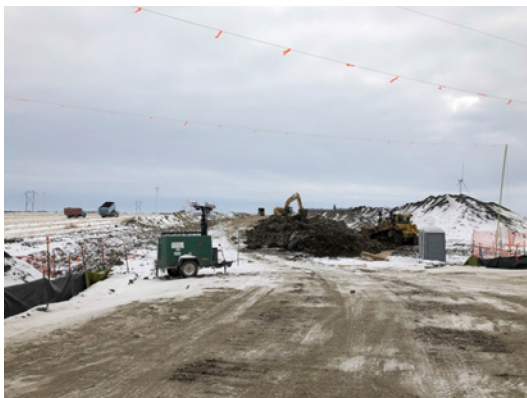
SF 45, photo facing east, one dozer and one excavator pushing dirt on the ROW.

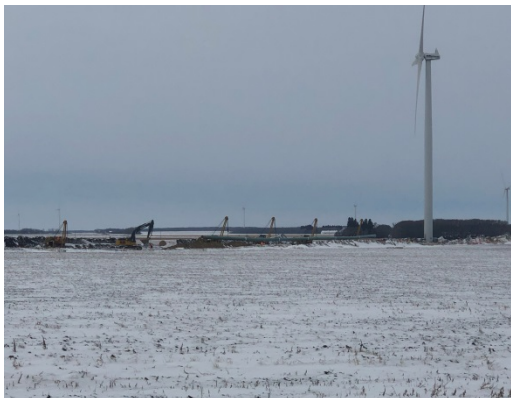
SF 48, photo facing west, side booms lowering in pipe.

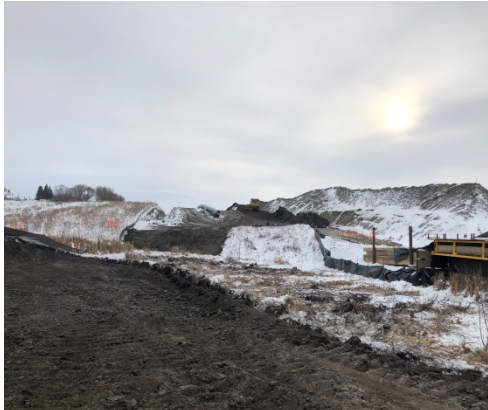
SF 40, photo facing east, one dozer pushing dirt up hill.

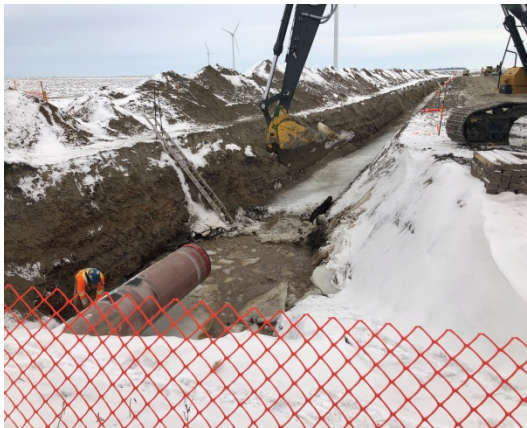
SF 49, photo facing east, excavator removing ice from trench.

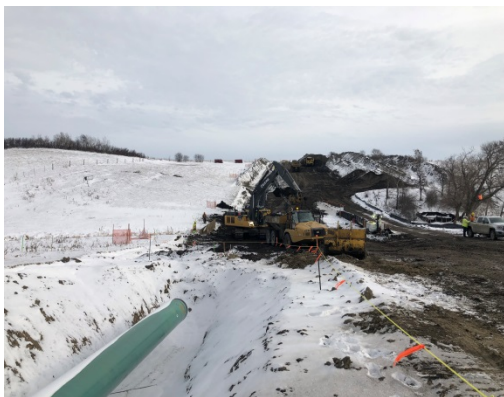
SF 39, photo facing east, equipment digging out creek crossing.

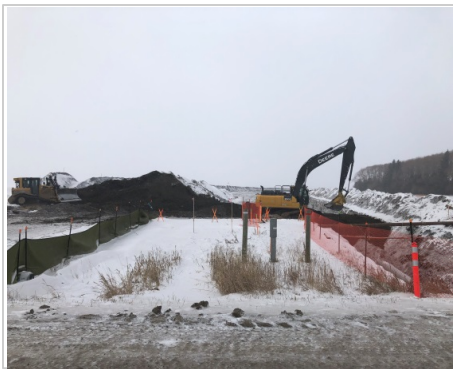
SF 49, photo facing west, excavator backfilling the pipe.

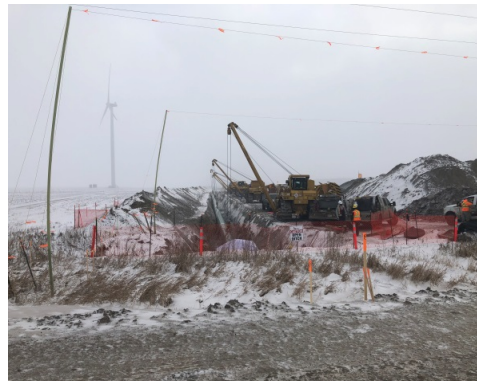
SF 49, photo facing east, tie in crew tying in the pipe.

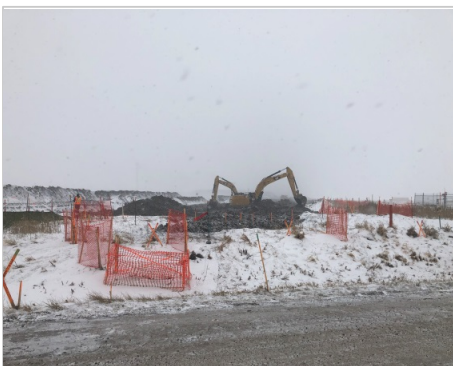
SF 47, photo facing east, two excavators moving dirt on top of pipe.

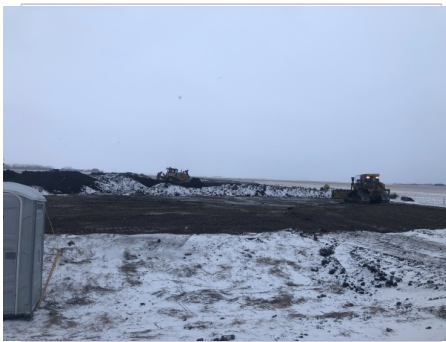
SF 16, photo facing west, crews pushing topsoil.

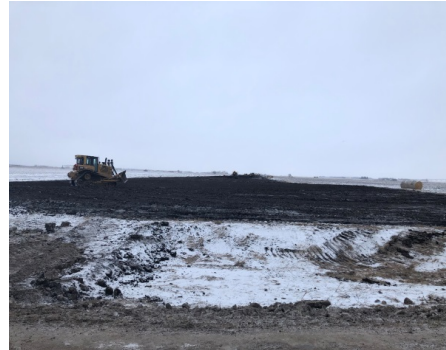
SF 16, photo facing east, crews pushing topsoil.

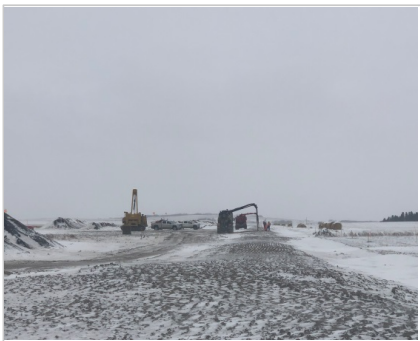
SF 35, photo facing west, hydrovacacs daylighting pipe.

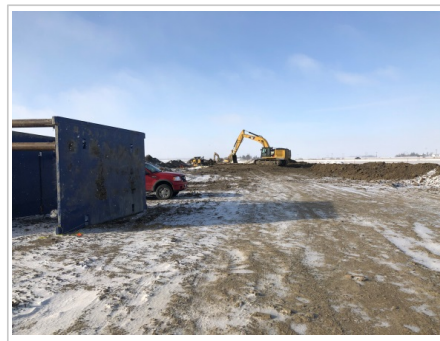
SF 41A, photo facing west, crews pushing dirt on ROW.

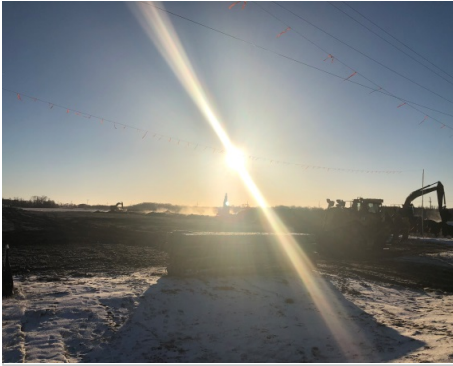
SF 9, photo facing west, crews pushing top soil back onto the ROW.

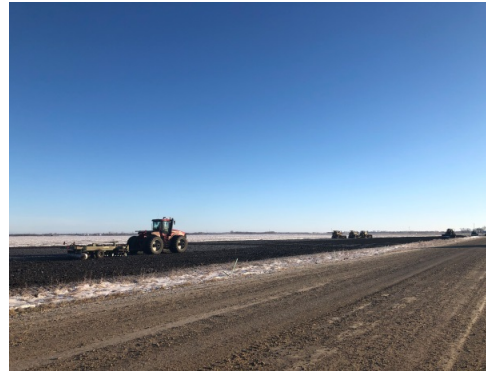
SF 17, photo facing north east, dozers back blading top soil, quad track disking.

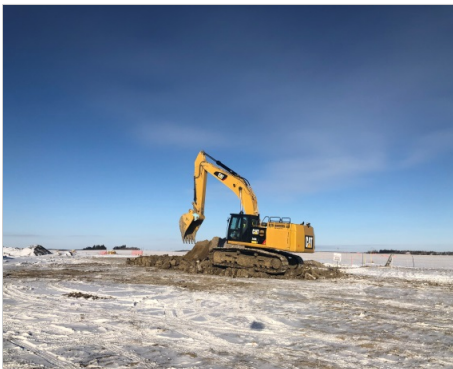
SF 35, photo facing north, excavator backfilling open ditch.

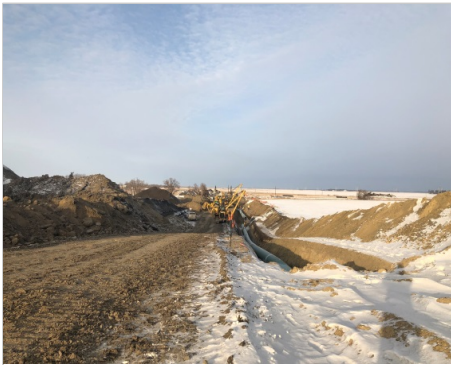
SF 28, photo facing west, crews tying in underneath the river.

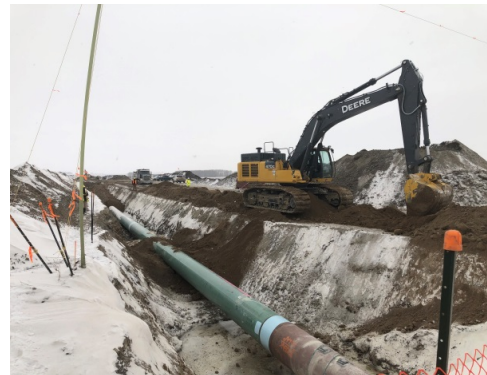
SF 49, photo facing south east, crews backfilling pipe.
