**MANITOBA METIS FEDERATION – MATRIX
SOLUTIONS INC. PARTNERSHIP**

INDIGENOUS CONSTRUCTION MONITORING

WEEKLY REPORT

SPREAD 8

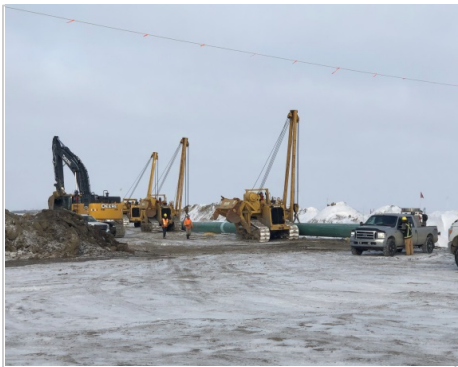
SF 50, photo facing north west, crews lowering in/tying in pipe.

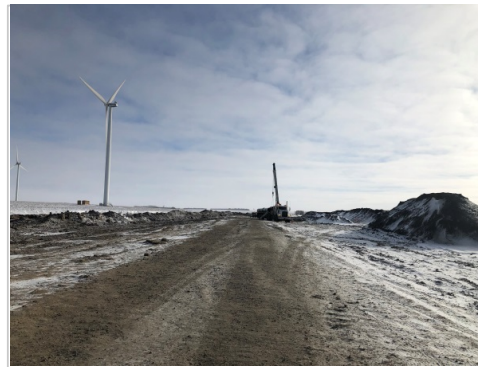
SF 49, photo facing east, semi boom loading extra pieces of short pipe, hauling them out.

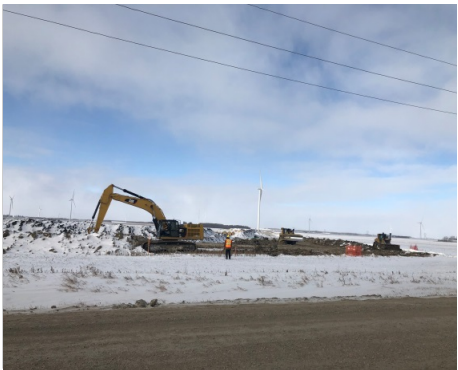
SF 48, photo facing west, crews pushing dirt, spreading it out.

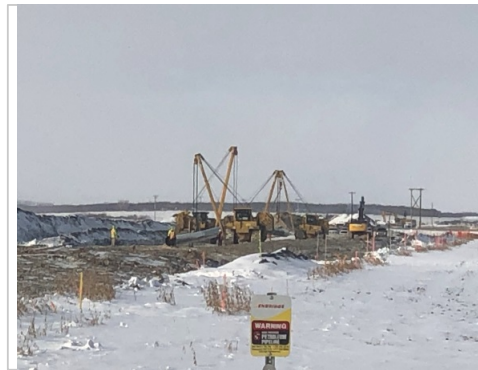
SF 41A, photo facing north west, crews preparing to lower in the pipe.

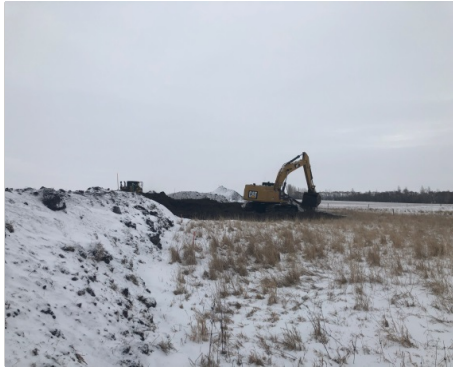
SF 23, photo facing east, excavator removing silk fencing from around wetland habitat.

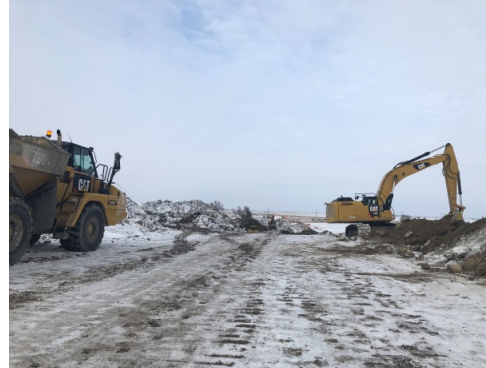
SF 28, photo facing west, crews backfilling the pipe.

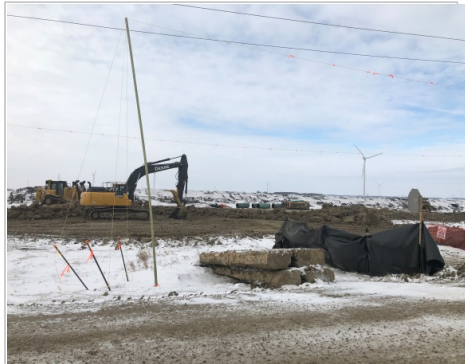
SF 48, photo facing west, two dozers and one excavator pushing dirt on the ROW.

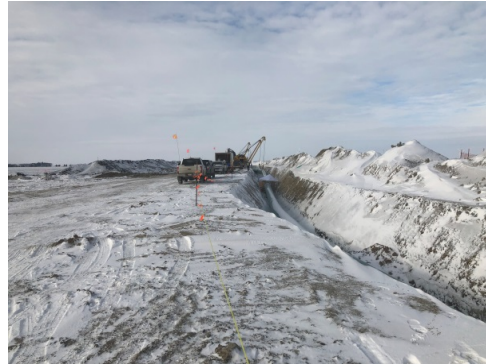
SF 50, photo facing west, tie in crew finishing tying in pipe, coating crew coating the pipe in the tent.

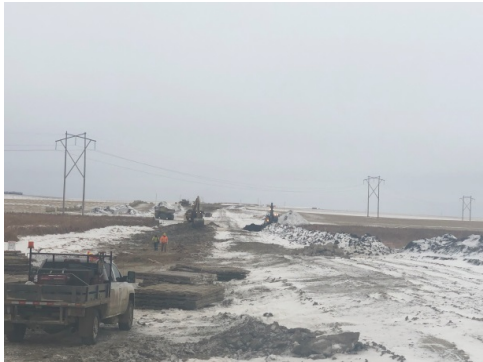
SF 30, photo facing east, crews removing rig mats and geotech from the ROW.

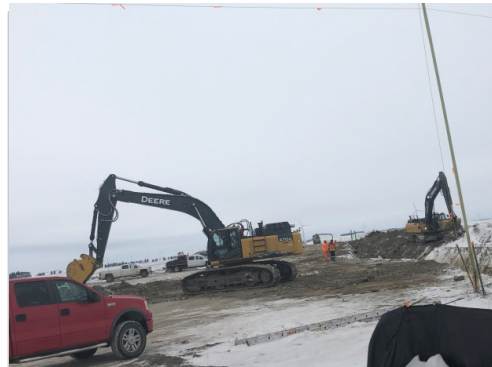
SF 50, photo facing west, two excavators backfilling the trench.

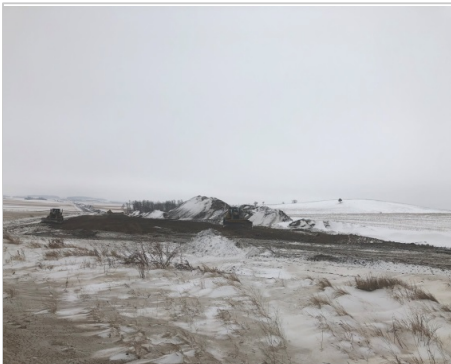
SF 32, photo facing south east, dozers pushing dirt on the ROW.

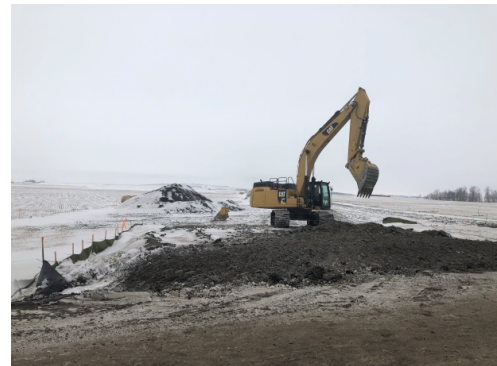
SF 34, photo facing west, excavator starting to rip up the approach for the ROW.

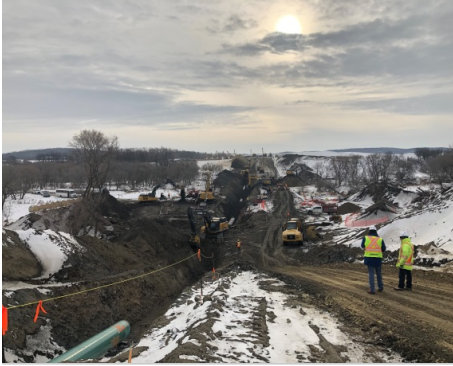
SF 35, photo facing south, excavators opening trench, excavators backfilling trench, rocktrucks hauling dirt.

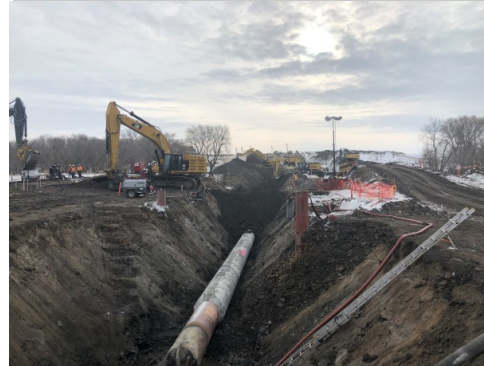
SF 35, photo facing south, excavator backfilling pipe.

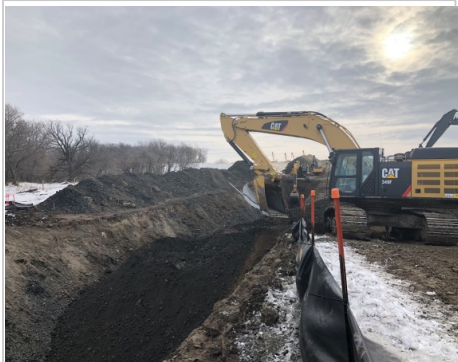
SF 35, photo facing south, excavator backfilling pipe.

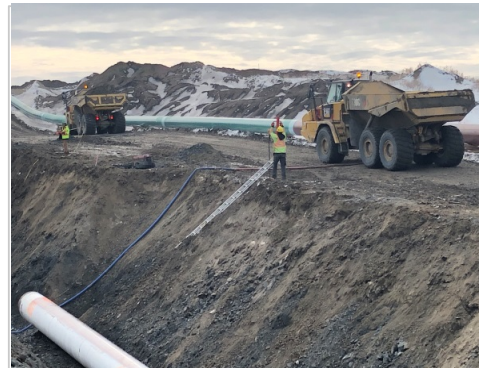
SF 35, photo facing south, one crew member tamping in metal post so he can then secure ladder to it.

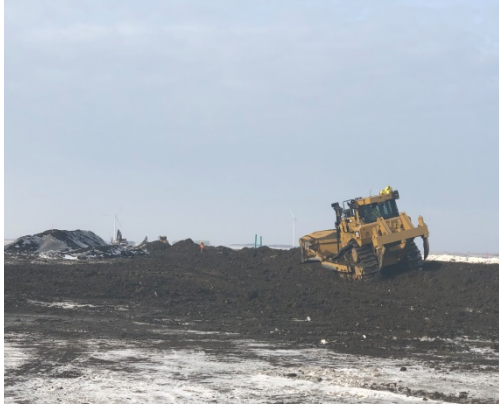
SF 50, photo facing west, two dozers and one excavator moving dirt on the ROW, smoothing/flattening it out.

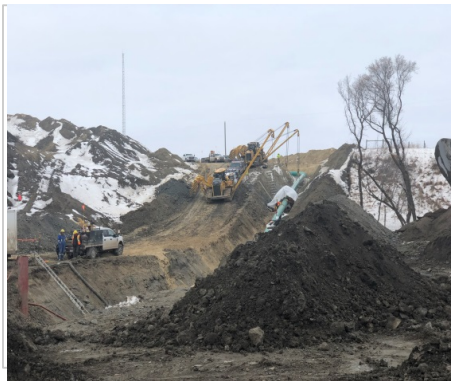
SF 35, photo facing north, tie in crew tining in.

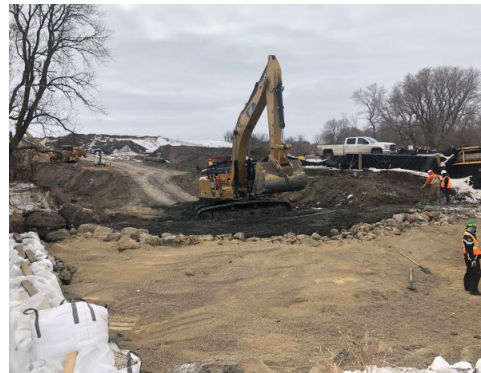
SF 35, photo facing south, excavator building up the river bank.

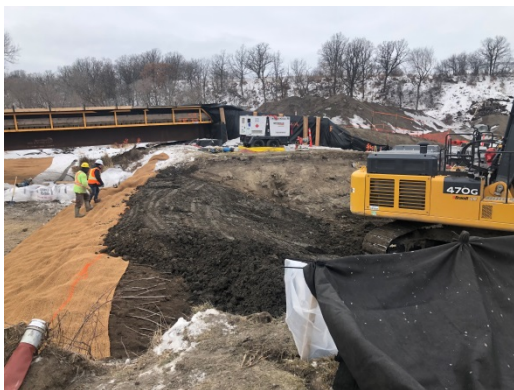
SF 35, photo facing west, excavator building up river bank on the other side.

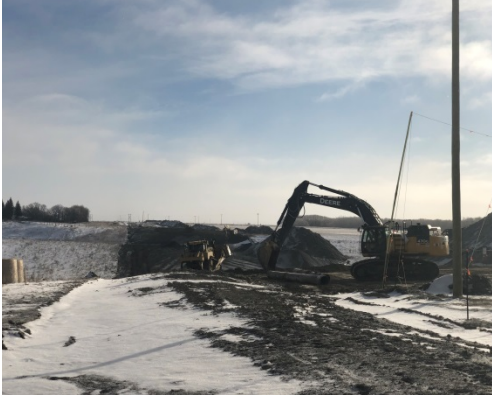
SF 40, photo facing east, two dozers and one excavator moving dirt.
