**MANITOBA METIS FEDERATION – MATRIX
SOLUTIONS INC. PARTNERSHIP**

INDIGENOUS CONSTRUCTION MONITORING

WEEKLY REPORT

SPREAD 8

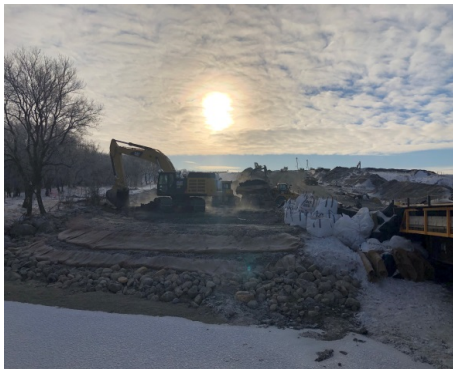
SF 35, photo facing south, crews backfilling the pipe.

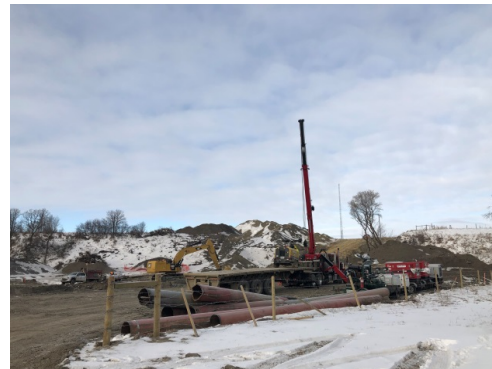
SF 35, photo facing north west, boom semi loading up light plants.

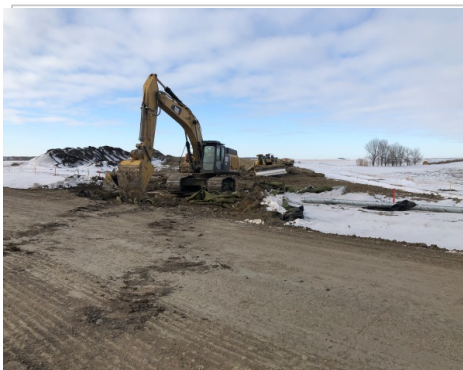
SF 38, photo facing north west, excavator pulling back approach.

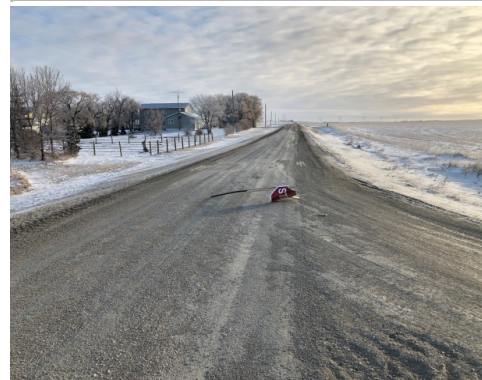
Just north of SF 33, SA stop sign lying on the road, I moved it off the road and set it off to the side besides the yield sign.

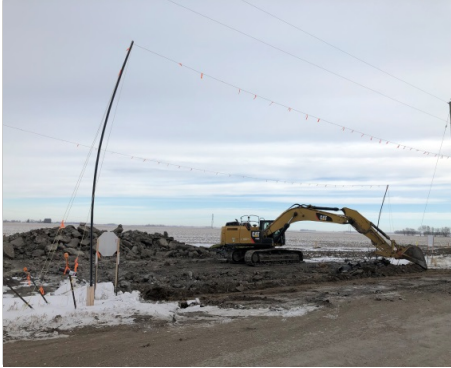
SF 24, photo facing north east, excavator pulling back approach.

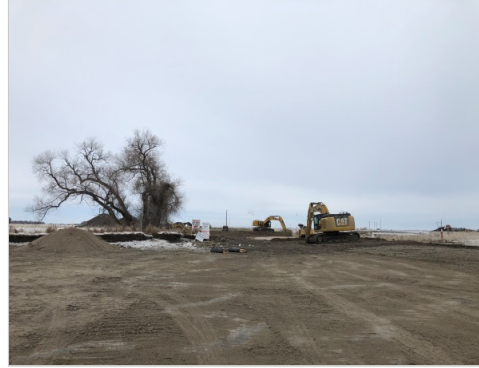
SF 28, photo facing west, two excavators building up creek banks.

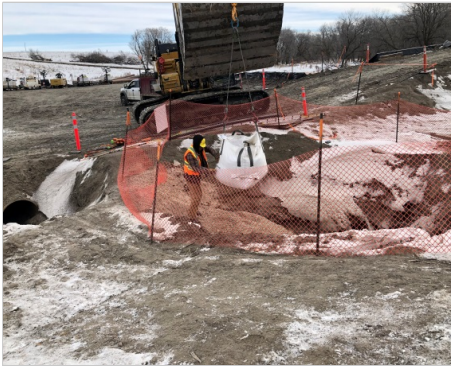
SF 35, photo facing south east, excavator dumping limestone into open pit.

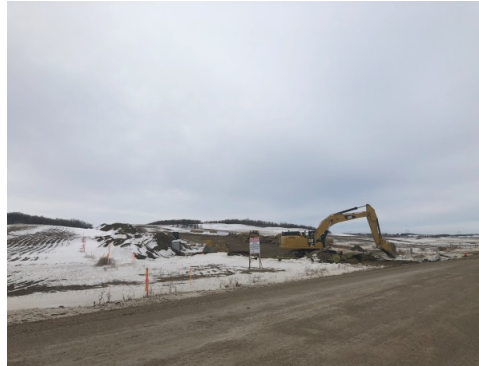
SF 36, photo facing north west, excavator pulling back approach.

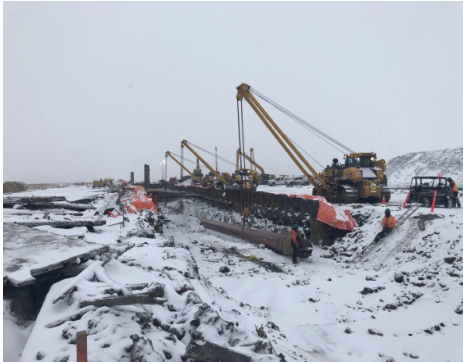
SF 22B, photo facing east, crews lowering in.

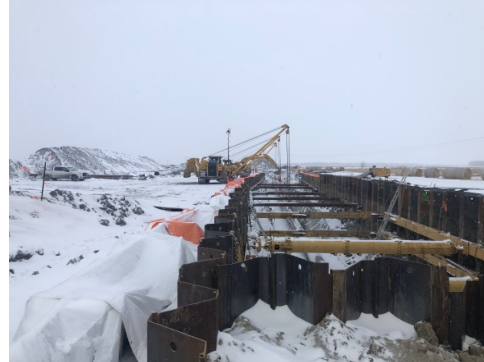
SF 22B, photo facing west, crews lowering in.

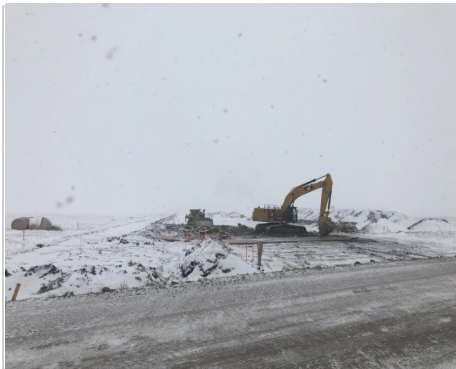
SF 25, photo facing east, one excavator pulling back approach, one dozer pushing frozen chunks of mud to the side of the ROW.

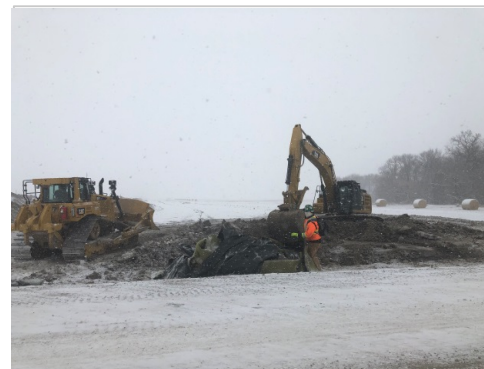
SF 26, photo facing north, one excavator pulling back approach, one dozer pushing frozen chunks of mud to the side of the ROW.

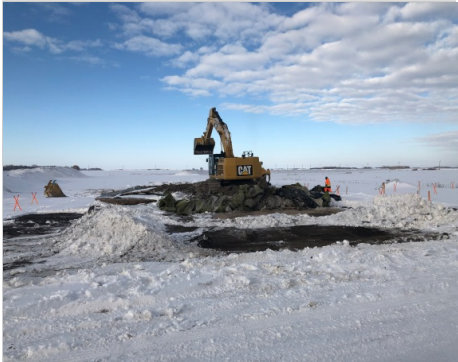
SF 20, photo facing west, crews pulling back approach.

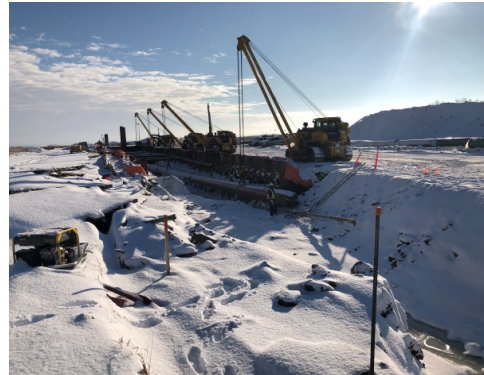
SF 35, photo facing east, crews have pipe in the trench preparing to tie in. Directional drill come up from the ground.

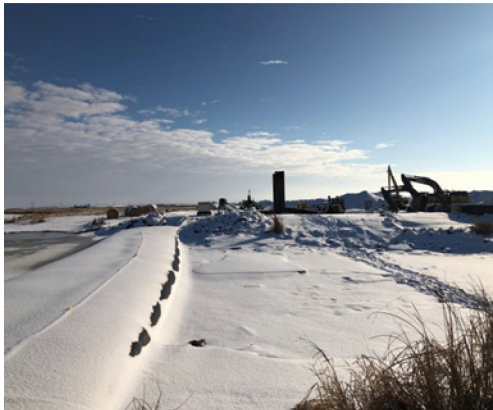
SF 35, photo facing east, directional drill has drill underneath the road.

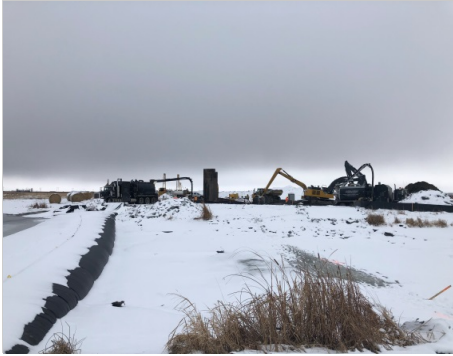
SF 22B, photo facing east, crew pulled pipe under the creek, hydrovaccers hydrovaccing.

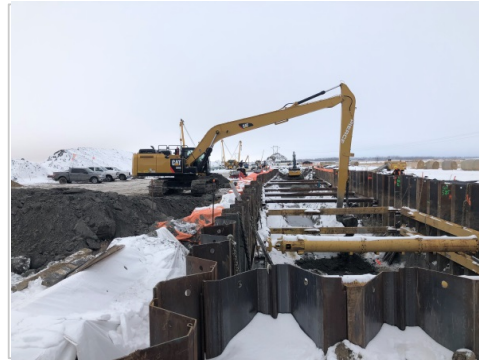
SF 22B, photo facing east, excavator filling dirt in the trench in one spot.

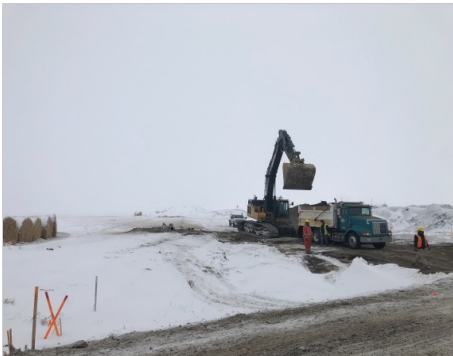
SF 41A, photo facing east, excavator pulled approach and is loading silk fence into the back of a tandem.

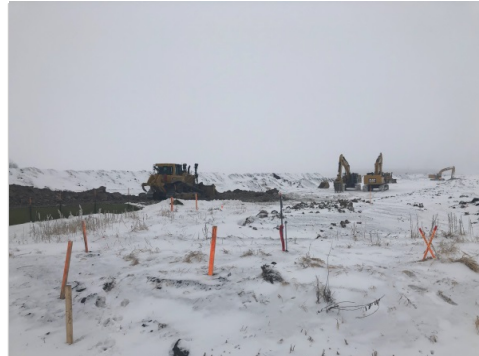
SF 47, photo facing west, dozer pushing dirt from approach back onto the ROW.

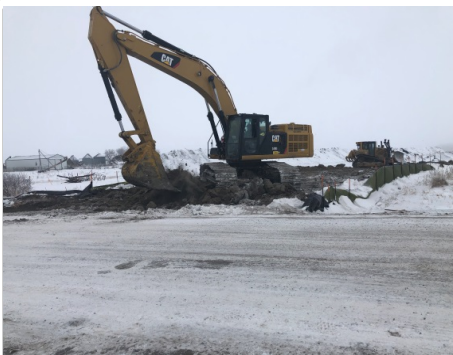
SF 47, photo facing west, excavator pulling back approach.

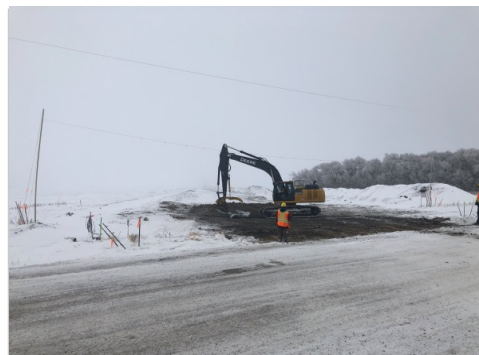
SF 47, photo facing east, excavator finishing up removing approach, culvert being crunched up, he then pulled the metal posts from the ground.

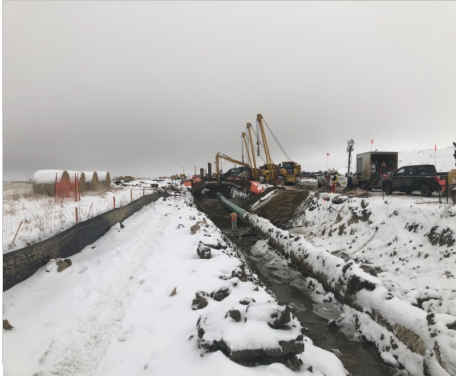
SF 22B, photo facing east, one crew member heating the weld on the pipe.

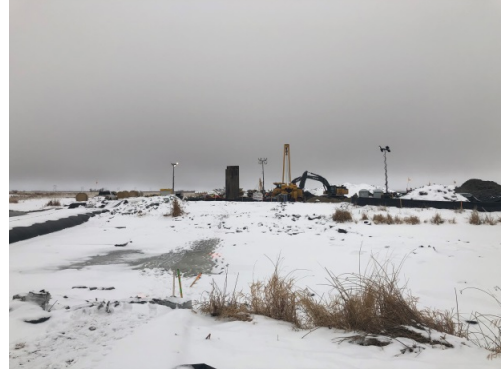
SF 22B, photo facing east across the creek, multiple excavators and dozers moving stones.

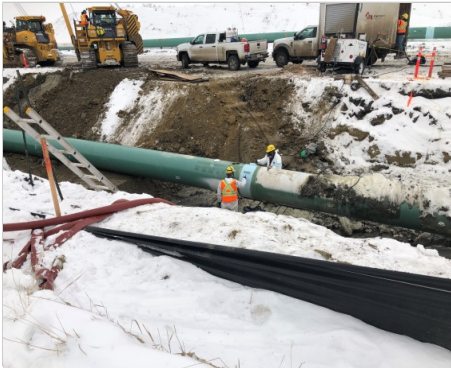
SF 22B, photo facing south east, coating crews applying the coating to the pipe.

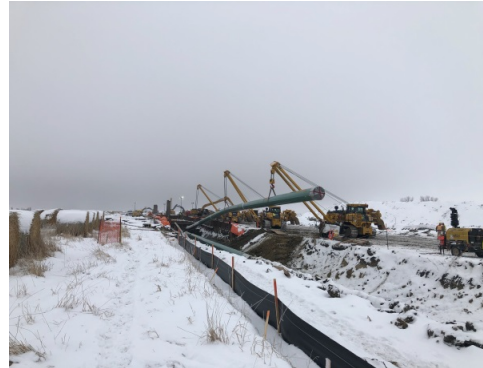
SF 22B, photo facing east, lowering in crew lowering in a section of pipe underneath the cross beams used to support the sheet metal piles.

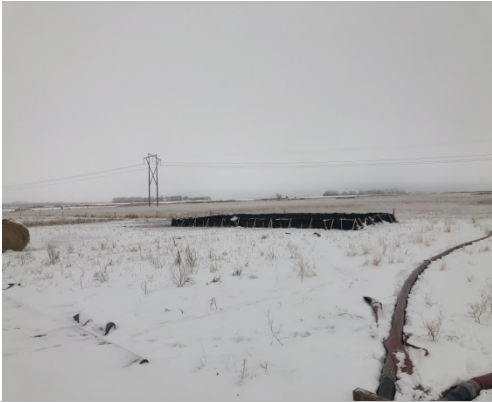
SF 22B, photo facing north from the east side of the gravel road, pig pen set up to collect water from the trench.
