**MANITOBA METIS FEDERATION – MATRIX
SOLUTIONS INC. PARTNERSHIP**

INDIGENOUS CONSTRUCTION MONITORING

WEEKLY REPORT

SPREAD 8

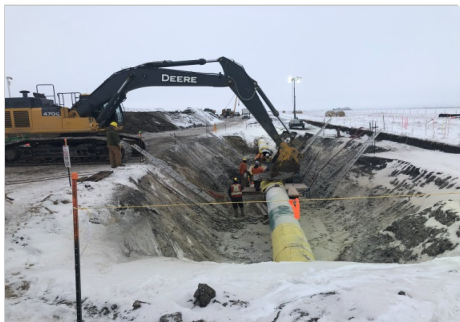
SF 5, photo facing west, crews preparing to install white valve.

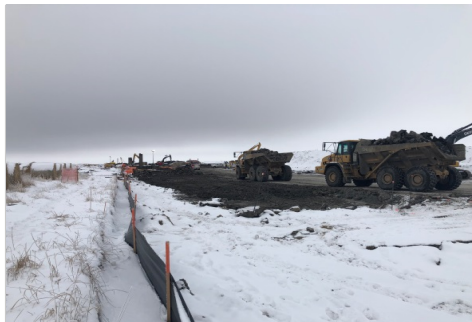
SF 22B, photo facing east, rock trucks preparing to dump dirt over top of pipe.

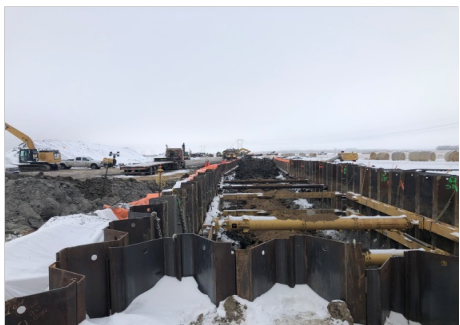
SF 22B, photo facing west, trench backfilled with dirt.

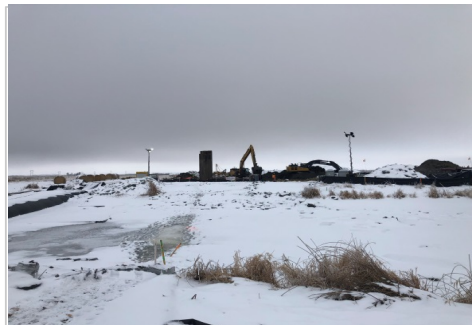
SF 22B, photo facing east to the other side of the creek, trench being backfilled.

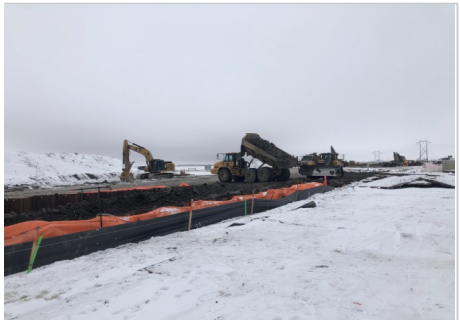
SF 22B, photo facing west, rock trucks dumping dirt on pipe, dozer then pushing that dirt down the pipe.

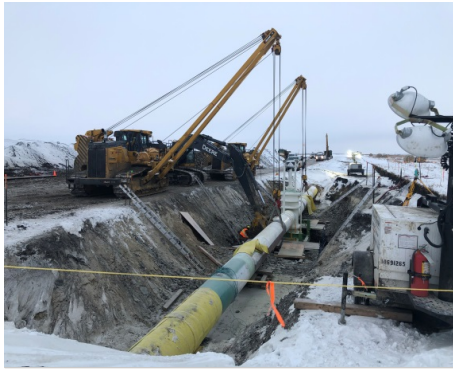
SF 5, photo facing west, valve is in place,
two side booms holding pipe.

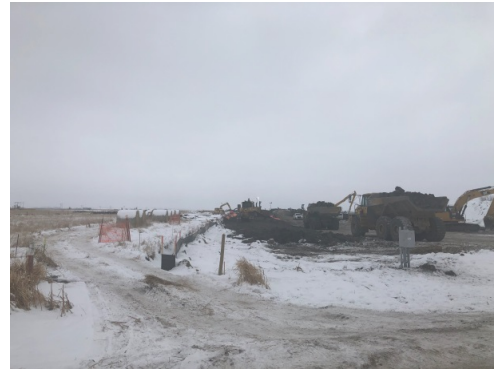
SF 22B, photo facing east, crews
backfilling the pipe.

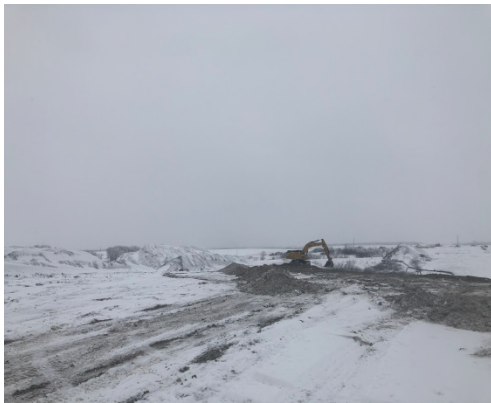
SF 40A, east side, one excavator building up
the hill bank.

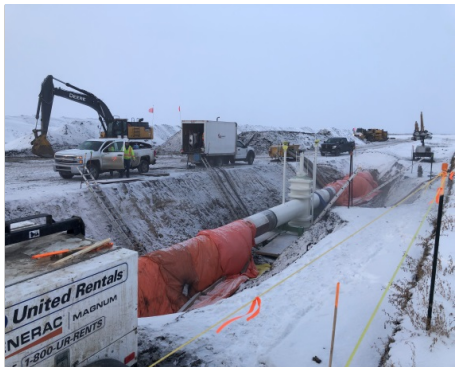
SF 5, photo facing west, valve installed, sandblasting crew on sight sandblasting the pipe.

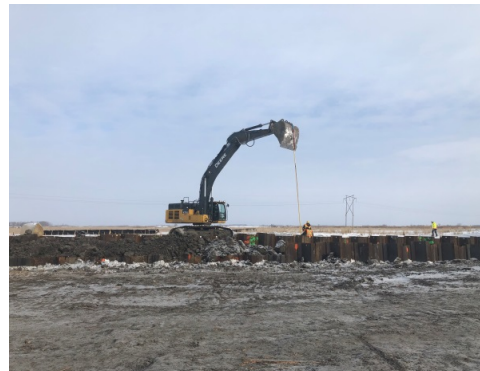
SF 22B, photo facing north, excavator removing sand points from the ground.

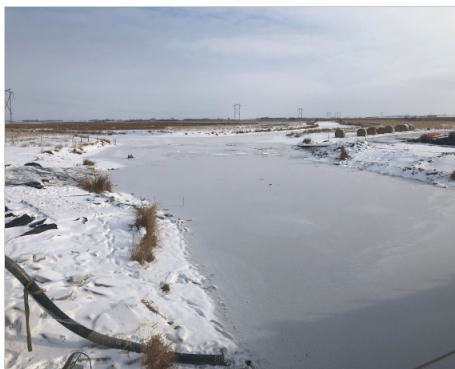
SF 22B, photo facing north, aqua damns removed from both sides of the creek.

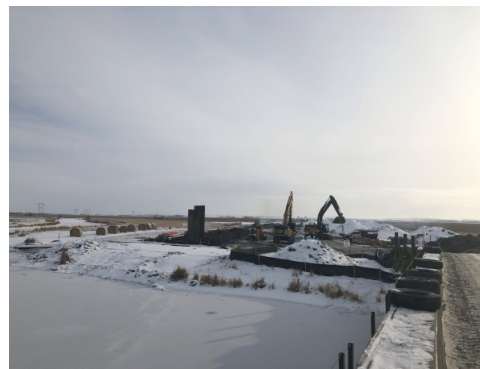
SF 22B, photo facing east, dozer pushing dirt over pipe, excavators moving misc things around.

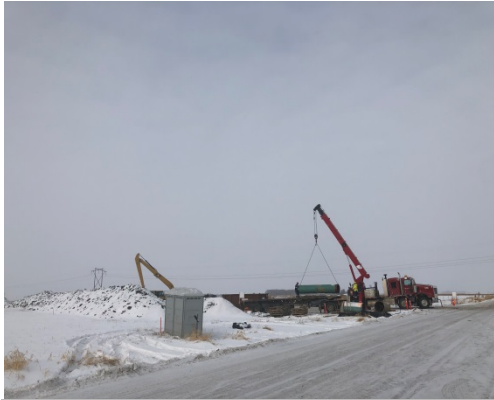
SF 22B, photo facing north west, boom semi truck loading up short pieces of pipe.

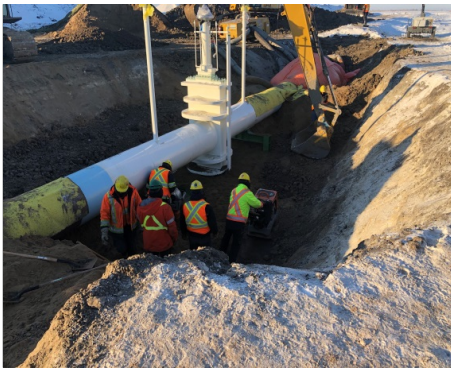
SF 5, photo facing west, crews packing down dirt in the trench with two tamping machines.

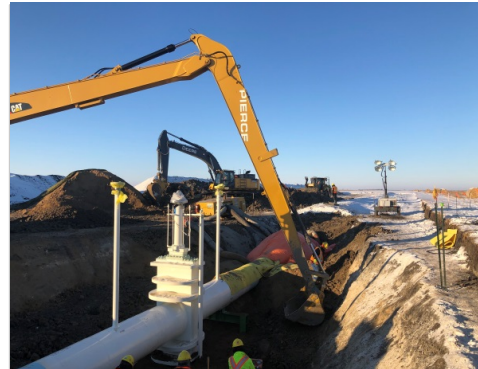
SF 5, photo facing west, excavator slowly backfilling pipe.

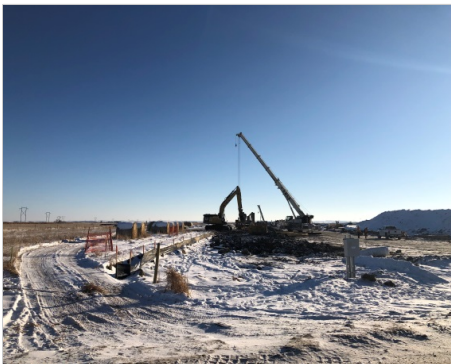
SF 22B, photo facing east, sheet metal piles being removed from the ground.

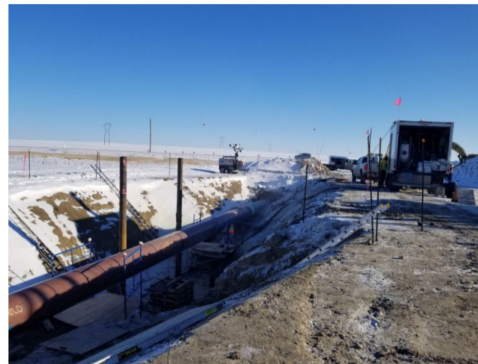
SF 42, photo facing east, crews sandblasting the pipe.

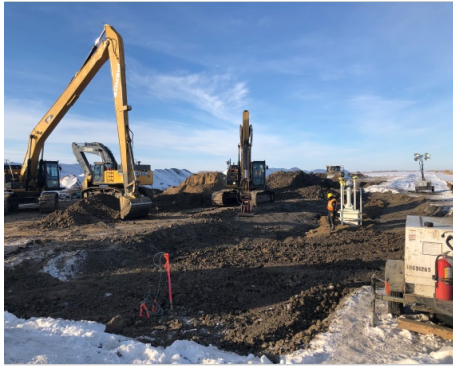
SF 5, photo facing west, crews backfilling pipe/valve.

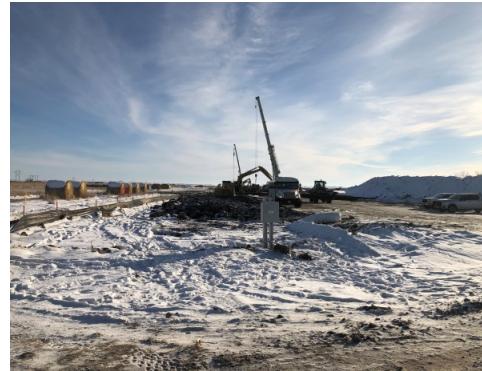
SF 22B, photo facing east, sheet metal piles being removed.
