**MANITOBA METIS FEDERATION – MATRIX
SOLUTIONS INC. PARTNERSHIP**

INDIGENOUS CONSTRUCTION MONITORING

WEEKLY REPORT

SPREAD 8

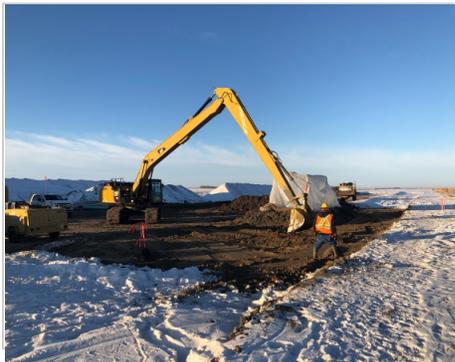
SF 22B, photo facing west, excavator finishing up packing down ground around the valve.

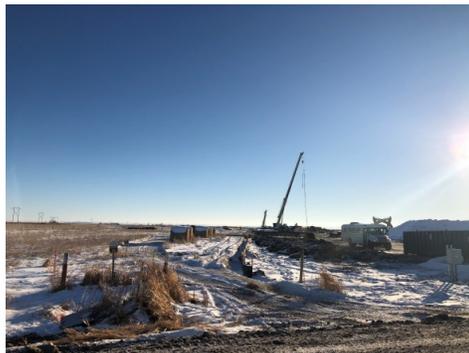
SF 22B, photo facing east, crews cleaning up the sight.

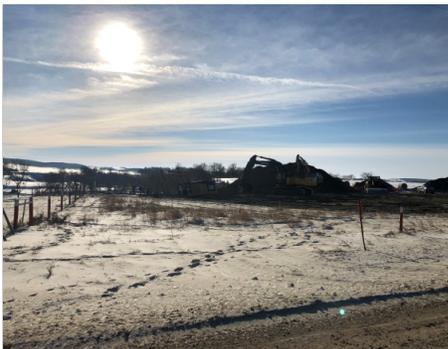
SF 35, photo facing south, crews building up hill bank.

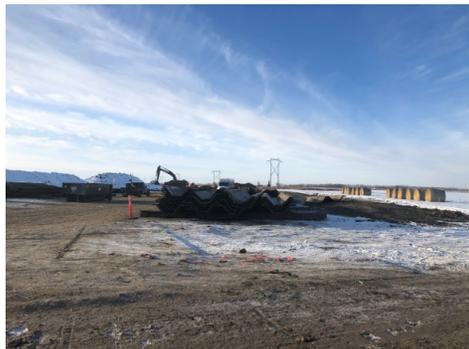
SF 22B, photo facing west, sheet metal piles all stacked up ready to be hauled out.

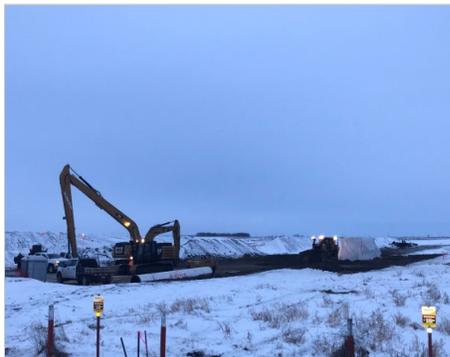
SF 5, photo facing west, valve installed and covered up.

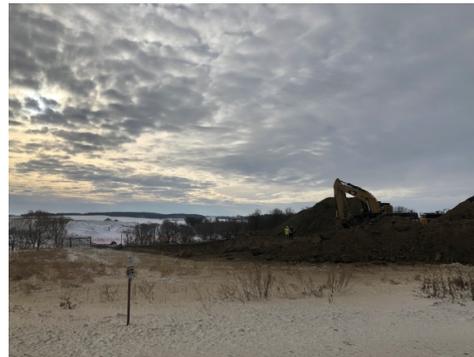
SF 35, photo facing south, crews building up hill bank.

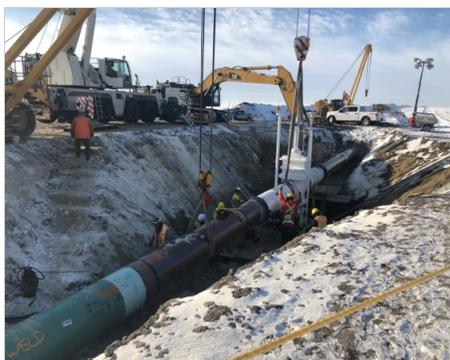
SF 42, photo facing west, valve in place, welders where on sight preparing to weld.

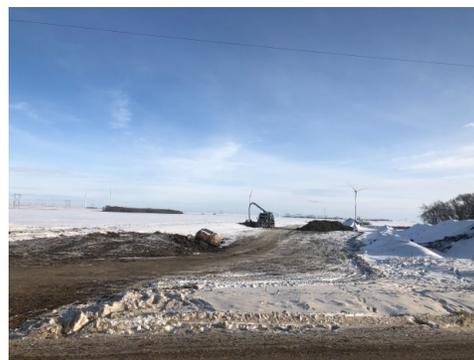
SF 47, photo facing east, hydro vac hydrovacating on top of the pipe.

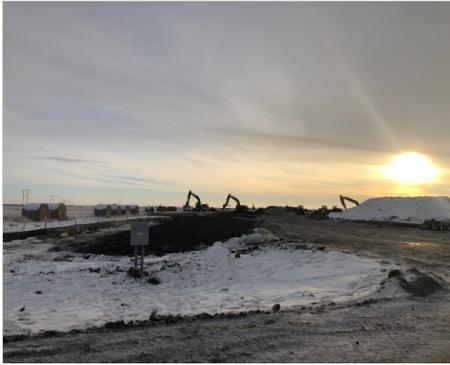
SF 22B, photo facing east, crews cleaning up the sight.

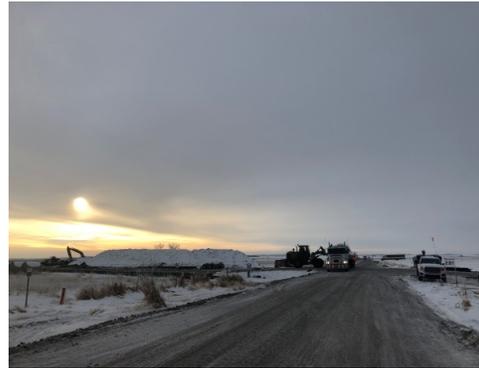
SF 22B, photo facing south, loader loading semi up with rig mats.

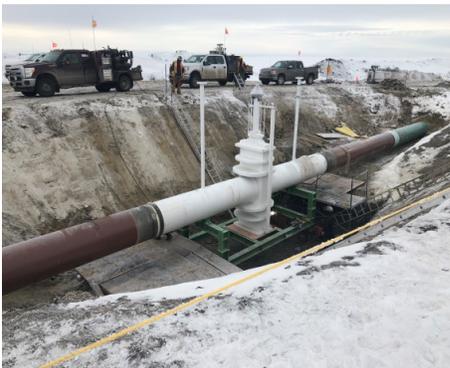
SF 42, photo facing west, valve installed, welders welding the green base on the valve.

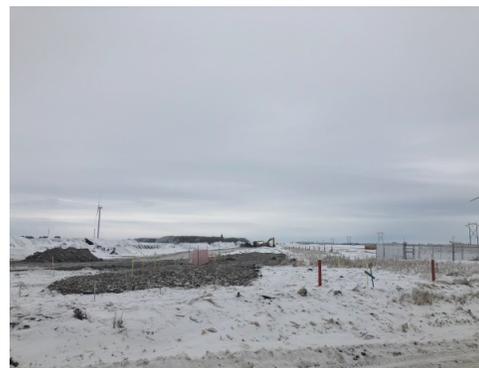
SF 47, photo facing west, ovality dig.

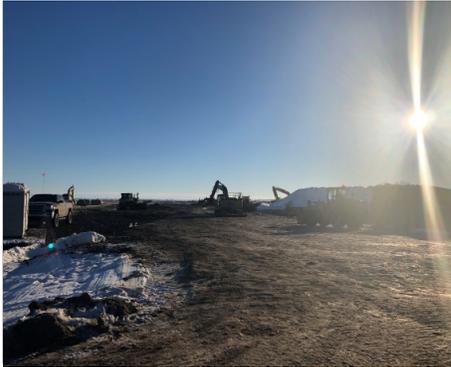
SF 22B, photo facing east, crews cleaning up sight, semis hauling out rig mats/sheet metal piles.

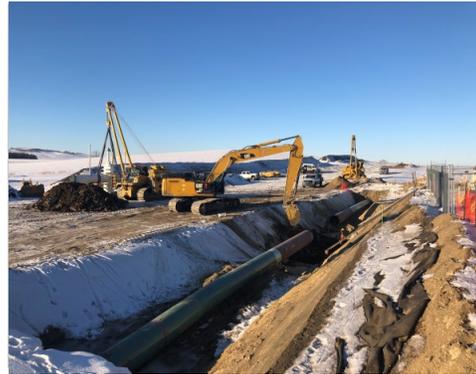
SF 28, photo facing west, pipe cut, excavator removing dirt, prepping for valve install.

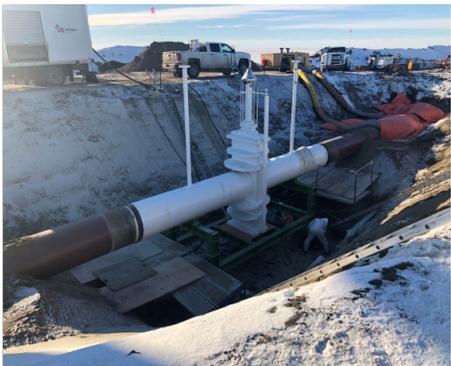
SF 42, photo facing west, valve installed, coating crews coating base under the valve.

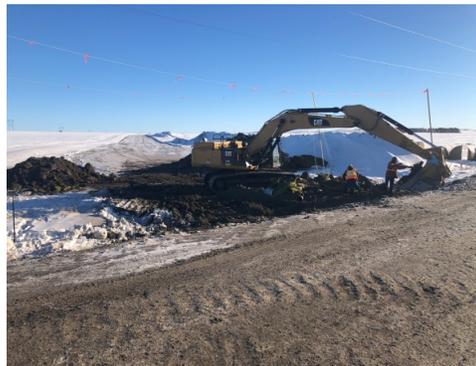
SF 42, photo facing south east, excavator removing approach.

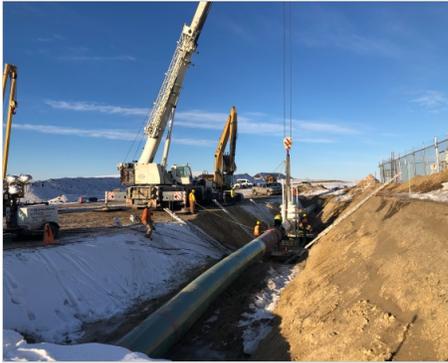
SF 28, photo facing west, crane lowering in valve, crews leveling valve.

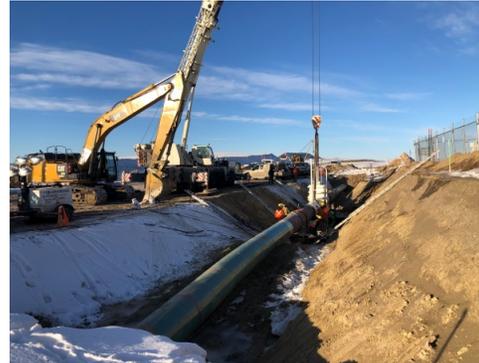
SF 28, photo facing west, crews heating the pipe with tiger torches.

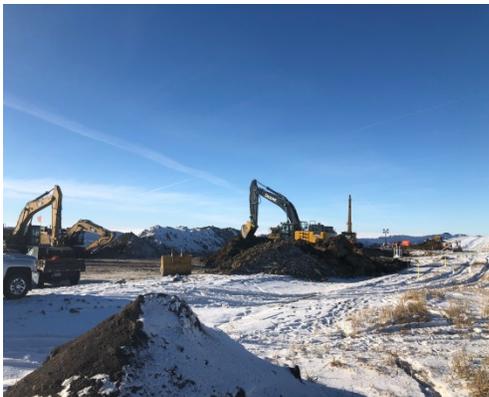
SF 42, photo facing west, crews backfilling valve/pipe.

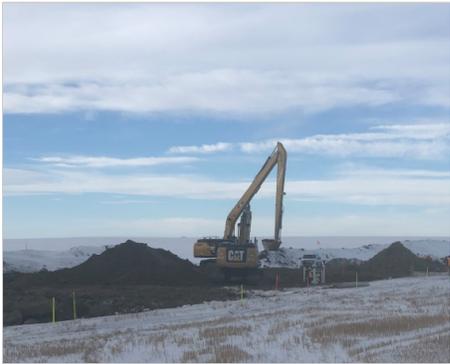
SF 42, photo facing west, two excavators backfilling, one packing down the dirt with a packer.

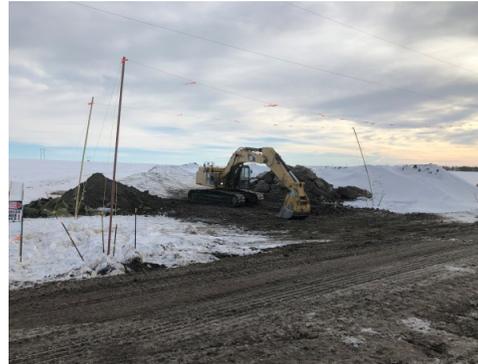
SF 42, photo facing south east, excavator packing down ditch where approach used to be.

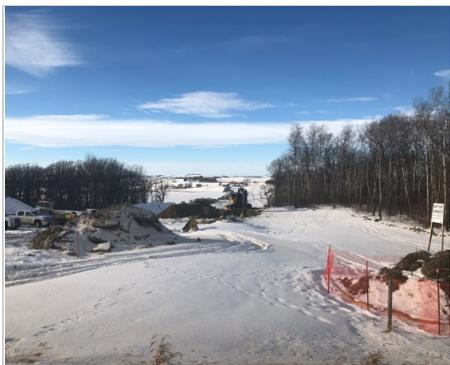
SF 31, photo facing west, ovality dig, hydro vac on sight.

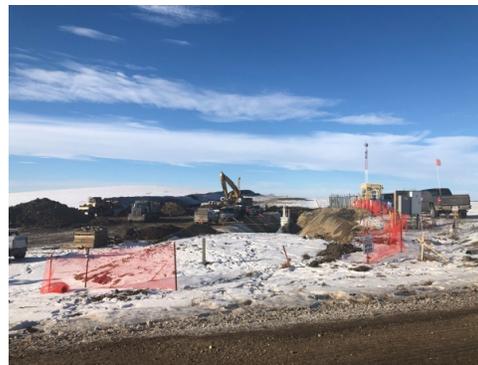
SF 28, photo facing west, excavator starting to backfill from the west side.

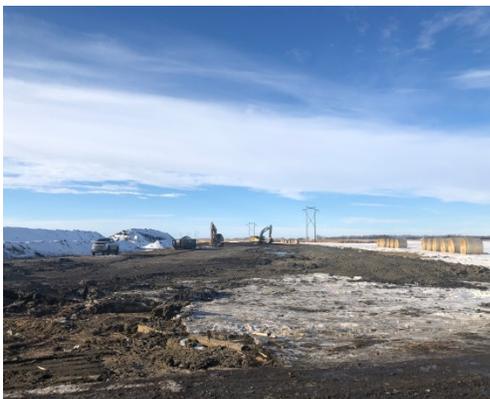
SSF 22B smoothing dirt over the pipe

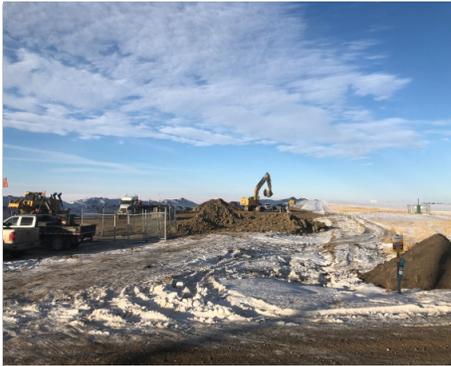
SF 42, photo facing west, valve backfilled, fencing for valve is on site.

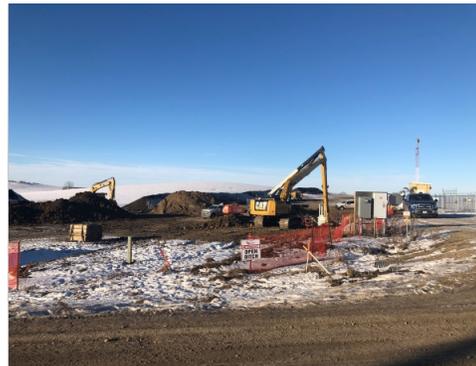
SF 28, photo facing west, excavator backfilling pipe, a crew member is in the trench using a boom lift because all the ladders have been removed.

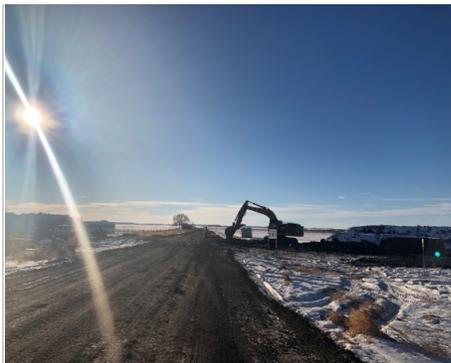
SF 22B, photo facing south, excavator pulling back approach.

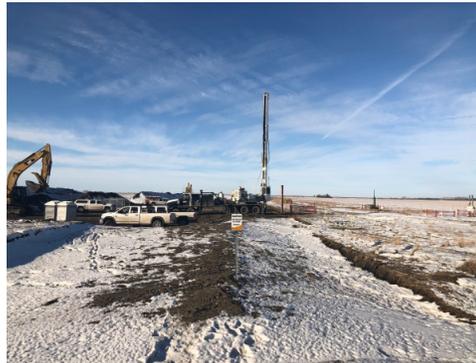
SF 5, photo facing west, driller drilling vertical holes just east of the valve.
