**SWAN LAKE FIRST NATION – MATRIX SOLUTIONS
INC. PARTNERSHIP**

INDIGENOUS CONSTRUCTION MONITORING

WEEKLY REPORT

SPREAD 8

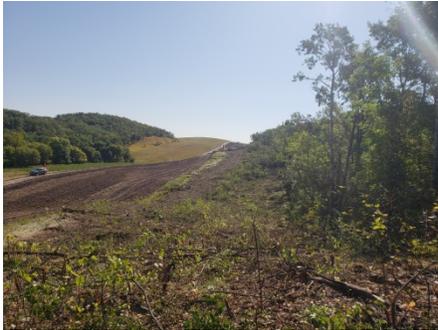
Photo facing East
SF 36 (KP969+200)
Photo of Culturally Sensitive area.

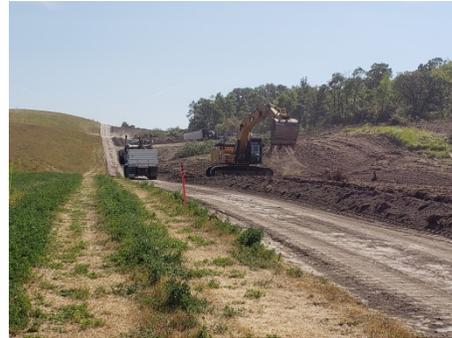
Photo facing East
SF 36 (KP969+200)
Excavator loading stumps into tandem trucks.

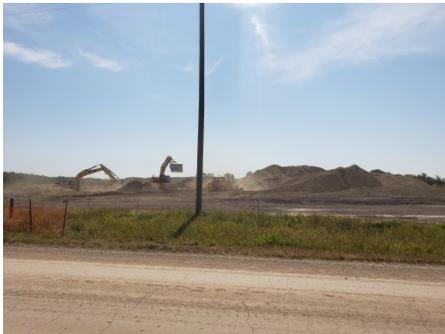
Photo facing South
SF 35 South side of the road. (Cypress river crossing)
Excavators stripping top soil from hill. Dozers piling top soil on South end of ROW

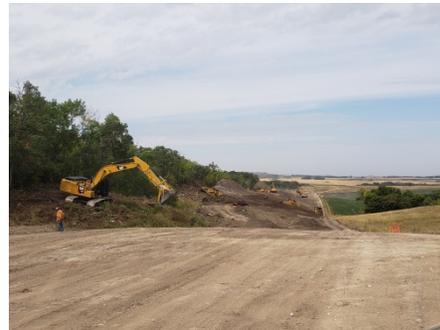
Photo facing West
SF 36 (KP969+500) Photo of Cultural Sensitive area.

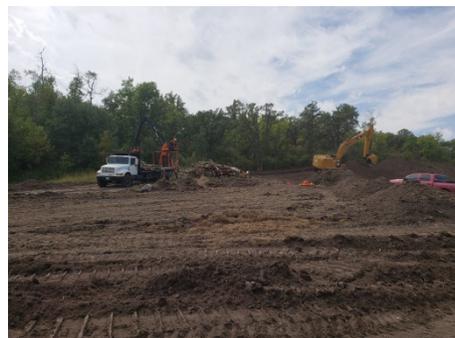
Photo facing South
SF 36 (KP969+500)
Excavator piling stumps, loading up tees.

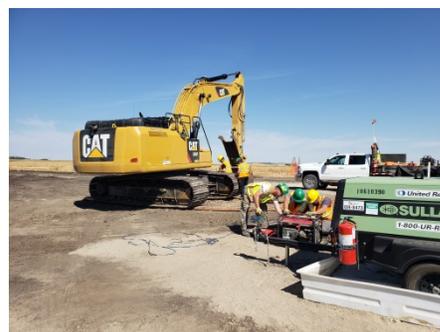
Photo facing North West
SF 37a
Photo of crew cleaning excavator.

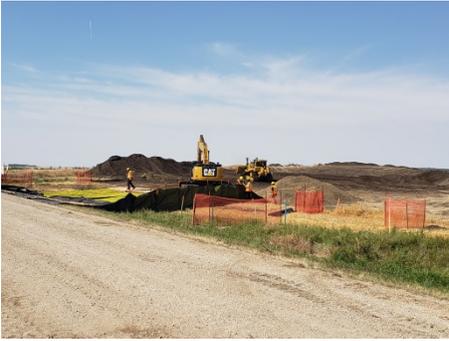
Photo facing North West
SF 38 (KP975)
Crew installing silt fencing. Excavator to place soil ontop of Geo Cloth and CAPELA cloth
