**SWAN LAKE FIRST NATION – MATRIX SOLUTIONS
INC. PARTNERSHIP**

INDIGENOUS CONSTRUCTION MONITORING

WEEKLY REPORT

SPREAD 8

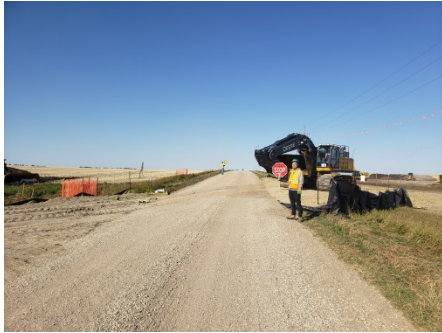
Sept 10/18
Photo facing West
SF 43 Access
Excavator crossing road with flaggers in place

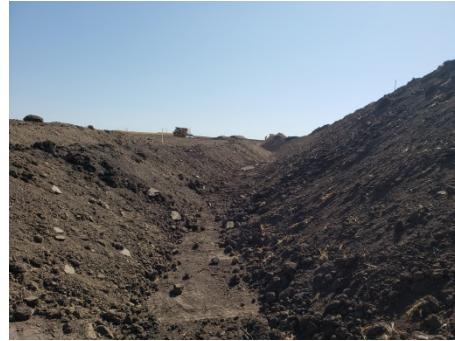
Sept 10/18
Photo facing east
SF 44 (KP984+923)
View of top soil and seconds piles.

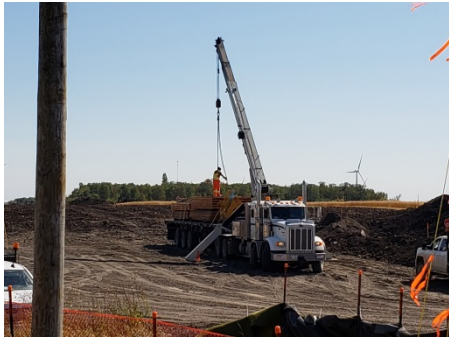
Sept 10/18
Photo facing South East
SF 45 East side of the road
Semi unloading access mats

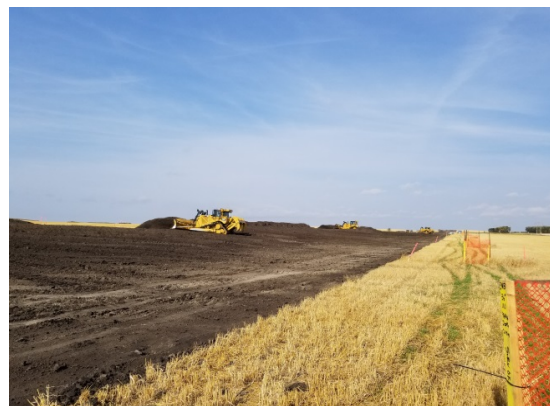
Sept 11/18
SF 44
Cats piling topsoil

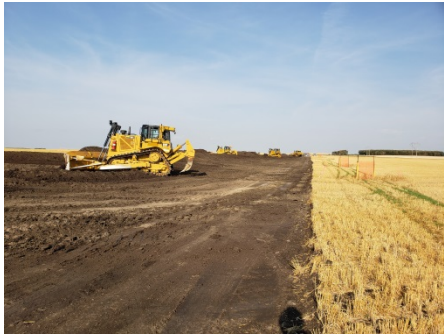
Sept 11/18
Photo facing West
SF 44A KP 986+746
Dozers stripping the ROW

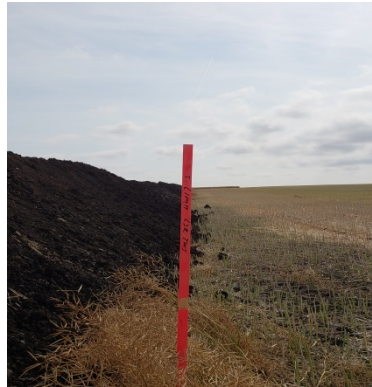
Environment: Fine clean and bleach when entering a new RM or land owner requested wash. ROW assessment by foremen before crews enter site. Attended morning safety meeting. Top soil and Grading crews are the only crews working. SF47 Laying out geotec for approach on East side. SF44 Caterpillars stripping topsoil. SF48A Silt fences and approaches and goal posts completed. SF48 Caterpillar pushing up topsoil. SF 44A (KP986+746) Dozers working to strip the ROW, spotters onsite to help operators stay within boundary lines. Garbage on the ROW, food containers, water bottles were picked up. SF 44 (KP984+900) Excavator fixing top soil piles, oiler moving along with the machine. SF 44 between KP 983+300 and KP 983+500 some top soil was over the boundary limit. Bigger chunks of soil I moved off by hand, Michael Jespersen was contacted in order to deal with the rest of the soil over the boundary line.

Sept 11/18
Photo facing East
SF 44 (Between KP983+300 and KP 983+500)
View of top soil exceeding the limit.

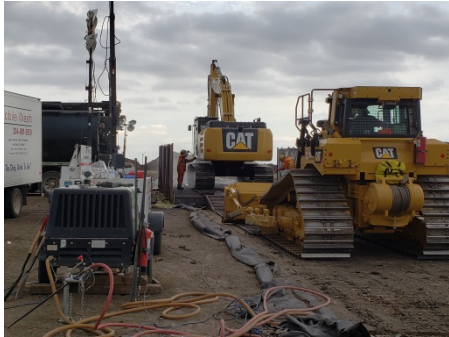
Sept 11/18
Photo facing East
SF 44A cleaning station
Excavator being cleaned by compressed air and water

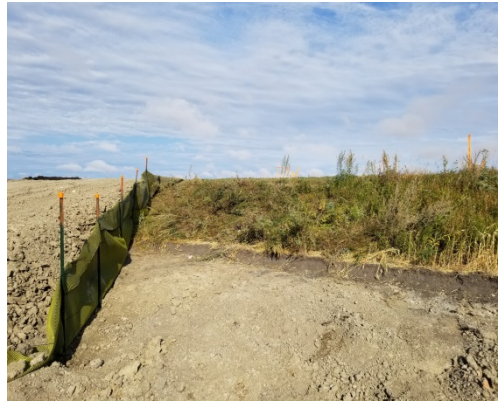
Attend morning meeting. SF45 Caterpillars pushing up topsoil, doing clean job. Approaches and fences look good. Grader moving transition to side. SF47 Approaches and silt fences done. SF 19 (KP936+720) Road boring crew onsite pumping water out of excavation pits into Geo-Tech cloth bags to filter the soil out of the water. Geo bags are placed North and South of the ROW in the ditches. SF 35 (KP 967) Cultural sensitive area was swept for any signs of traditional or cultural heritage objects/tools, none were found. *During ROW stripping a Rare Plant (Blunt-fruited Sweet Cicely) was stripped along with the soil it was on. Soil containing plant material was kept separate from other soils and was fenced off and signs were put in place. Survey crew was onsite staking the ROW, all proper PPE was worn. SF 24 North side of the road Pipe bending was taking place. Side boom assisted Pipe bending machine by holding pipe in place while the process of bending the pipe occurred. Once completed pipe was placed on skids. SF 46 Equipment cleaning was taking place. Crew members worked to clean off bigger chunks of soil from the tracks of the equipment with hammer drills and chisels. Machines proceeded to the next section of cleaning which was being sprayed down with compressed air to rid what-ever loose soil is on the equipment. The equipment then entered the final step of the cleaning process. Equipment was washed with pressure washer and bleached once wash was complete. All crew members were wearing the proper PPE requirements for each section of the cleaning process.

Sept 12/18
SF45 Facing West. Silt fence and cutting of edges.

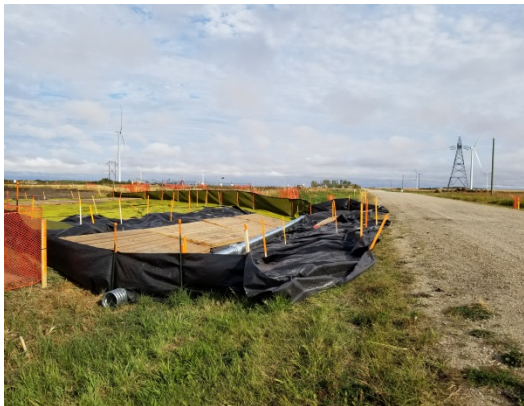
Sept 12/18
SF47 facing North. Silt fence geo- tec and pads laid down for approach to be covered.

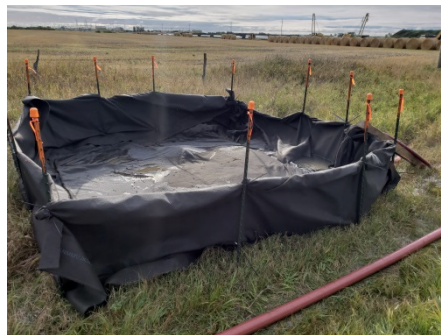
Sept 12/18
Photo facing South East
SF 19 (KP936+720)
Water being pumped into Geo bag.

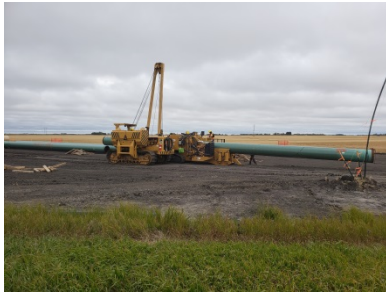
Sept 12/18
Photo facing North
SF 24 North side of the road
Pipe bending taking place.

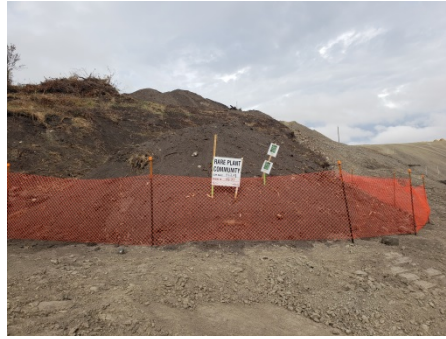
Sept 12/18
Photo facing North West
SF 35 (KP967)
Rare plant material fenced off and kept separate from other soil piles.
