**SWAN LAKE FIRST NATION – MATRIX SOLUTIONS
INC. PARTNERSHIP**

INDIGENOUS CONSTRUCTION MONITORING

WEEKLY REPORT

SPREAD 8

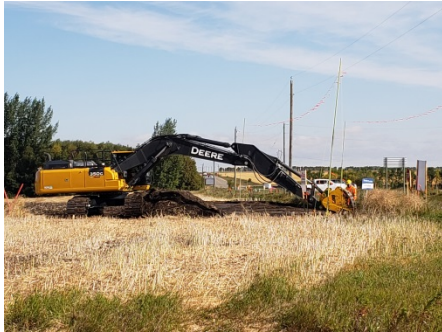
Sept4/18
Photo facing North - SF 39
Excavator stripping the edges of the ditch line

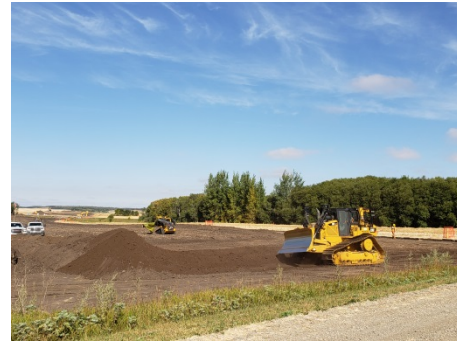
Sept4/18
Photo facing North West – SF 38A
Dozer removing the improper soil that was used for the approach

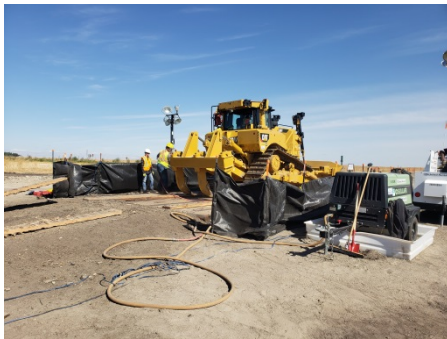
Sept4/18
Photo facing North East
SF 37A cleaning station
Dozer being sprayed with compressed air.

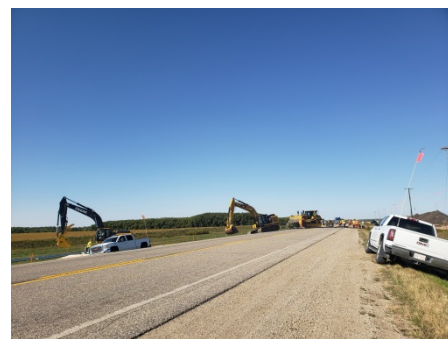
Sept 5/18
Photo facing South West – SF 41
Equipment crossing Hwy 23

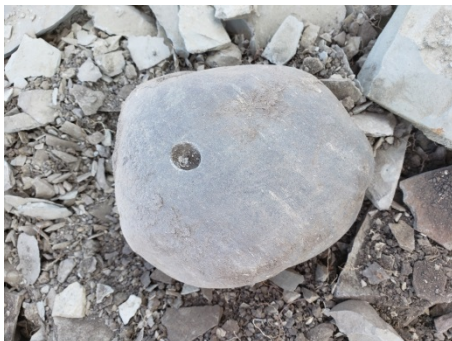
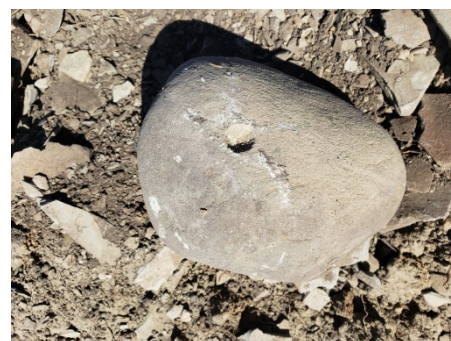
Fine clean and bleach when entering a new RM or land owner requested wash. Junior monitors sent to monitor construction at culturally sensitive area (SF38, KP 975) SF 48 Top soil stripping taking place adjacent to the St Leon station on the east side of the road. Excavators were stripping the edges of the ROW. Dozer was onsite waiting to pile soil on the southern side of the ROW. SF 41 Hwy 23 crossing. Crew was mobilizing two excavators and one dozer across the highway. Flaggers were in place to stop traffic, wearing the appropriate PPE. Geo cloth, Wood, and tires were laid out and used for the equipment to cross. SF40 (KP977+752) A unfinished traditional tool was found when

doing site was being swept (See attached photo). Enbridge E.I was called to stake off area and to call Golder Archaeologist. Once onsite Archaeologist took photos of area and documented the location. Object was tagged and placed into a bag to be removed from site for further investigation. Top soil piles were visually inspected to search for any other signs of traditional or cultural objects. None were found. Elder Dave Scott from Swan Lake First Nation contacted, and he wanted to view the object if Golder was okay with the viewing. Elder Dave Scott determined that it could be unfinished tool, possibly a tethering stone.

Sept 5/18
Photo facing West
SF 40 (KP977+752) Near creek.
Photo one side of unfinished traditional tool

Sept 5/18
Photo facing West
SF 40 (KP977+752)
Photo of opposite side of unfinished Traditional tool.

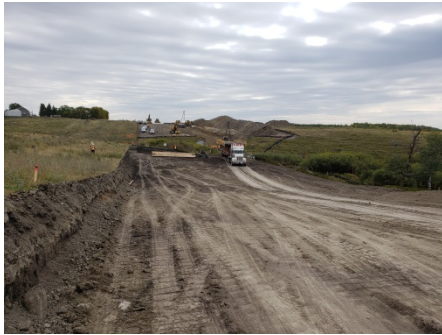
Junior monitors sent to monitor construction at culturally sensitive area (SF38, KP 975) SF 40 (KP978) Bridge installment was taking place at a creek. Excavators prepping area for bridge installment. Rig trucks were in place on the East side of the creek to assist with the bridge being installed. Once bridge was put in place crew worked to build ramps to the bridge. Environment team onsite to monitor frogs. SF 38 (KP975) to SF 39 was swept for signs of traditional and cultural objects/tools, none were found. Boundary lines were also inspected; no soil exceeded the boundary line. SF 39 Approach installation taking place. Crew onsite laid out Geo-tech cloth on built approach. Gravel was brought in by tandem trucks. Gravel was spread out and compacted by excavator.

Sept 6/18
Photo facing East
SF 40A (KP978)
Bridge being installed at creek crossing

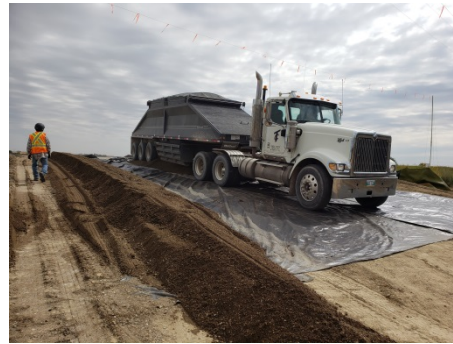
Sept 6/18
Photo facing South East
SF 39
Gravel being laid out of tandem truck

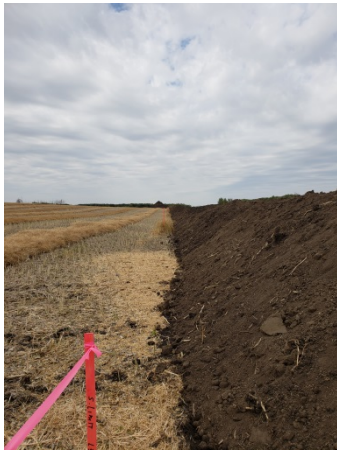
Sept 6/18
Photo facing West
SF 39 West side of Hwy 34
Top soil piles within boundary line

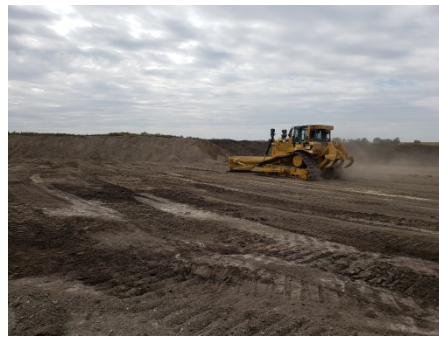
Weather/Environment: Mix of Sun and Cloud with a high of 19. Fine clean and bleach when entering a new RM or land owner requested wash. SF 40A (KP978+140) Top soil stripping was taking place. One dozer onsite site stripping soil and piling on the south side of the ROW. Bridge that was installed had the proper safety and environmental requirements in place. Safety rails on bridge were installed. Geo Cloth and silt fencing surrounding area are installed to prevent erosion. Top soil piles were inspected for any signs of traditional and heritage objects/tools, none were found. Boundary lines were inspected, all soil piles within boundary line limits. SF 43 (KP981+225) Top soil stripping taking place. Dozers onsite site stripping and piling top soil on the South side of the ROW. Once completed all five dozers waited on the access for flaggers to arrive. I called flaggers and informed them dozers needed to be crossed at SF 43. Once flaggers arrived traffic was stopped; and dozers proceeded into the next field.

Sept 7/18
Photo facing South West
SF 40A (KP978+140)
one dozer piling top soil on the South side of the ROW

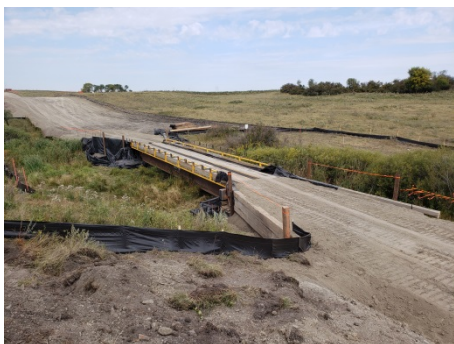
Sept 7/18
Photo facing North West
SF 40A (KP978)
Bridge installed at creek crossing.

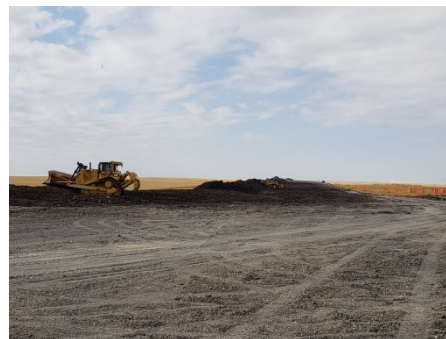
Sept 7/18
Photo facing West
SF 43 (KP981+225)
Dozers stripping and piling top soil.

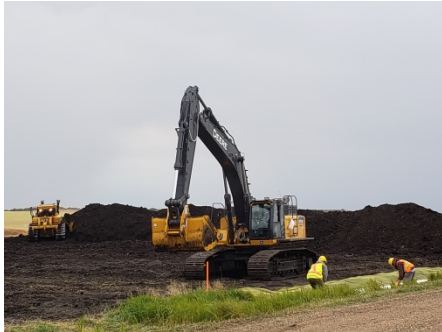
Sept 8/18
Photo facing SE
SF 43A east side of road
Crew laying out CAEPLA cloth, dozer piling soil

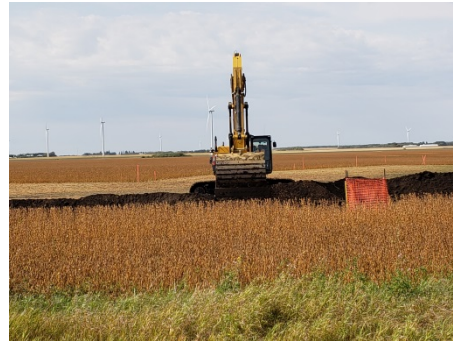
Sept 8/18
Photo facing West
SF 48 West side of road across from St Leon station
Excavator stripping edges of ROW.

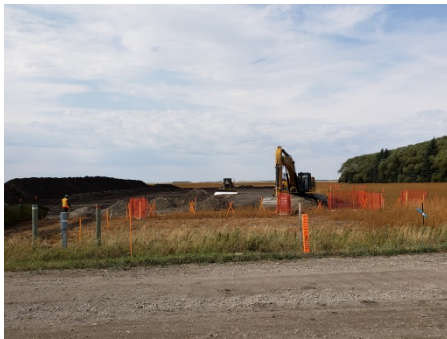
Sept 8/18
Photo facing West
SF 43 (KP996+383)
Excavator and dozer working to strip the edges of the
ROW and build an approach.
