**SWAN LAKE FIRST NATION – MATRIX SOLUTIONS  
INC. PARTNERSHIP**

**INDIGENOUS CONSTRUCTION MONITORING**

**WEEKLY REPORT**

**SPREAD 8**

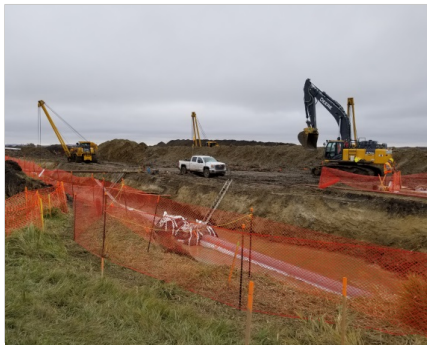
SF22 Facing South, South East  
Side boom holding up pipe in the trench. Excavator cleaning up wet clay. Crew pumping water out of trench.

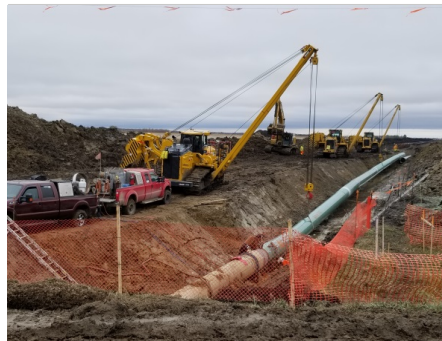
SF25 Facing West  
Side Booms holding up pipe while crew member works on the pipe.

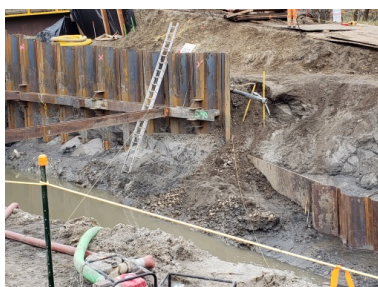
SF 8 Oak Creek Crossing (KP 921+205) I went with Golder Archaeologist to retrieve a bone that was found last week, after retrieving the bone we went up the hill to the soil piles that were removed for trench. As we searched for any signs of bones or traditional/heritage objects the wetlands crew informed us that they had found another bone in the trench approximately 10-20 meters from where the last one was found. Upon leaving the soil piles we found a much smaller bone fragment in the soil. Upon leaving the site a crew member called us back to the site after finding another bone in the trench approximately 10 meters from the bone that was found today. Archaeologist

removed bones from site for further investigation, possible mature bison and juvenile bison. 6 pieces of bones has been found in trench in total since digging began.

Photo facing South East  
SF 8 (KP921+205) Oak creek crossing #1  
Location of area on where two bones were found.

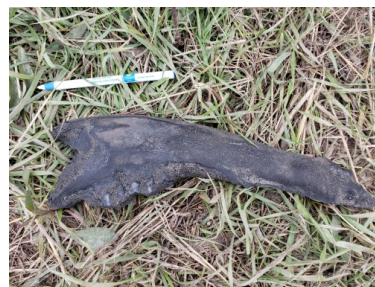
Photo facing South  
SF 8 (KP921+205) Oak creek crossing #1  
Jawbone with some teeth still intact.

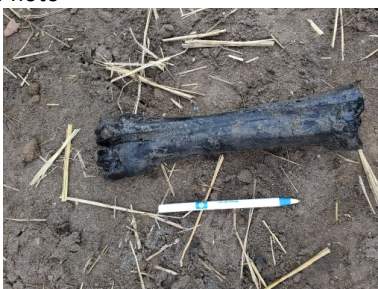
Photo facing South  
SF 8 (KP921+205) Oak creek crossing #1  
Bone that was found in trench.

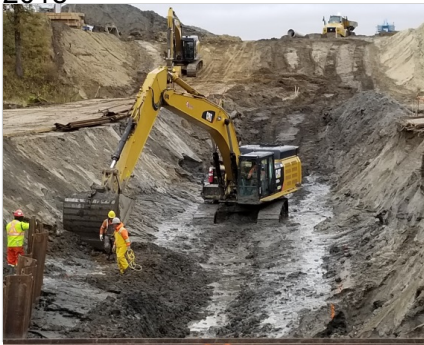
SF8 Oak Creek Crossing  
Facing West  
Excavator scraping mud to drain water to the pumps.

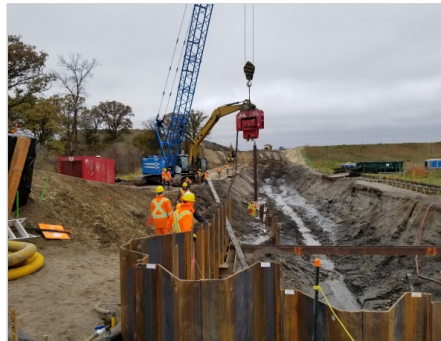
SF8 Oak Creek Crossing  
Facing West  
Wetlands crew on site installing sheet metal pipe.

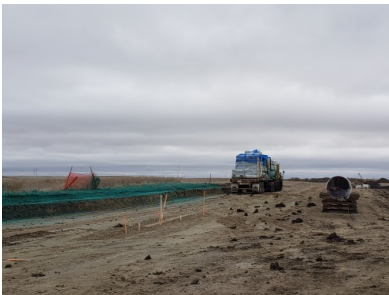
Photo facing East  
SF 37A East side of the road.  
Mulching crew spraying edge mulch

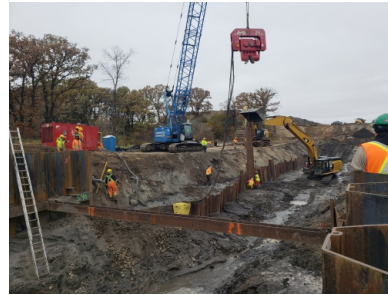
Photo facing South West  
SF 8 (KP921+205) Oak creek crossing #1  
Crew is installing sheet metal piling.

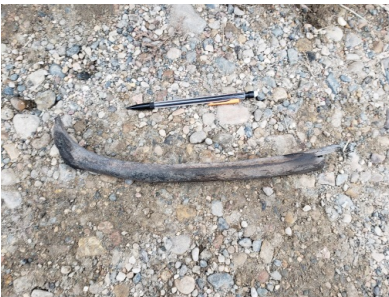
Photo facing South  
SF 8 (KP921+205) Oak creek crossing #1  
Rib bone fragment that was found in trench.

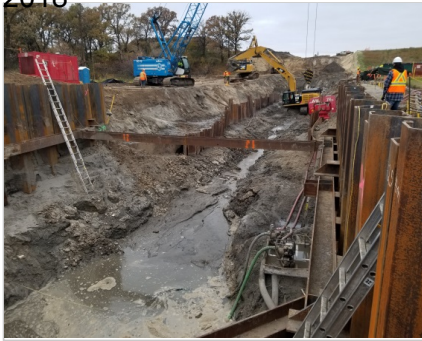
SF8 Oak Creek Crossing  
Wetlands crew on site installing sheet metal piles.

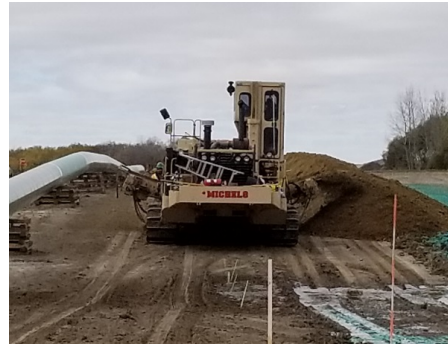
SF39 KP 975+700  
Mainline ditching working on site.

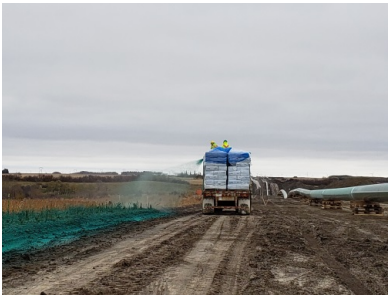
Photo facing East  
SF 39 East side of the road  
Mulching crew spraying edge mulch

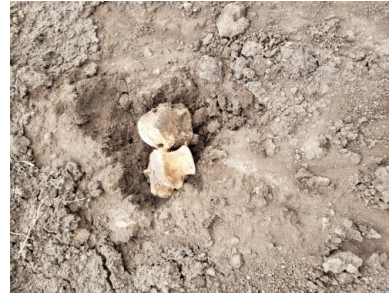
SF 39 (KP976+500) Mulching crew is onsite. Crew is spraying edge mulch on the North side of the ROW. When mulching machine runs out of water, the water trucks refills the water tanks on the machine. Crew is working West to East. While checking soil piles some bone fragments were found. Enbridge environment and Golder archaeologist were notified. I waited onsite for the Golder archaeologist who arrived at 3:00 PM. Once archaeologist arrived, we did a sweep of the area looking for any signs of other bones or heritage/traditional objects, none were found. Archaeologist determined the bones were fairly modern.

Photo facing South  
SF 39 (KP976+500)  
Small bone fragments found in soil pile.

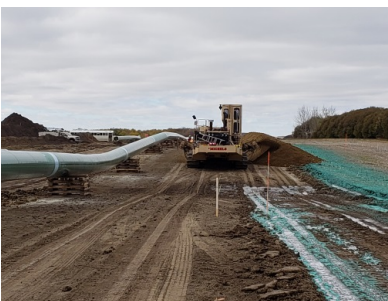
Photo facing West  
SF 39 (KP975+700)  
Trenching machine digging trench.

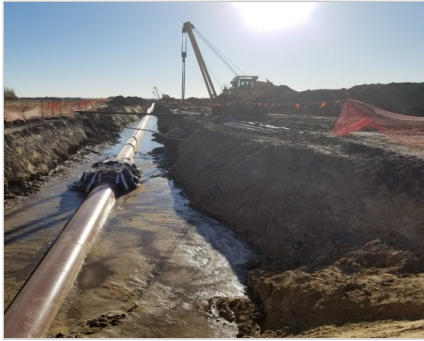
SF22 Facing East KP 941+ 0.55  
Side booms holding up the pipe for crew members working on it.

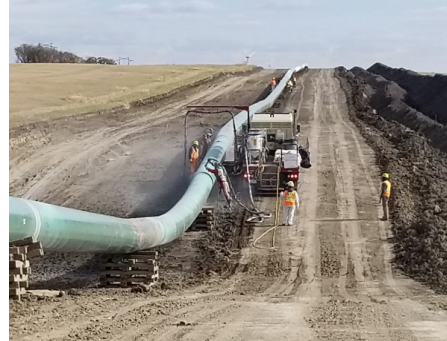
SF44 Facing East  
Sand blasting crew working on the pipe and another crew were working ahead of them cleaning paint and welds.

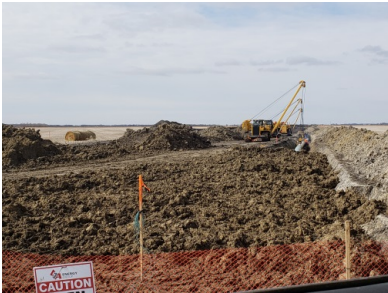
Photo facing West  
SF 25 West side of the road  
View of backfilling and tying in.

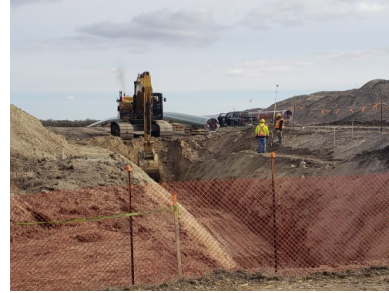
Photo facing East  
SF 31 East side of the road.  
Excavator is digging Bore trench

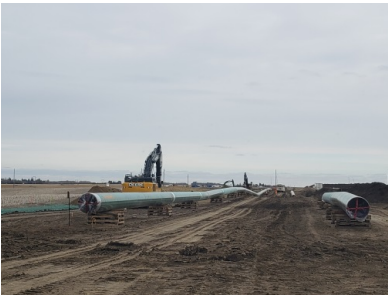
Photo facing East  
SF 38 East side of the road.  
Excavators digging trench.

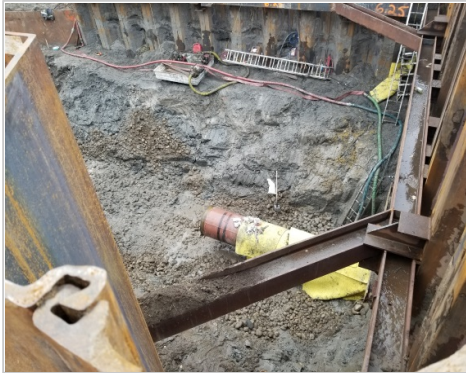
SF8 Facing North Oak Creek Crossing  
Tie-in crew pumped out water and pipe is now visible. pumps are in trays.

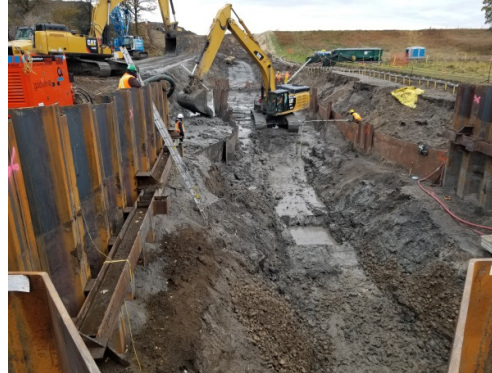
SF8 Facing West Oak Creek Crossing  
Excavator digging trench, moving clay to the side and another excavator loading the clay into rock trucks. A tie-in crew

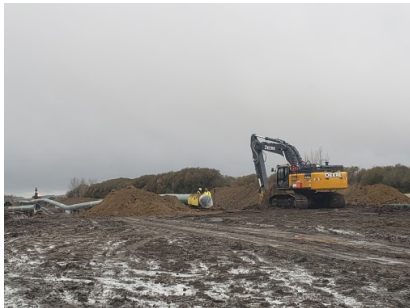
Photo facing North West  
SF 39 West side of the road  
Excavator digging trench

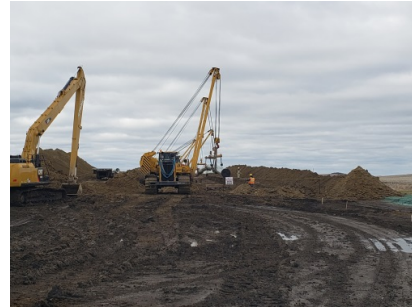
Photo facing North  
SF 38 North side of the road  
Lowering in pipe
