**SWAN LAKE FIRST NATION – MATRIX SOLUTIONS
INC. PARTNERSHIP**

INDIGENOUS CONSTRUCTION MONITORING

WEEKLY REPORT

OCTOBER 15TH TO OCTOBER 20TH

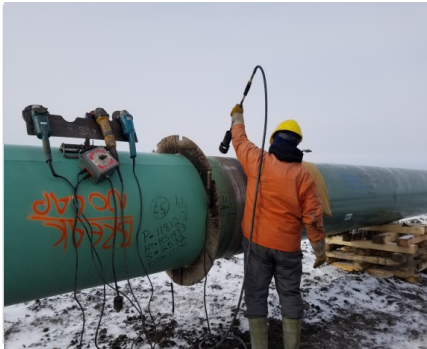
SF50 Facing West
Repair crew heating up the weld with a tiger torch and then covering with a blanket.

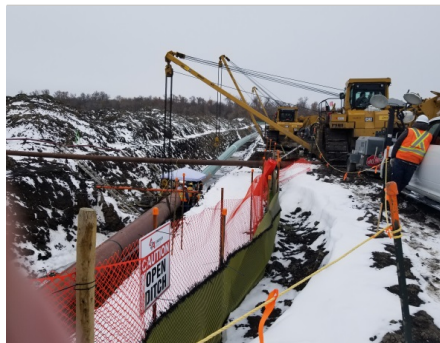
SF26 Facing South
Side boom holding pipe for the Tie-In crew on the South side of road.

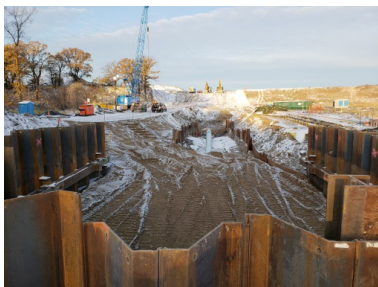
Photo facing West
SF 8 Oak creek crossing
Crew prepping for the days work.

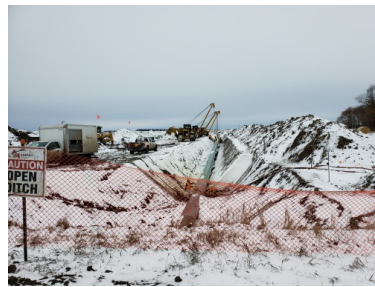
Photo facing North
SF 26 North side of the road
Tie in crew is onsite tying into the mainline.

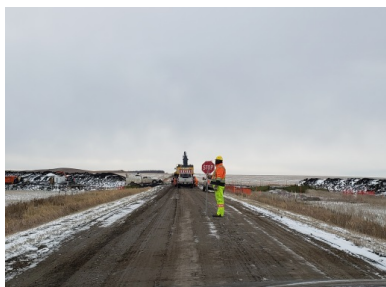
Photo facing South
SF 23A
Crew unloading equipment. Flaggers stopping traffic.

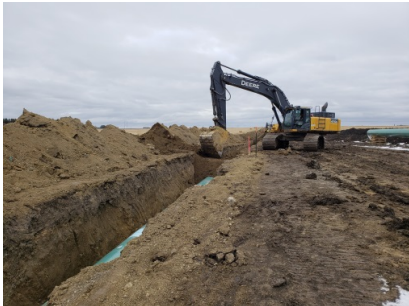
Photo facing East
SF 41 East side of the road.
Excavator backfilling trench.

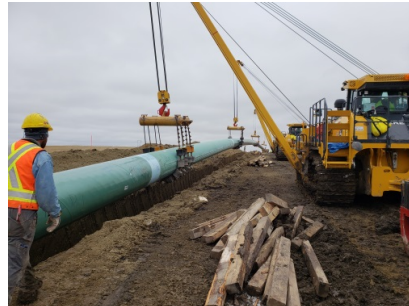
Photo facing East
SF 42 East side of the road
Lowering in pipe into trench.

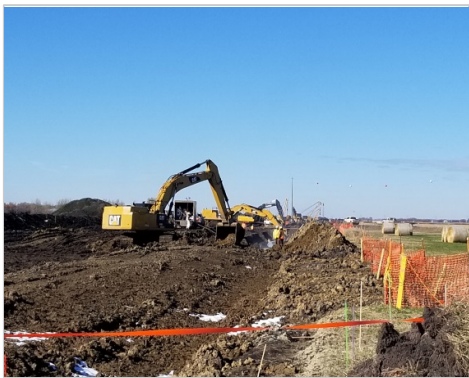
SF24A Facing West
Excavators covering pipe.

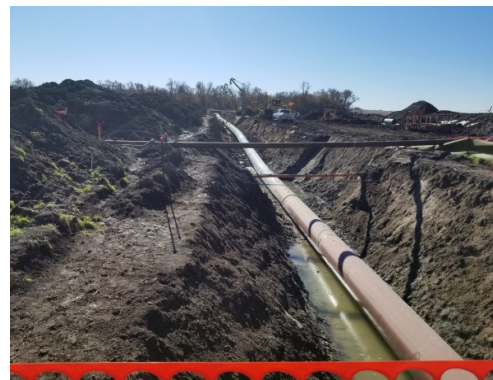
SF26 Facing South
Side Booms holding the pipe for the
welding crew.

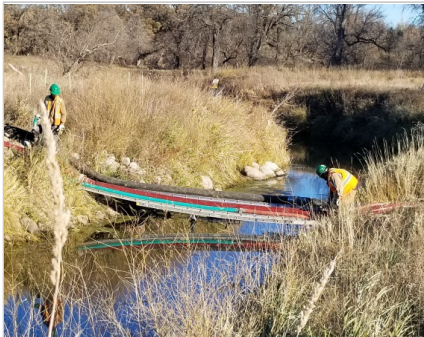
SF8 KP 921+275 Facing North
De-watering crew have a ladder bridge for the water hoses to cross the creek and go to the silt bags on the North side of the trench.

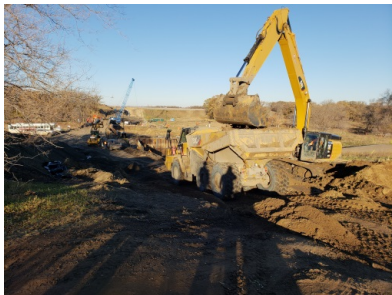
Photo facing North West.
SF 8 Oak creek crossing.
Excavator placing soil into rock truck.

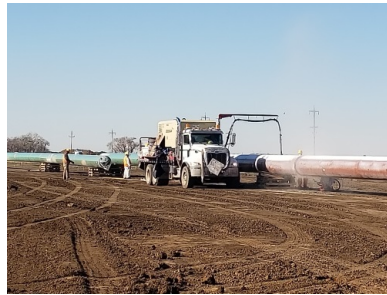
Photo facing North West.
SF 10 West side of the road.
Crew sand blasting pipe.

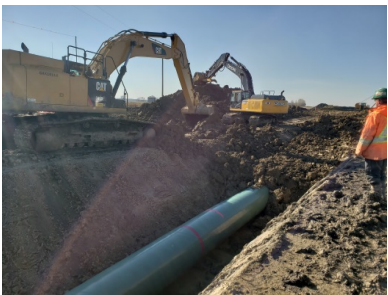
Photo facing North West
SF 24 North side of the road.
Excavators backfilling trench.

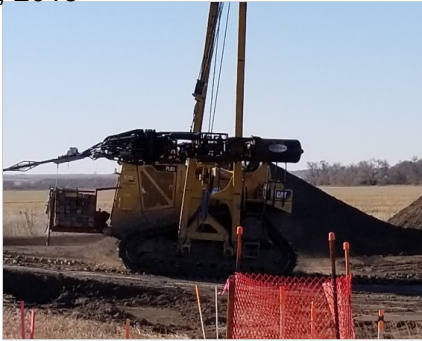
SF12 Facing South KP 926+639
Two excavators carrying the welding pig
across the road to the East side.

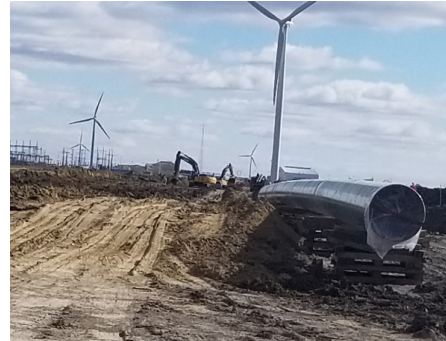
SF47 Facing East KP 990+471
Excavators are backfilling trench, and
tandem trucks are hauling sand for them.

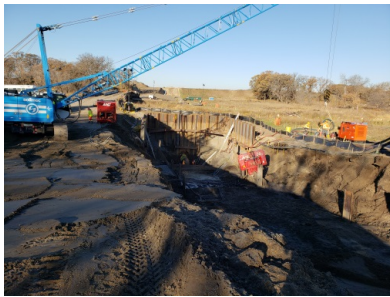
Photo facing North West.
SF 8 Oak creek crossing.
Crane preparing to instal large water pump
into Bore pit.

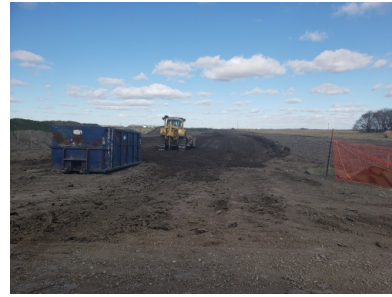
Photo facing North.
SF 26 North side of the road.
Dozer leveling the ROW.

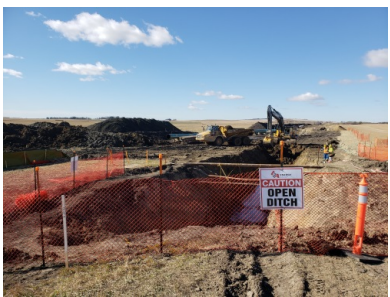
Photo facing West
SF 34 West side of the road.
Crew excavating Tie-in ditch.

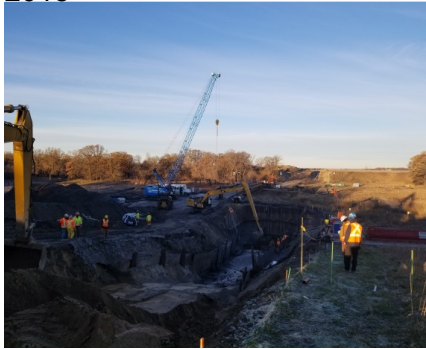
SF8 Oak Creek Crossing KP 921+345
De-watering crew working on the East side. Long boom cleaning trench.

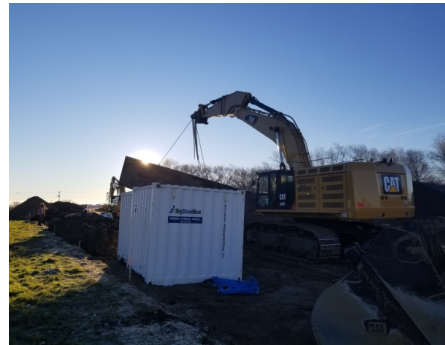
SF8 Oak Creek Crossing KP 921+345
Large excavator unloading sheet metal off of a truck.

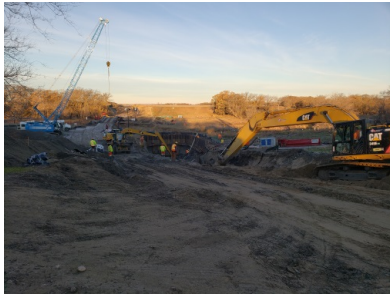
Photo facing North West.
SF 8 Oak creek crossing.
Excavators digging trench, crew is pumping out water from Bore pit.

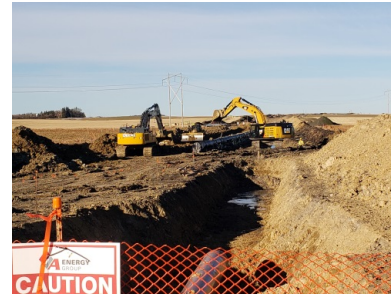
Photo facing West.
SF 25 West side of the road.
Crew is digging Tie-in trench

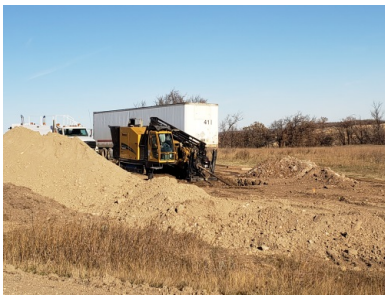
Photo facing North
SF 32 North side of the road.
Directional drilling taking place.
