**SWAN LAKE FIRST NATION – MATRIX SOLUTIONS  
INC. PARTNERSHIP**

**INDIGENOUS CONSTRUCTION MONITORING**

**WEEKLY REPORT**

**SPREAD 8**

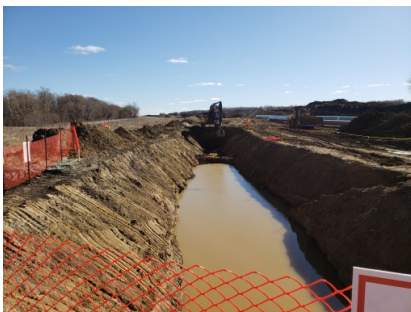
SF 38 (KP 975+003) Cultural sensitive area. Crew is onsite excavating tie-in trench. Soil is being removed and placed into a rock truck which is piling East of the trench. Soil is also being piled adjacent to trench by a dozer. A oiler is with the excavator giving depth measurements. Proper fencing and signage is installed around the open trench. Water needs to be pumped out of trench once trenching is complete.

Photo facing South East  
SF 38 (KP 975+003)  
Excavators digging tie in trench.

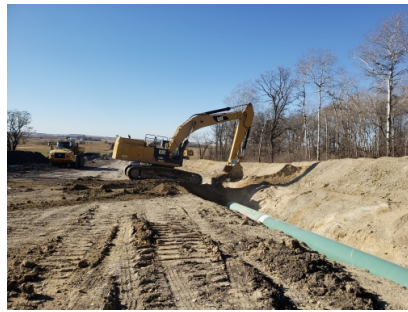
SF 31 (KP 960) Tie-in crew is onsite backfilling tie-ins. Excavators are placing soil on top of pipe, oiler is watching for rocks that could potentially damage the pipe. When found they are removed and placed aside. Dozer is onsite piling soil on the edge of the trench in preparation for when the pipe is safely covered.

Photo facing West.  
SF 31 (KP 960)  
Crew is placing soil on top of pipe.

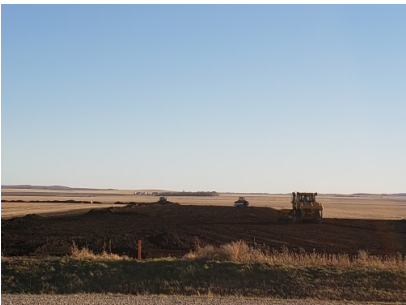
Photo facing South  
Kickoff  
Dozers are working together to level the  
ROW.

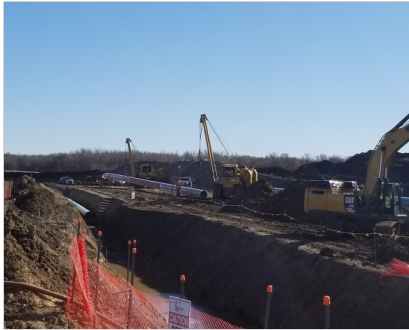
SF38 KP 975+975.9 Facing South East  
Excavator moving clay away from the ditch. Side booms bringing pipe to be placed in ditch.

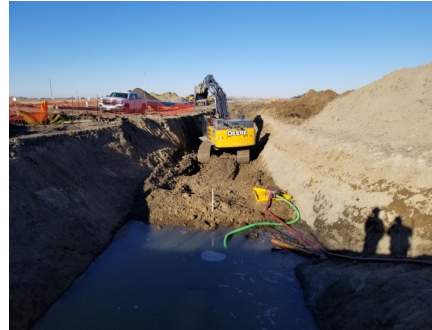
SF35 KP 967+514 Facing West  
Excavator and the de-watering crew are trying to pump water out of the ditch.

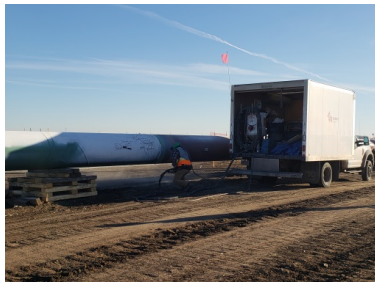
Photo facing North east  
SF 11 (KP924+848)  
Sand blaster cleaning welding joint.

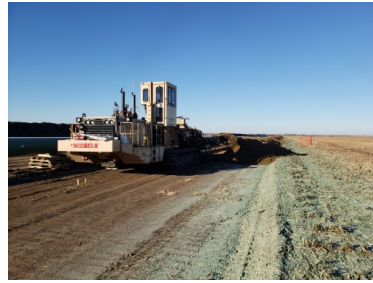
Photo facing South West.  
SF 11 (KP924+848)  
Ditcher is digging trench.

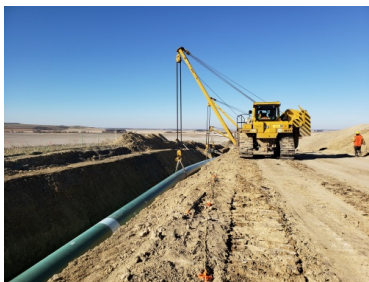
Photo facing West  
SF 29 West side of the road.  
Sidebooms with slings maneuvering pipe.

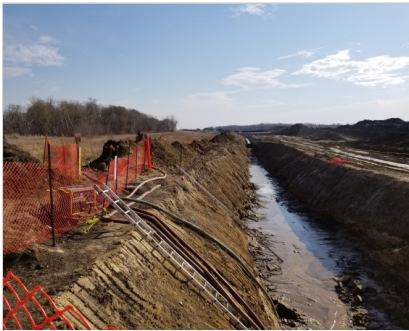
SF38 KP 975+000 Facing South East  
Generator and water pump in spill  
trays, ladder not tied on, fence in place.

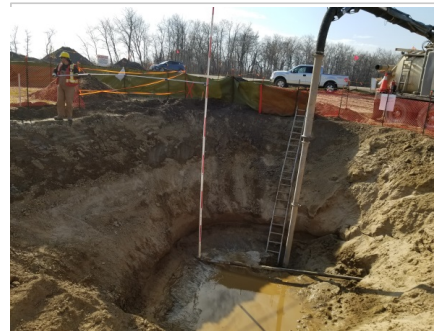
SF38 KP 974+957 Facing South West  
Crew member holding stick for the  
surveyor. Hydro-vac taking water out of  
the trench. HD drill shaft visible also.

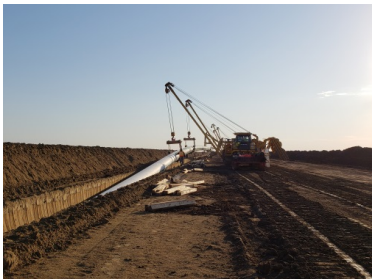
Photo facing East  
SF 10 East side of the road.  
Pipe is being lowered in.

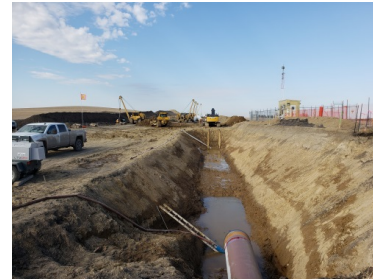
Photo facing West  
SF 28 (KP955+877)  
Crew is excavating tie in trench.

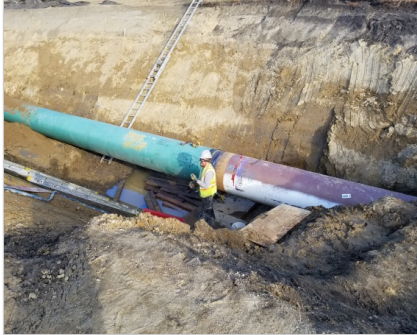
SF28 Facing North West KP 955+874  
Ultra sound crew checking weld on the pipe.

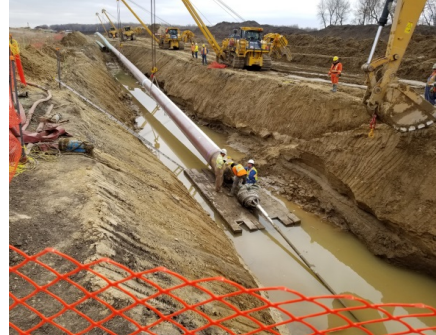
SF38 Facing South East KP 975+000  
Excavator lowered reamer in the ditch for

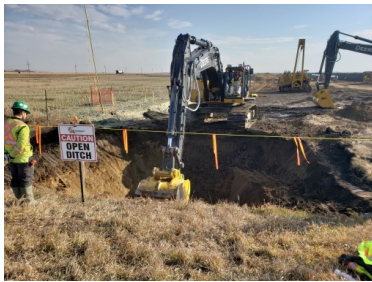
Photo facing East  
SF 10 East side of the road.  
Excavator digging bell hole.

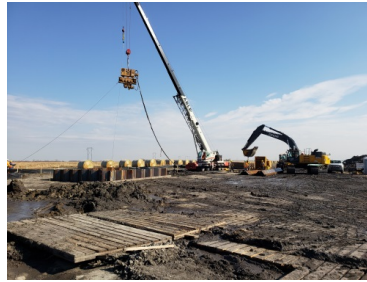
Photo facing North East  
SF 22B (KP 944)  
Crew is installing sheet metal piles.

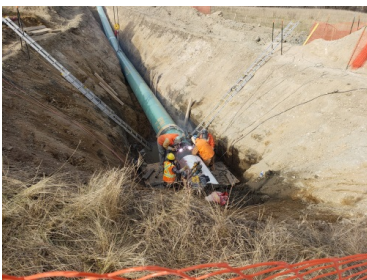
Photo facing North West  
SF 32 North side of the road.  
Crew onsite welding pipe together.

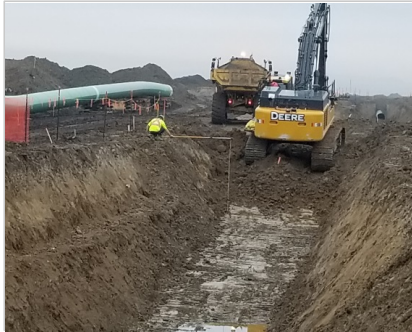
SF35 KP 967+475 Facing West  
Excavator digging ditch and loading clay into rock truck. Crew member measuring depth of ditch.

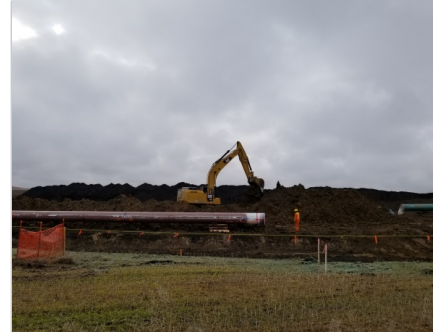
SF43 KP 982+774 Facing South  
Excavator moving clay pile to the side. Fences in place.

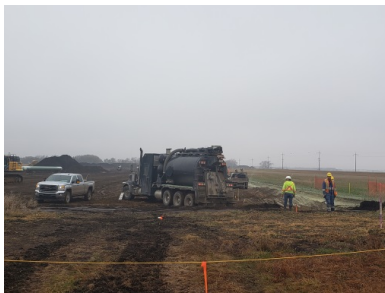
Photo facing West  
SF 10 West side of the road.  
Hydro vac preparing to locate utilities.

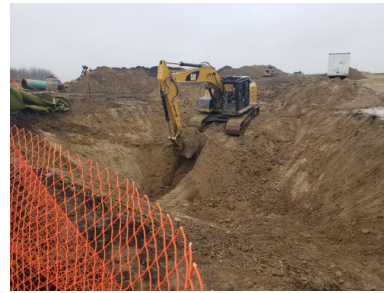
Photo facing North West  
SF 38 (KP 974+957)  
Crew is carefully removing soil next to pipe.

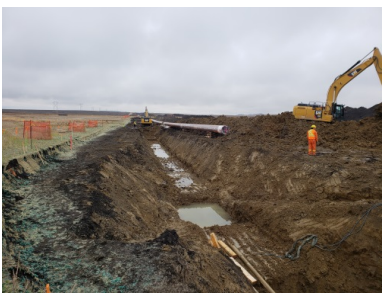
Photo facing South East  
SF 43 South side of the road.  
Excavators removing soil from trench and ROW.

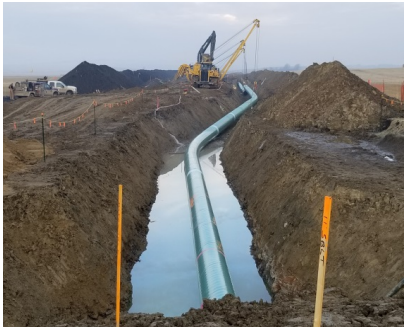
Description & Location:  
SF34 KP 966+476 Facing West  
Three side booms holding pipe for Denver Reid tie-in crew. De-watering crew pumping water from one end of the ditch to the other.

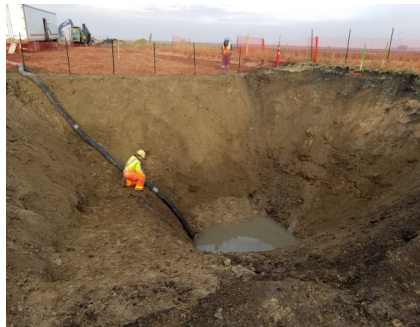
Description & Location:  
SF41A KP 979+410 Facing West  
Hydro-vac crew de-watering the ditch. Fences are in place.

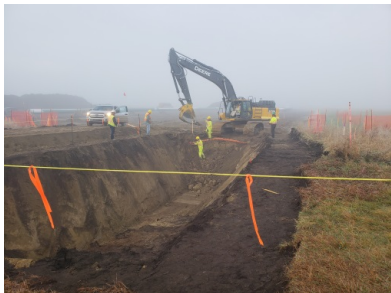
Description & Location:  
Photo facing West  
SF 10 West side of the road.  
Crew members using shovels to expose existing utilities.

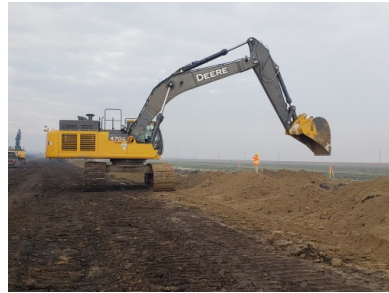
Description & Location:  
Photo facing North West  
SF 11 (KP 924)  
Excavator is backfilling trench.

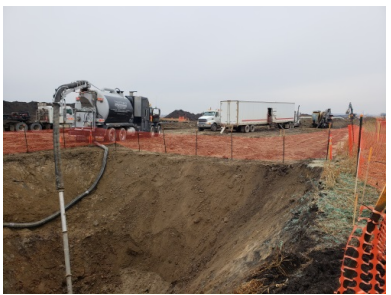
Description & Location:  
Photo facing South West  
SF 41A (KP979+400)  
Hydro vac removing water, Drill rig drilling under road.
