**SWAN LAKE FIRST NATION – MATRIX SOLUTIONS
INC. PARTNERSHIP**

INDIGENOUS CONSTRUCTION MONITORING

WEEKLY REPORT

OCTOBER 29TH TO NOVEMBER 3RD

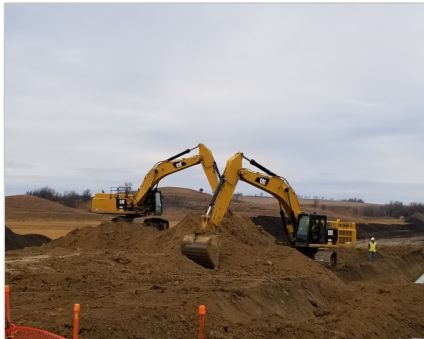
SF33 KP 964+964 Facing West
Excavators backfilling ditch

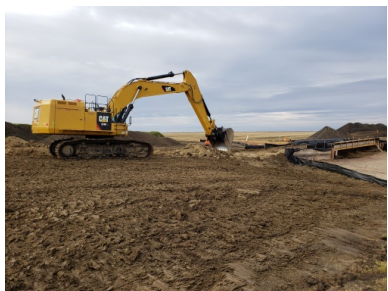
Photo facing South West
SF 3 (KP913+205)
Excavator in the process of removing ramp
to the bridge.

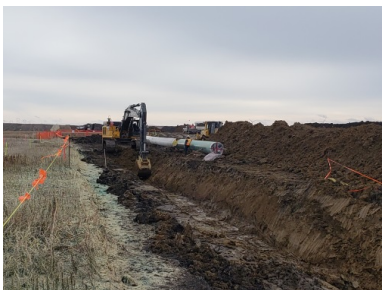
Photo facing South East
SF 43 (KP982+819)
Excavator is digging tie-in trench and
placing soil in a pile.

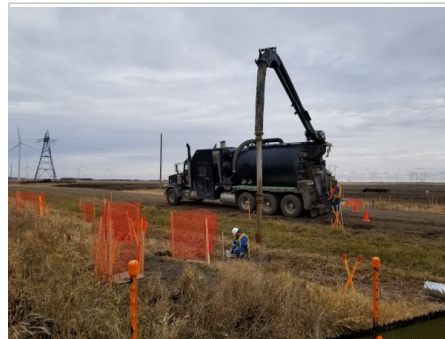
SF47 KP 990+471 Facing North North East
Hydro-vac making hole for visual on fibre
optic cable.

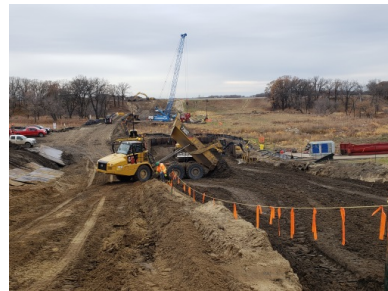
Photo facing West
SF 8 Oak Creek crossing #1
Crew is backfilling trench.

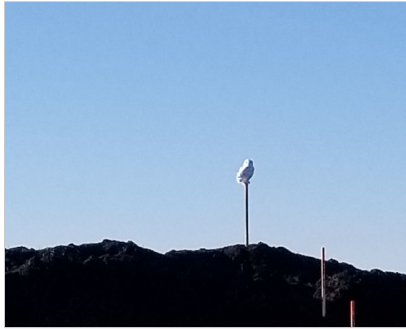
SF24A KP 949+600 Facing South
Snowy Owl on top of the topsoil pile.

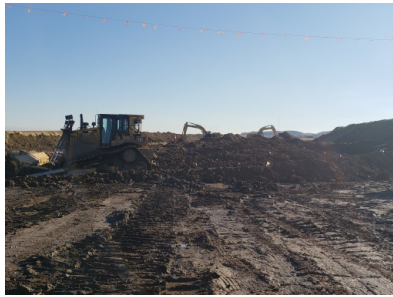
Photo facing East
SF 34, Road 66W
Excavators and dozer working to backfill trench.

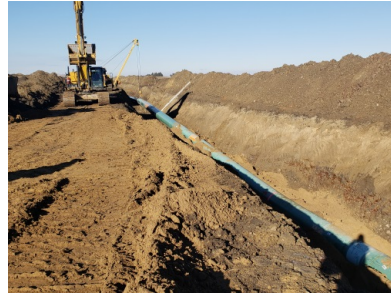
Photo facing West
SF 35, Road 30N
Crew is placing sand around pipe.

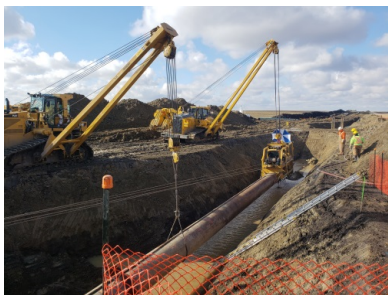
Photo facing South West
SF 42 West side of the road.
HD Boring is taking place, drilling under the road.

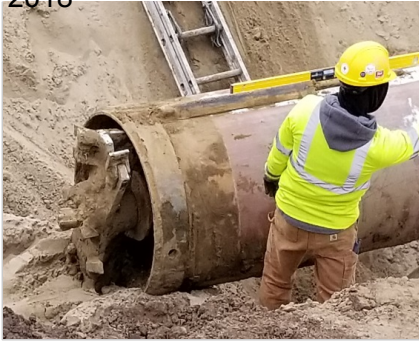
SF12 KP 926+639 Facing South West
Drill head and crew member on the side as
the boring starts.

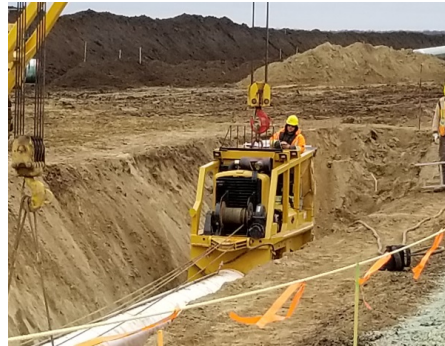
SF12 KP 926+639 Facing West South West
Slip Bore unit ready to start boring under
the road.

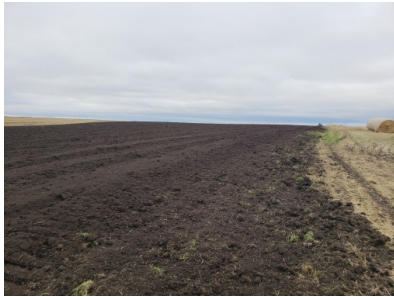
Photo facing West
SF 3 West side of the road.
View of Top soil that is put back.

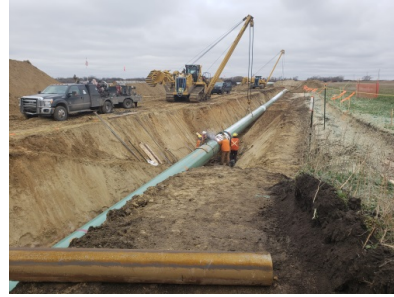
Photo facing West
SF 10 Rd 89W
Crew is welding pipe joint together.

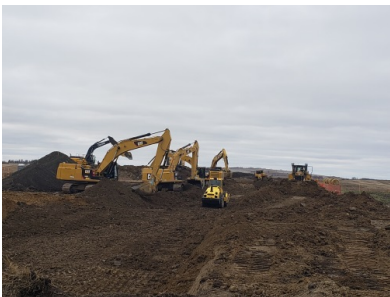
Photo facing South West
SF 35 Rd 30N
Crew is working together backfilling trench.

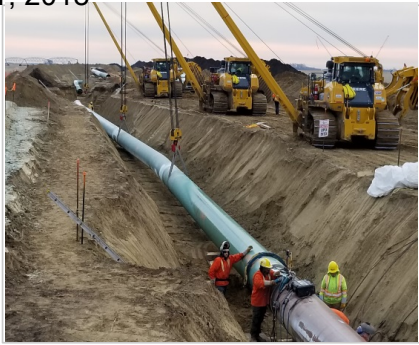
SF11 KP 924+989 Facing East
Side-booms holding the pipe in place while tie-in crew clamp and weld it.

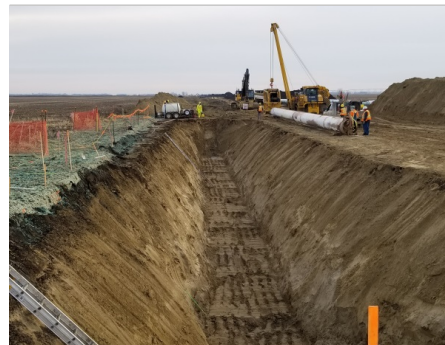
SF15 KP 929+962 Facing west
Bore crew getting the skid bore unit ready to work.

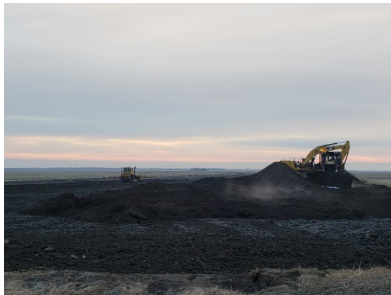
Photo facing East
SF 3 East side of the road.
Top soil being put back.

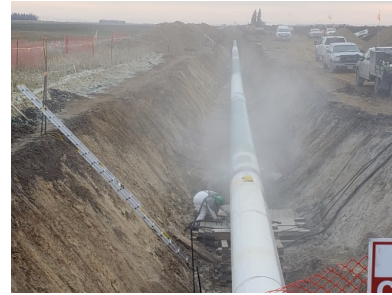
Photo facing East
SF 10 Rd 89W (KP 923+335)
Crew member is sand blasting the pipe joint.

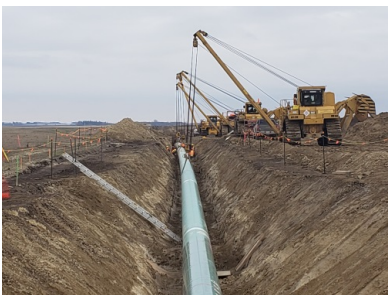
Photo facing South East
SF 37 South side of the road.
Crew tying into the mainline.

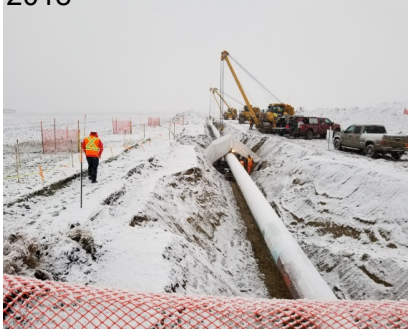
SF12 KP 926+665 Facing East
Tie-in crew welding under tent due to snowing conditions. Ladders tied to the T-posts. Wet and slippery on ROW.

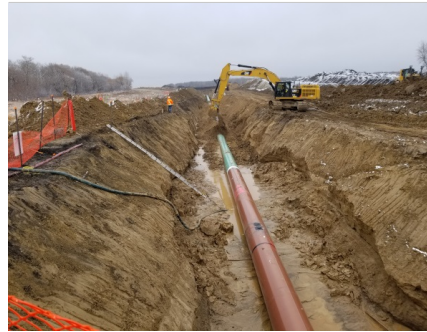
SF38 KP 975+000 Facing South East
Two excavators backfilling the ditch while another loads a rock truck with clay. Caterpillar is moving clay pile closer

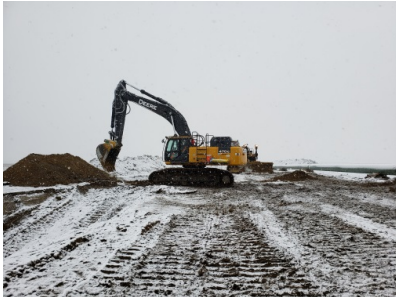
Photo facing East
SF 15 East side of the road.
Excavator is excavating tie-in trench.

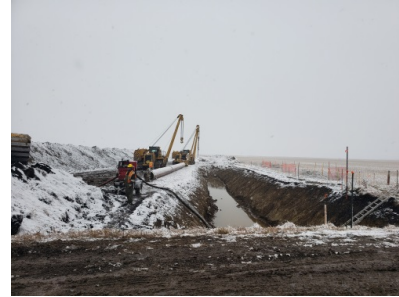
Photo facing West
SF 16 West side of the road.
Crew is pumping water out of trench.

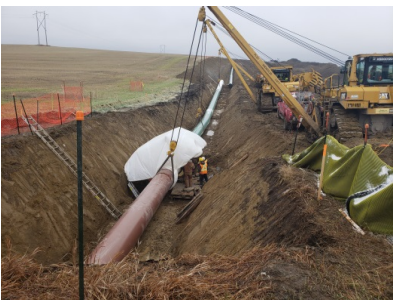
Photo facing East
SF 44 West side of the road.
Crew tying into the mainline.

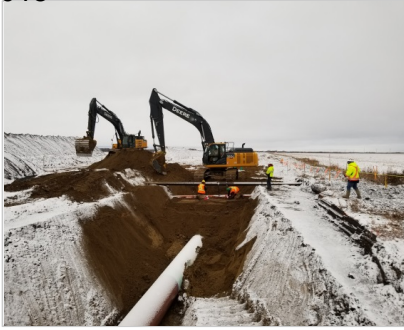
SF11 KP 924+989 Facing West
Two excavators backfilling the ditch. Crew taking off straps to remove the pipe holding up the cable.

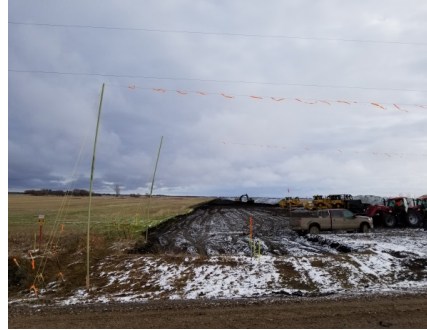
SF6 KP 916+608 Facing East
Excavators and caterpillars leveling transition. Clean up crew on site.

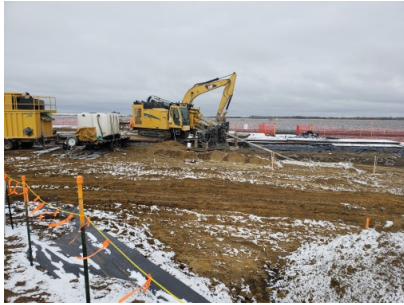
Photo facing North
SF 9 North side of Hwy #2
Drill rig drilling under Hwy #2

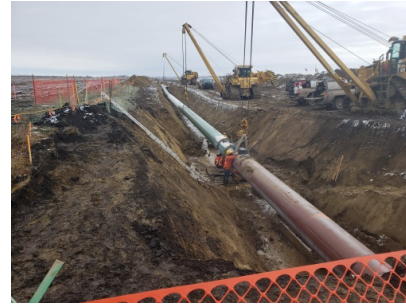
Photo facing East
SF 16 East side of the road.
Crew is tying into the mainline.

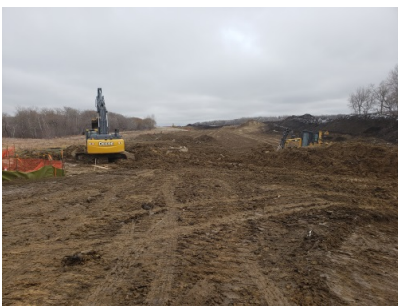
Photo facing South East
SF 38 South side of the road.
Crew is backfilling trench.
