**SWAN LAKE FIRST NATION – MATRIX SOLUTIONS
INC. PARTNERSHIP**

INDIGENOUS CONSTRUCTION MONITORING

WEEKLY REPORT

SPREAD 8

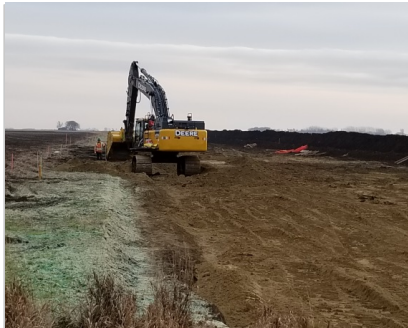
SF12 KP 926+634 Spotter watches as the operator carefully removes the clay piled on the mulch.

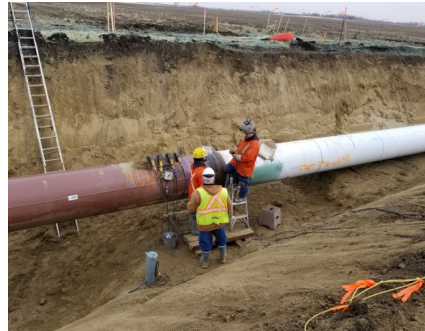
SF15 KP 929+962 Welding crew repairing welding and the welding inspector is with them. Crew wearing PPE and the ladder is tied to the T-posts.

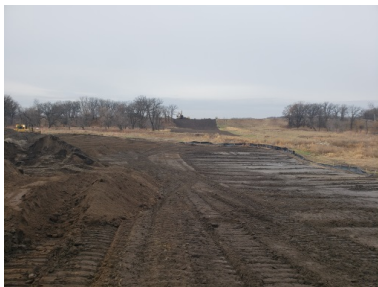
Photo facing West
SF 8 Oak creek crossing
View of Oak creek crossing, soil is being put back.

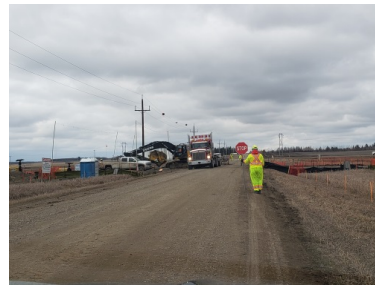
Photo facing North
SF 41A
Excavator is being unloaded, flaggers are in place stopping traffic.

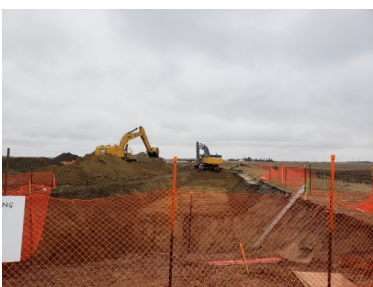
Photo facing West
SF 41A West side of the road.
Crew is excavating Bore ditch.

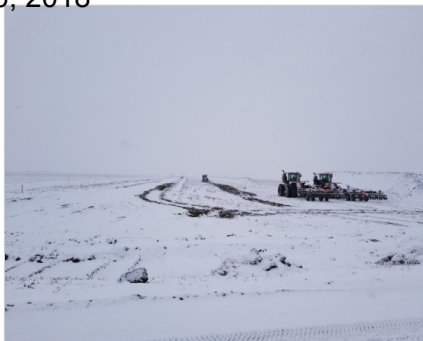
SF12 KP 926+634 Facing East
Grader leveling clay, three tractors working. One tractor is ripping and the other two are discing.

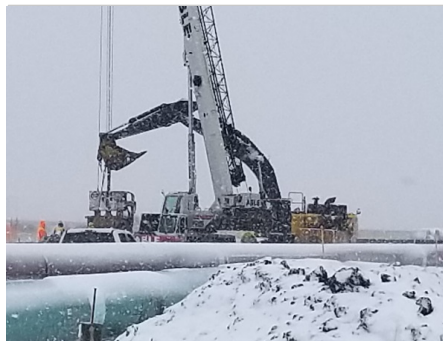
SF22B Facing East
Crane with vibrating hammer and an excavator sheet piling.

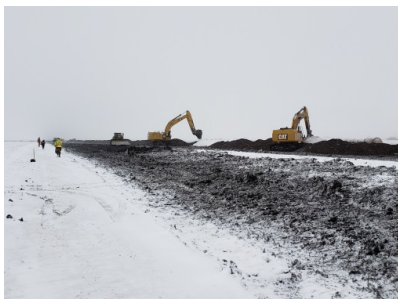
Photo facing South East
SF 6 (KP918-376)
Clean up crew is putting back top soil.

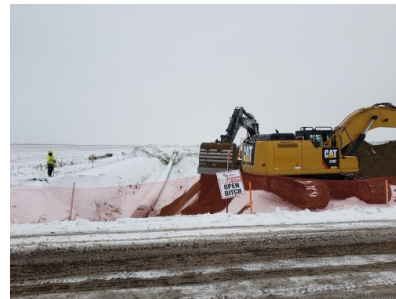
Photo facing East
SF 15 East side of the road.
Excavators are backfilling tie in trench.

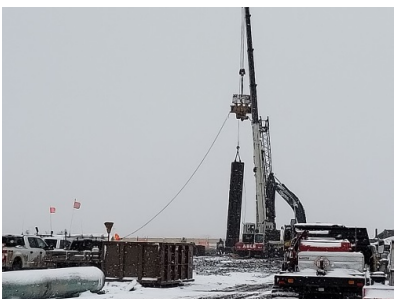
Photo facing East
SF 22B East side of the road.
Wetlands crew is installing sheet metal piles.

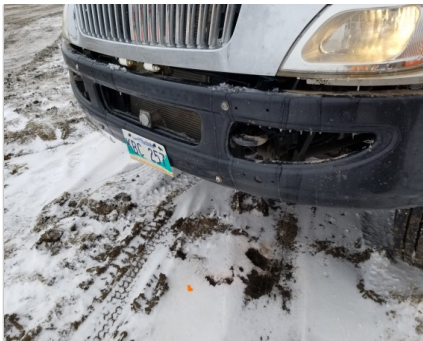
SF10 A caterpillar is levelling transition. SF14 There are two excavators backfilling the ditch. SF17A KP 933+360 Excavator moving the reamer to be attached to the shaft. HD drill is on site. Crew bus was leaking coolant on the ROW close to the restrooms. Asked bus driver to get a spill tray put underneath. Reported to my supervisor who called environmental, a picture was taken of the spill. SF41A Excavator digging ditch and loading rock truck with spotter working with excavator. Fuel truck on site fuelling up the side booms that are holding the pipe for the tie-in crew. Crew bus on site. Crew wearing PPE. An excavator with spraying attachment spraying tackifier on the topsoil. Tandem truck hauling water for the spray crew.

SF17A KP 933+360 Facing South East
Crew bus leaking coolant

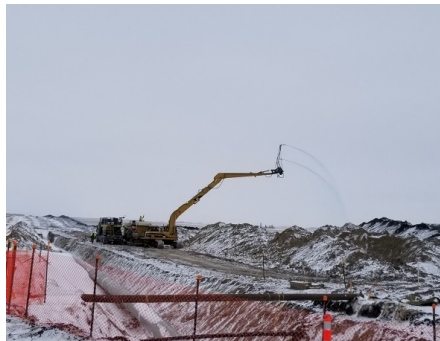
SF41A KP 979+415 Facing East
Excavator with spraying attachment
spraying tackifier on the topsoil.

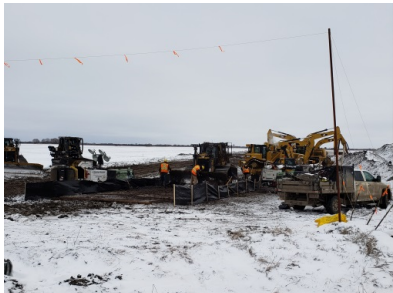
Photo facing North East
SF 6 (KP918-376)
Clean up crew is clebbing equipment before
leaving site.

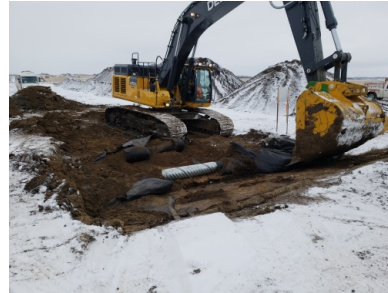
Photo facing South East
SF 11 Rd 88W
Excavators is removing half of the approach.

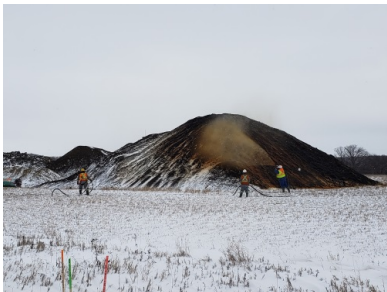
Photo facing South
SF 35 South side of the road.
Site is spraying Tackifier on the soil piles.

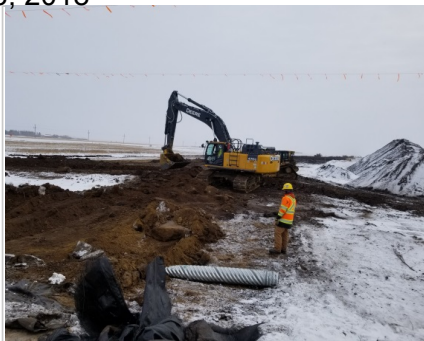
SF10 KP 923+315 Facing East
Excavator Taking out approach and Crew cleaning up.

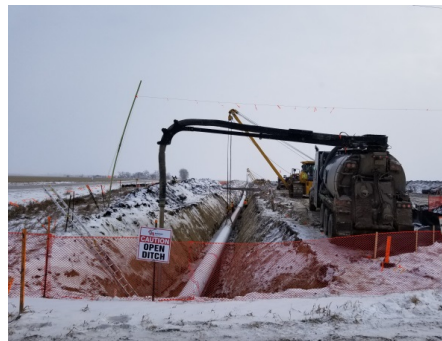
SF17A KP 933+360 Facing East
Hydro-vac is de-watering the ditch.

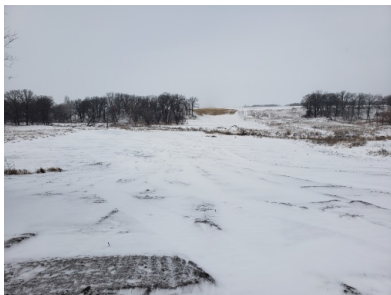
Photo facing West
SF 8 (KP921+260)
View of top soil put back at Oak creek crossing #1

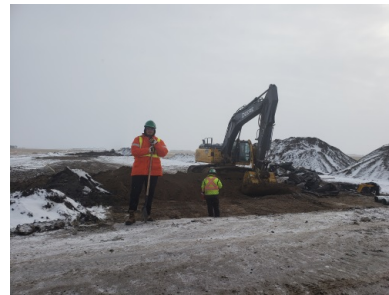
Photo facing East
SF 11 Rd 88W
Excavators is removing the rest of the approach.

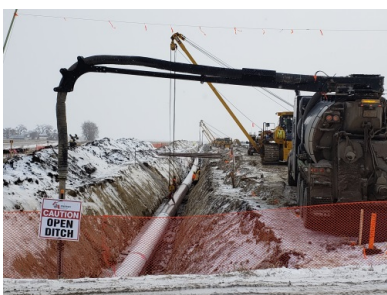
Photo facing East
SF 17A (KP933+335)
Bore crew is onsite in the process of pulling the pipe through the bore hole.

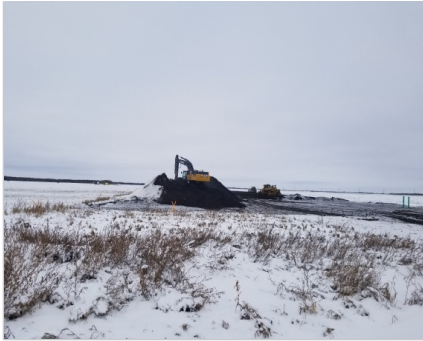
SF11 KP 924+979 Facing West
Excavator moving topsoil away from the edge of the ROW.

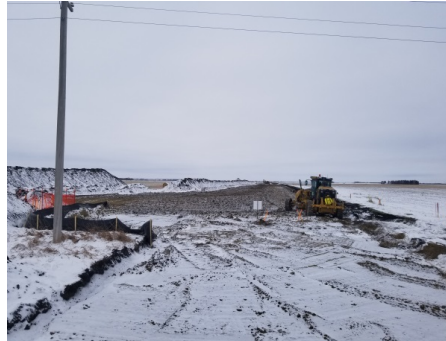
SF14 KP 928+318 Facing West
Grader leveling topsoil along the edge of the ROW.

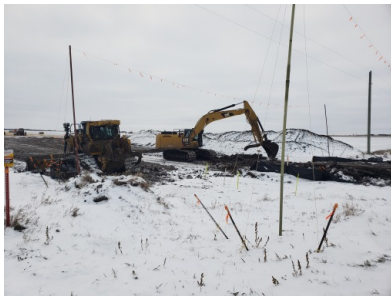
Photo facing South East
SF 6 East side of the road.
Excavator is removing approach, dozer is spread top soil throughout the ROW.

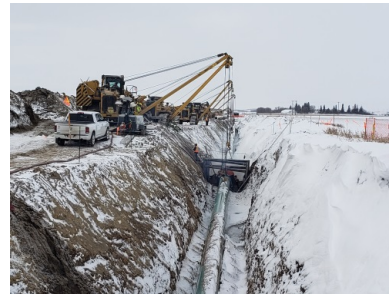
Photo facing West
SF 41A (KP979+410)
Crew using a trench box. Welders are tying into the mainline.

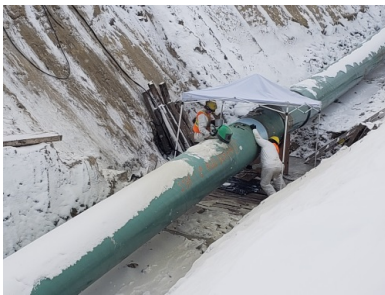
Photo facing South West
SF 43A (KP 983+023)
Crew is coating the weld joints on the pipe.

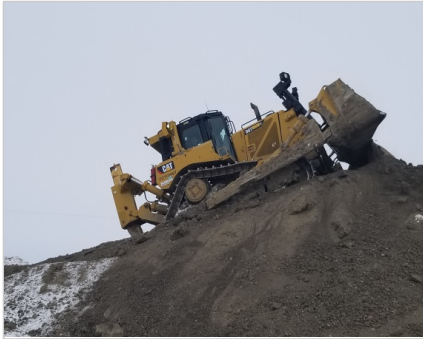
SF50 Facing North
Caterpillar moving clay away from the ditch
and pilling it to the side.

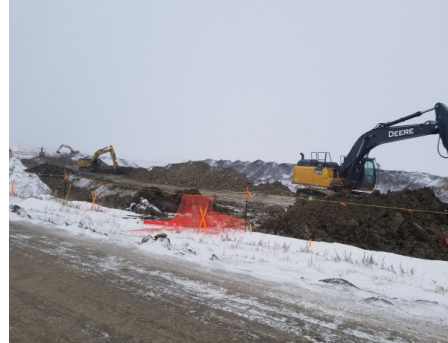
SF43 Facing South East KP 982+774
Excavators backfilling the ditch.

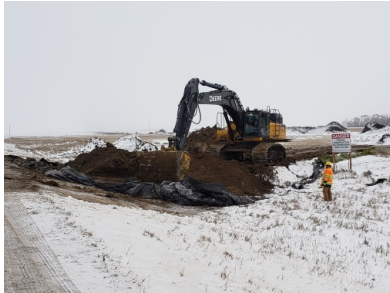
Photo facing South East.
SF 9 South of Hwy #2.
Excavator is removing the approach and geo
cloth.

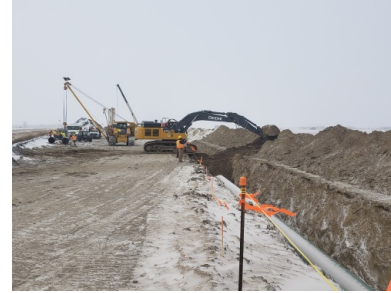
Photo facing West
SF 17 West side of the road.
Excavator is backfilling tie in trench.

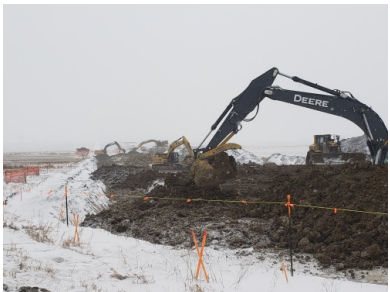
Photo facing South East
SF 43 South side of the road.
Excavators and dozer are backfilling trench.
