**SWAN LAKE FIRST NATION – MATRIX SOLUTIONS
INC. PARTNERSHIP**

INDIGENOUS CONSTRUCTION MONITORING

WEEKLY REPORT

SPREAD 8

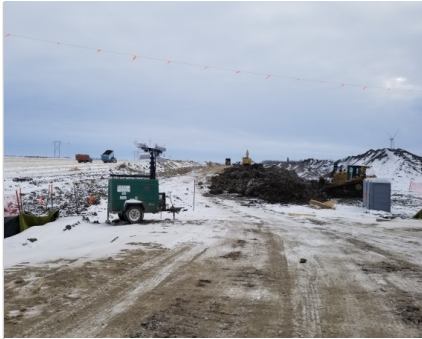
SF45 Facing East
Excavator and caterpillar breaking up the frozen clay.

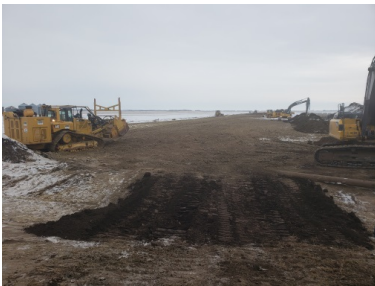
Photo facing East.
SF 14 East side of the road.
Crew is onsite prepping ROW for top soil placement.

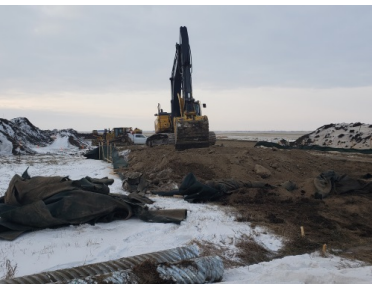
Photo facing North West.
SF 15 West side of the road.
Excavator is removing half the approach and geo cloth.

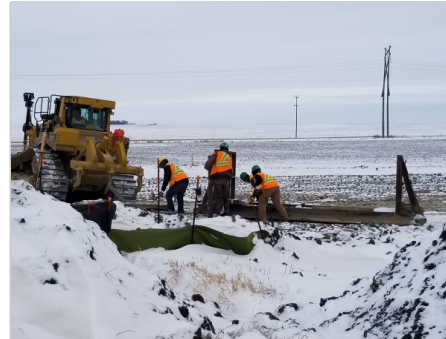
SF43A Facing North North East
The clean up crew are loading up skids onto the sloop that the caterpillar is pulling.

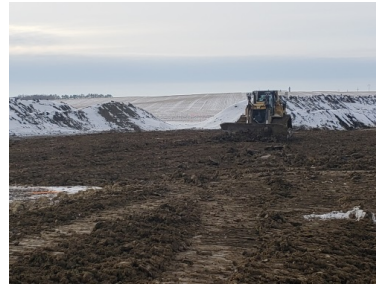
Photo facing South West.
SF 43A West side of the road.
Dozer is leveling the ROW.

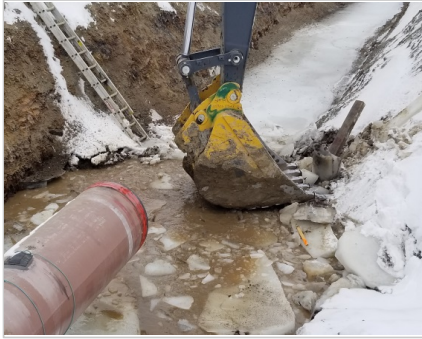
SF49 KP 996+398 Facing East
Excavator removing ice for the de-watering crew. Ladder is tied on to the T-posts.

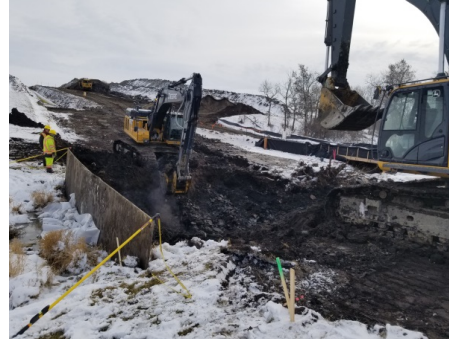
SF39 KP 976+600 Facing East
Excavators digging the ditch at the creek. Sheet piles and plastic holding the water back.

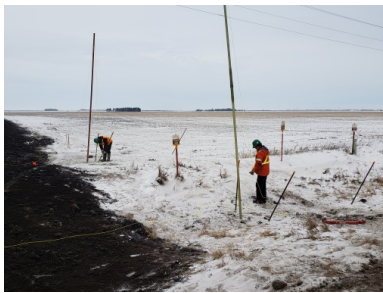
Photo facing North West
SF 14 West side of the road.
Crew members taking down one set of goal posts.

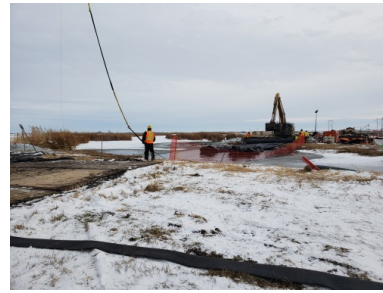
Photo facing North East
SF 22B (KP943+74)
Crew is pulling aqua dam across the creek.

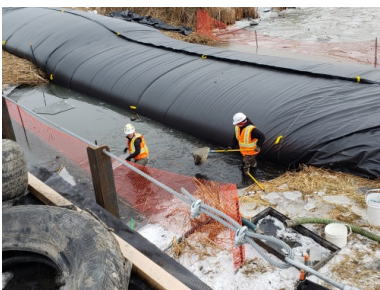
Photo facing South East
SF 22B (KP943+74)
Golder aquatics team searching for fish.

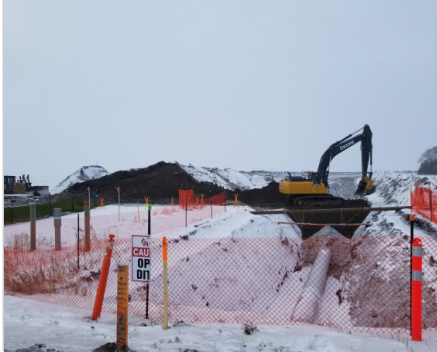
SF49 KP996+383 Facing West
Excavator and caterpillar backfilling ditch.

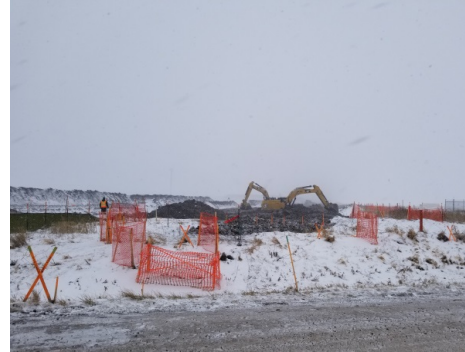
SF47 Excavators and caterpillars
backfilling the ditch. Spotter watching.

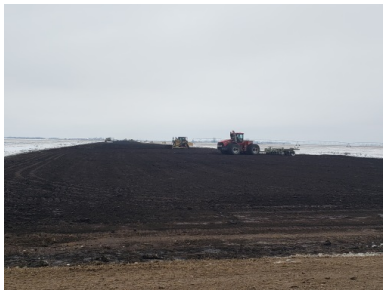
Photo facing East.
SF 15 East side of the road.
Tractor is tilling the ROW.

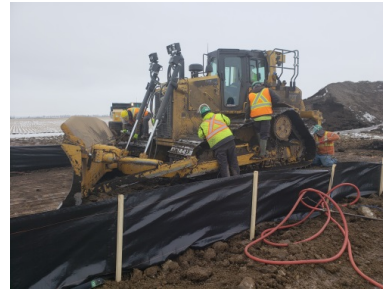
Photo facing South West
SF 16 West side of the road.
Crew members are cleaning equipment.

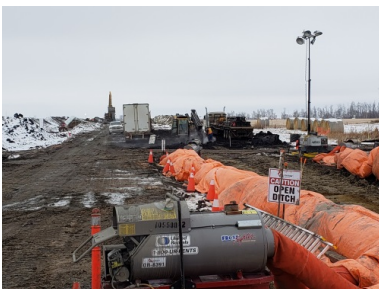
Photo facing West
SF 22B (KP943+74)
Drill rig is drilling under creek.

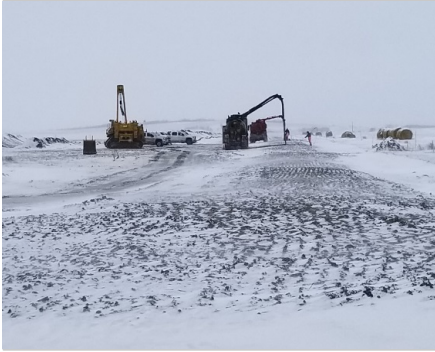
SF35 KP 976+475 Facing West
Two hydro-vac trucks and crew daylighting
the pipe.

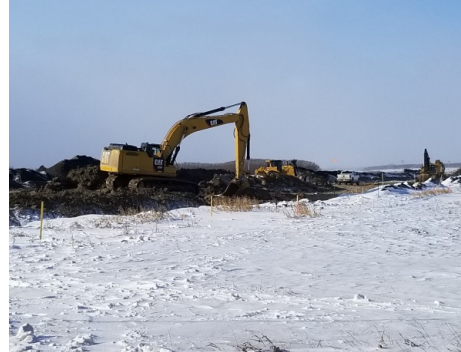
SF41A KP 979+410 Facing West
Caterpillars and excavators are backfilling
the ditch.

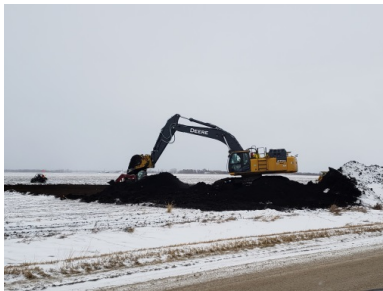
Photo facing North East.
SF 17 North side of the road
Excavator pulling top soil pile away from
the edge of the ROW.

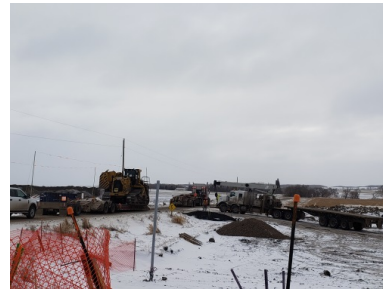
Photo facing South East
SF 28 access.
Side boom is being unloaded at access.

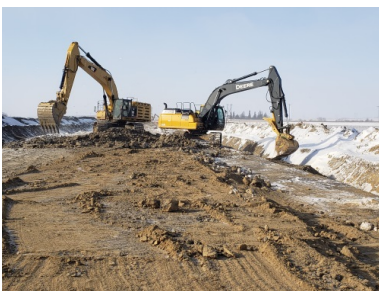
Photo facing North West
SF 41A (KP979+410)
Excavators backfilling trench.

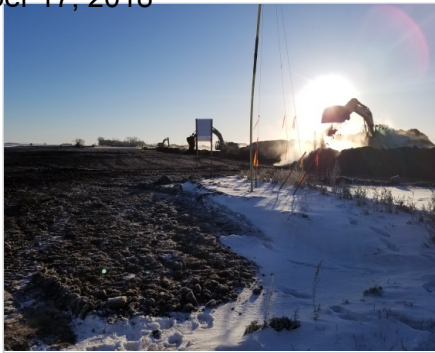
SF9 Facing East
Excavators and caterpillars leveling the topsoil.

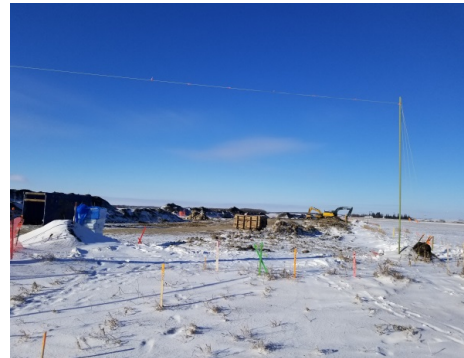
SF41 KP 979+410 Facing West
Excavators and caterpillars breaking up the clay and leveling it out.

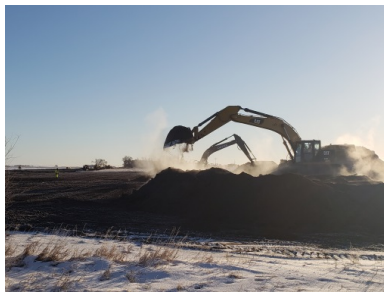
Photo facing East.
SF 8 East side of the road.
Excavators pulling top soil from the edges of the ROW.

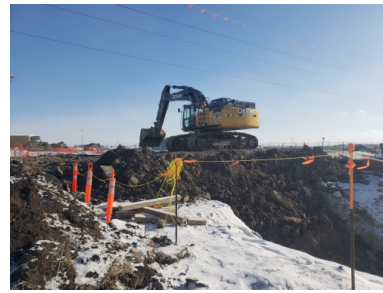
Photo facing South East.
SF 48 West side of St Leon station.
Excavator is backfilling open cut road.

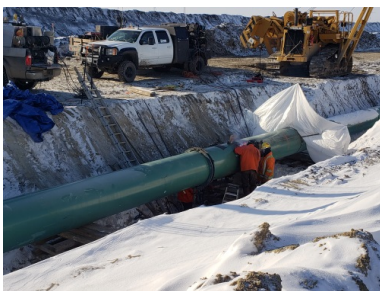
Photo facing South West.
SF 48A (KP994+310)
Welding crew onsite welding sections of the pipe.
