**SWAN LAKE FIRST NATION – MATRIX SOLUTIONS
INC. PARTNERSHIP**

INDIGENOUS CONSTRUCTION MONITORING

WEEKLY REPORT

SPREAD 8

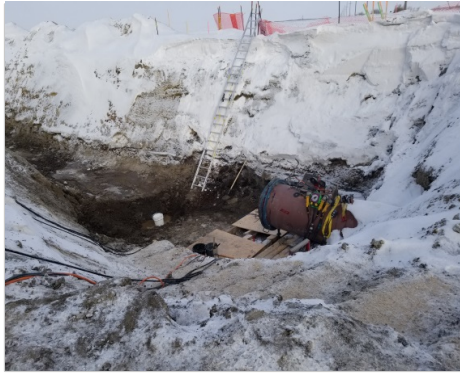
SF50 KP 1000+140 Facing North West
Tie-in crew waiting as pipe is about to be
lowerd in.

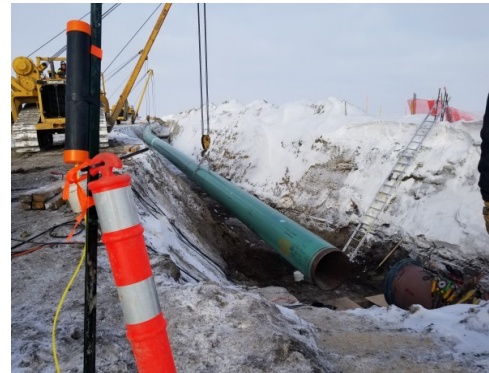
SF50 KP 1000+140 Facing West
Side-booms lowering pipe to tie in.

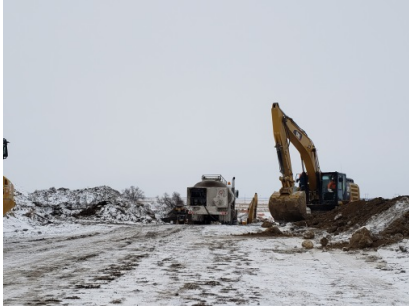
Photo facing West.
SF 27 West side of Cypress #1
Refueling truck is onsite refuelling
equipment.

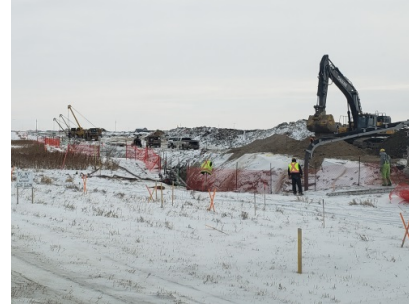
Photo facing South East.
SF 41 South side of the road.
Hydro Vac is removing water from the trench.

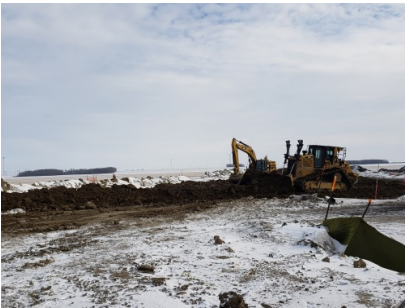
Photo facing North East.
SF 48A (KP994+310)
Excavators and a dozer are working together
to backfill tie in trench.

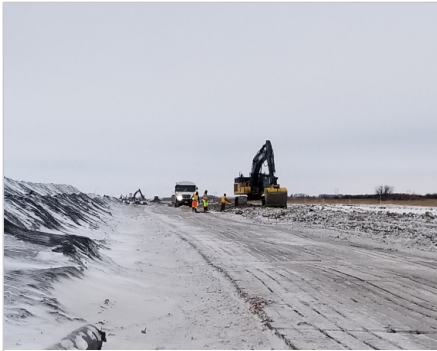
SF23 KP 948+000 Facing West
Excavator breaking up clay and removing
geo-tec.

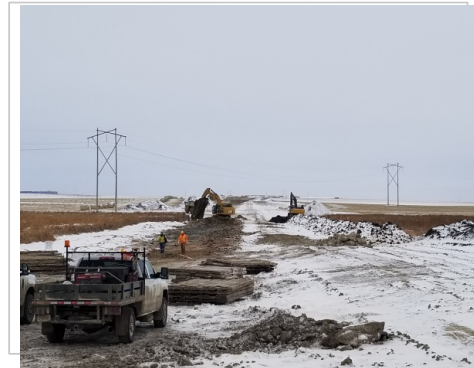
SF30 Facing West
Excavator loading geo-tec onto a rock
truck.

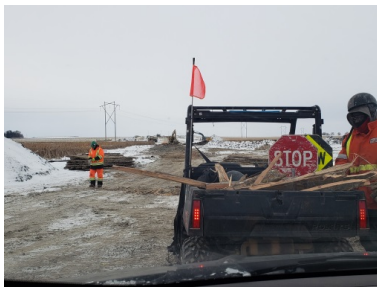
Photo facing West.
SF 30 West side of the road.
Crew members collecting debris from the
ROW.

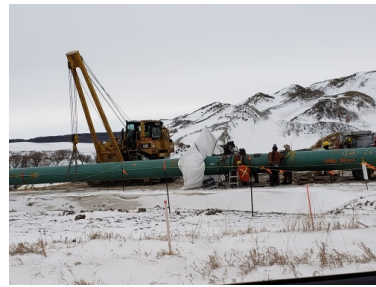
Photo facing South.
SF 35 South side of the road.
Welding crew is onsite welding sections of the
pipe.

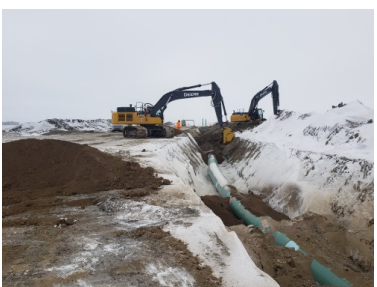
Photo facing West.
SF 50 West side of the Hwy.
Excavators are placing soil on top of the
pipe covering it.

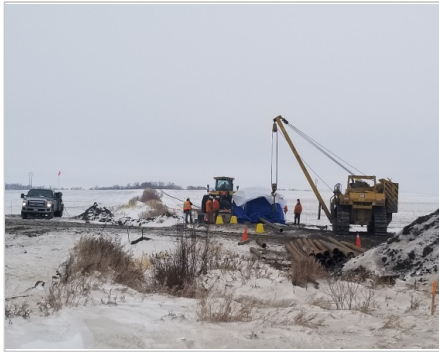
SF35 KP 976+475 Facing North
Side boom holding pipe for the welding crew
doing tie-in for testing the main pipe.

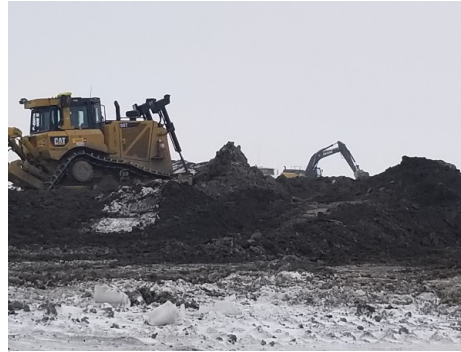
SF50 KP 1000+129 Facing West
Caterpillar and excavator backfilling
ditch.

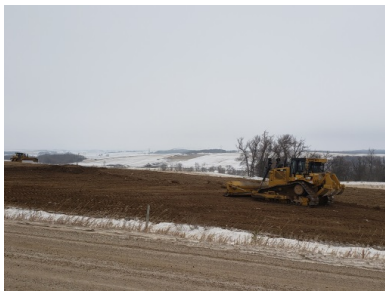
Photo facing North West.
SF 32 North side of the road.
Dozers are leveling the ROW.

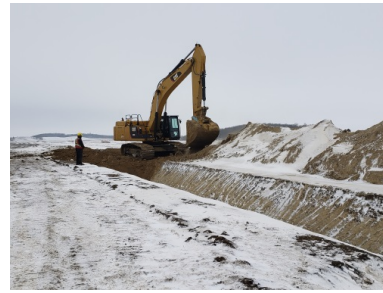
Photo facing North West.
SF 37 (KP 971+263) North side of the road.
Excavator placing soil into trench.

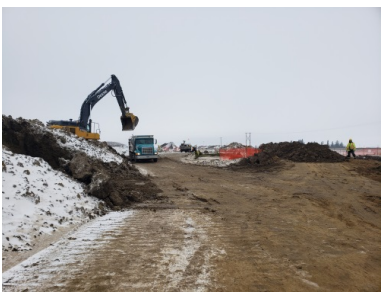
Photo facing West.
SF 41A South side of Hwy #2.
Excavators are placing into dump truck.

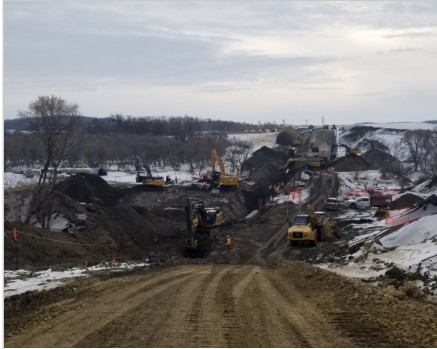
SF35 KP 968+000 Facing Southeast
Excavators and a caterpillar digging and backfilling ditch.

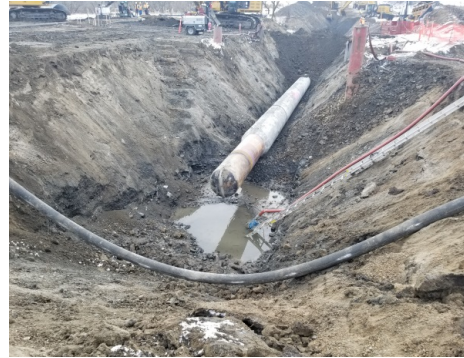
SF35 KP 968+000 Facing Southeast
Ditch being backfilled over the pipe that is coated with gunnite.

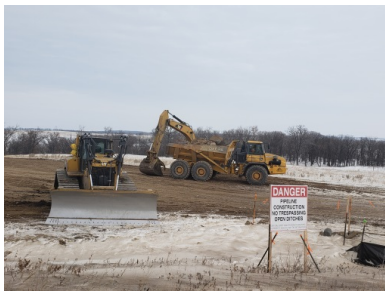
Photo facing North.
SF 32 North side of the road.
Excavator loading rock truck with rocks.

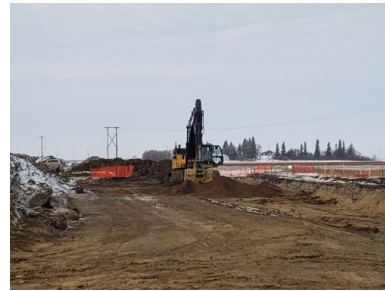
Photo facing North West.
SF 41 South side of Hwy #23.
Excavator placing soil into the trench.

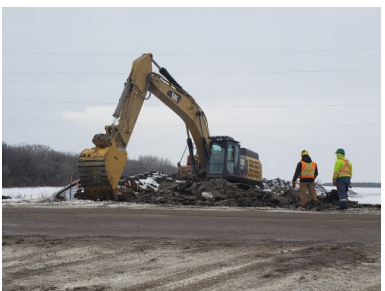
Photo facing West.
SF 39 West side of Hwy #34.
Excavator removing part of the approach.

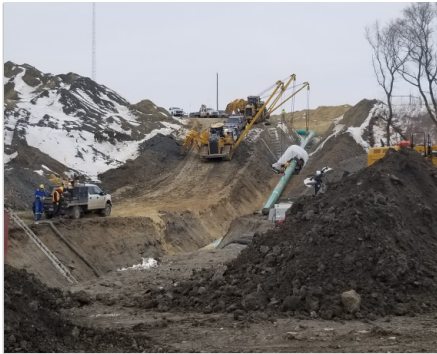
SF35 KP 968+000 Facing North West
Tie-in crew working on side of the hill.

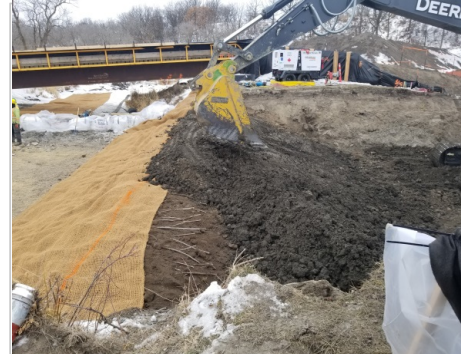
SF35 KP 968+000 Facing South West
Excavator banking side of the creek with mud.

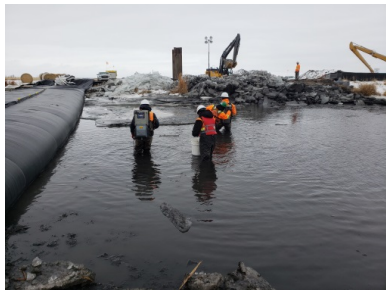
Photo facing East
SF 22B Oak Creek #3
Golder Biologists are fish salvaging.

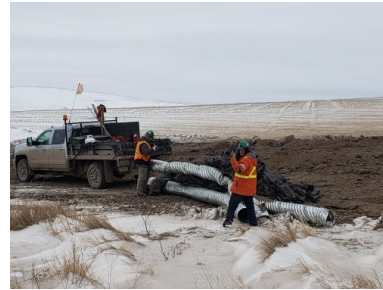
Photo facing South
SF 32 Southside of the road.
Crew members are removing debris from the ROW.

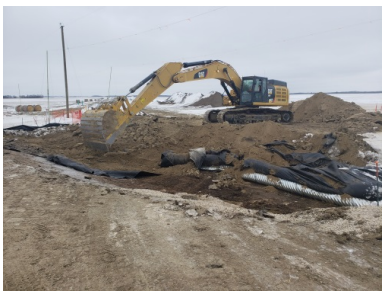
Photo facing South East
SF 37 South side of the road.
Excavator removing the approach.
