**SWAN LAKE FIRST NATION – MATRIX SOLUTIONS
INC. PARTNERSHIP**

INDIGENOUS CONSTRUCTION MONITORING

WEEKLY REPORT

SPREAD 8

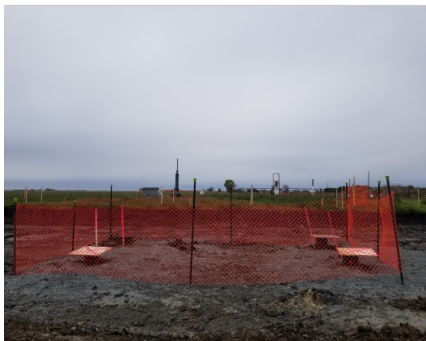
SF5 Facing North
Pipes cut shorter.

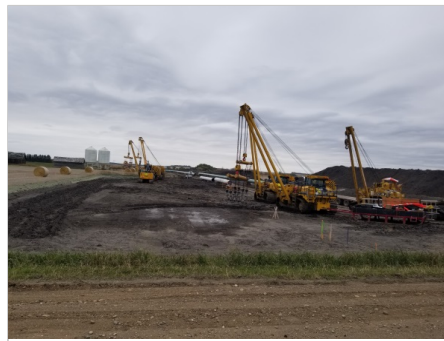
SF26 Facing East
Side Booms moving down ROW.

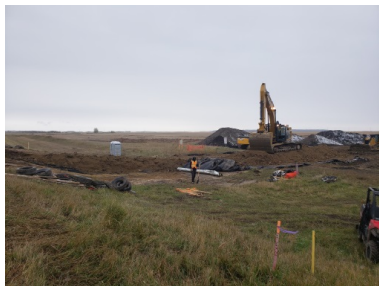
SF 2 (KP911+616) Excavator stripping half of the approach. Geotex cloth used works well when removing approach. Dozer is track packing the ROW. Crew members assisting excavator when needed, also cleaning soil that was tracked onto the Hwy. Traffic was speeding by the work site, I went and checked the road construction signs to assure they were uncovered. I warned the crew member that traffic was ignoring the signs and to be cautious when vehicles are coming.

Photo facing South West
SF 2 (KP 911+616)
Excavator stripping half the approach.

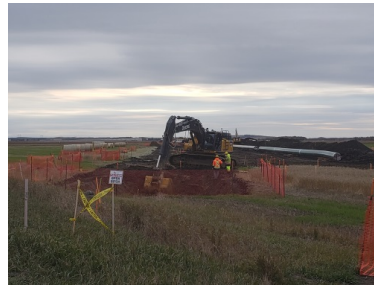
SF 24 Bore crew is onsite. Excavator digging trench for bore drilling. Snow fence has been placed around the open pit being dug. Dozer pushing soil that is being removed for the trench is being piled on the South side of the ROW away from the other soil piles. Crew members are exposing foreign utilities using shovels.

Photo facing South East
SF 24 South side of the road.
Excavator digging bore pit, Crew members
using shovels to expose foreign utility.

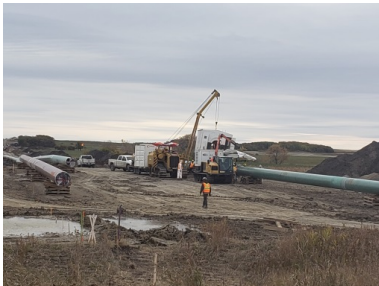
Photo facing South East
SF 30 East side of the road.
Coating crew is onsite coating weld joints
on pipe.

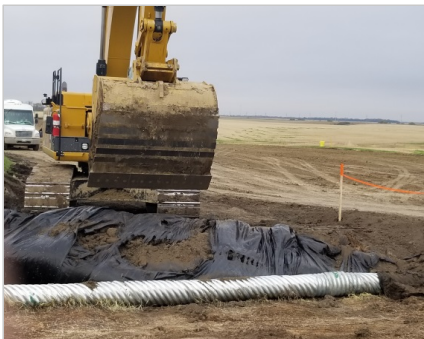
SF3 Facing West
Excavator removing clay and Geo-tec from south half of approach.

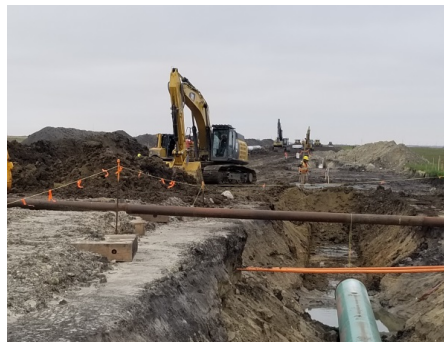
SF5 Facing West
Excavator digging trench while caterpillar moves clay to side.

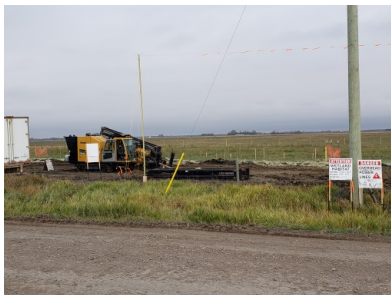
SF (KP 940+950) Wetland habitat, Bore crew is onsite. Bore drilling is taking place, drilling diagonal North to South underneath road. Excavator on the South side of the road is continuing to dig bore pit. Soil is being placed into a rock truck and is being piled on the ROW away from Top soil and Seconds piles. Open ditch is fenced off and has proper signage. Stairs have been built into the pit for access. SF 23 Bore crew is onsite. Side booms are being used to pull pipe through the bore hole underneath the road. Open ditch barriers removed temporarily for work to take place. Flagging crew is onsite stopping traffic when needed. Pipe was removed and taken across the road going West to East. SF 24 (KP949+600) Bore crew onsite, continuing to dig trench on the South side of the road. Excavator removing soil and placing on the ROW for the dozer to pile adjacent to the trench away from other soil piles. Trench is fenced and roped off. Stairs were built into the pit. Existing line crossing has been exposed and is being held in place with rope. A crew member is assisting excavator when needed, giving him depth measurements. SF 8 (KP921+205) Oak Creek crossing, further digging was required for Bore pit. E.I informed of me when they would start digging. Upon arrival I was informed that another bone was found while digging the next 1M down. I informed worker that was onsite to keep it onsite until I knew what to do with it as there was no Golder Archaeologist in the area. I stayed onsite until the latest I could, no further bones were found. Crew dug another 2m deep. Wishing well was installed to pump water out of the pit. Water was being pumped into silt bags. SF3 Clay on both sides of road are spread out and graded. Excavator on West side ramp pulling up geo-tec and clay. East side also making the ramp narrower. SF4 Taking out ramps on both sides of road. Caterpillars levelling clay farther down ROW. Excavator digging trench while caterpillar moves clay on west side. On the East side caterpillar taking out ramp. Two excavators also waiting. SF6 On East side grader levelling clay and caterpillar levelling transition. On West side excavator waiting for spotters to cross road.

Photo facing North West
SF 22 (KP 940+950)
Directional driller drilling underneath road.

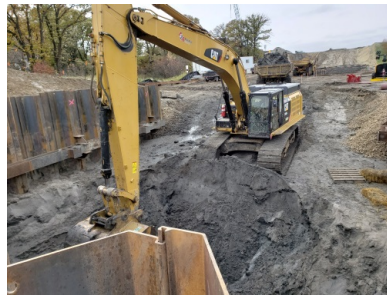
Photo facing South West
SF 8 (KP921+205)
Excavator digging Bore pit.

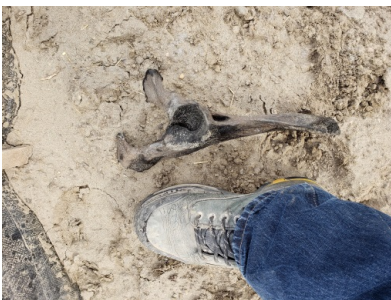
Photo facing North
SF 8 (KP921+205)
Bone that was found while digging the Bore pit. Approximately 1 foot in length.

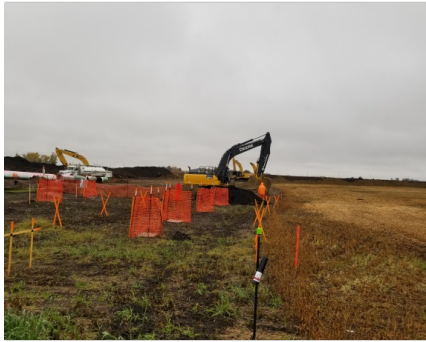
SF20 Facing West
Excavator digging along West side of road.
Excavator being fueled up.

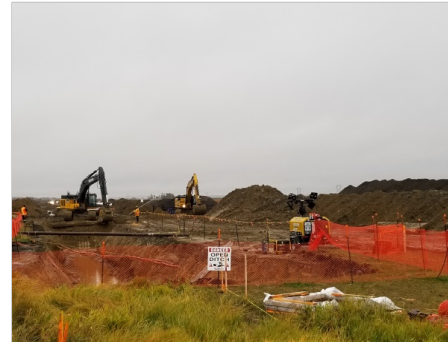
SF22 Facing South East
Excavator digging trench while another
moves clay to side.

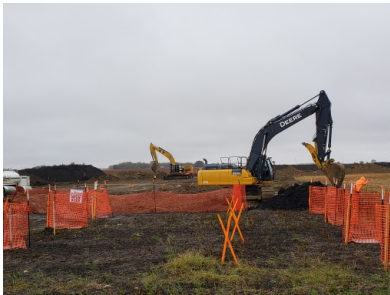
Photo facing West
SF 20 West side of the road.
Crew is working on Environmental
deficiencies.

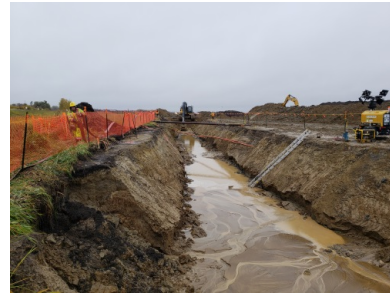
Photo facing South east
SF 22 South side of the ROW
Excavator continuing to dig trench, crew
pumping water out of trench.

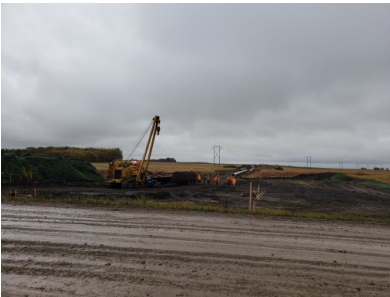
Photo facing West
SF 30 West side of the road
Crew is retrieving skids and placing on
trailer.

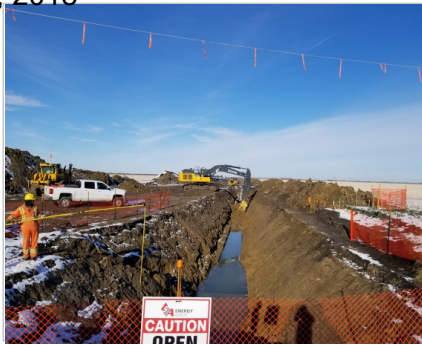
SF25 Facing West
Excavator cleaning trench
Crew member checking trench

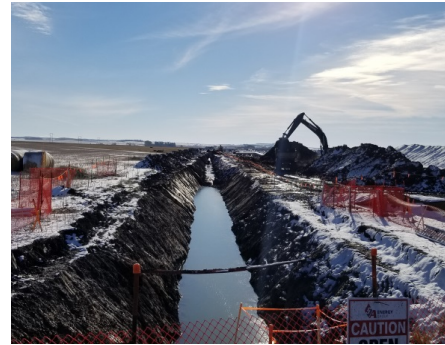
SF25 Facing East
Excavator loading rock truck
Water in trench

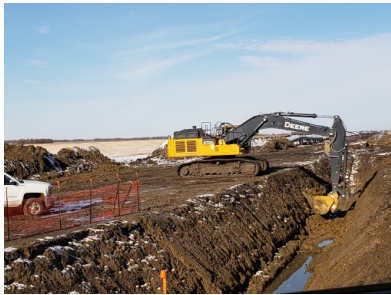
Photo facing South West
SF 25 West side of the road.
Excavator is cleaning out trench.

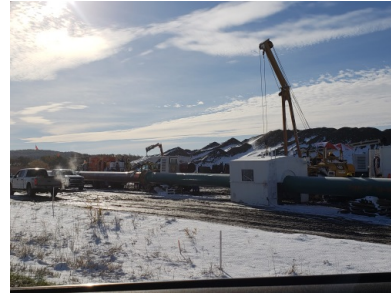
Photo facing South east
SF 35 South side of the ROW.
Coating crew coating welds.

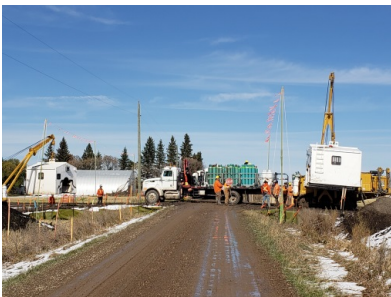
Photo facing North
SF 40A Road crossing.
Propane truck trading out propane tanks.

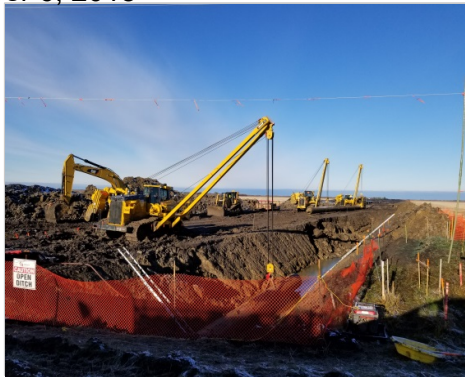
SF25 Facing West
Excavater parked.Side boom holding up
pipe,and other side booms moved into
place.

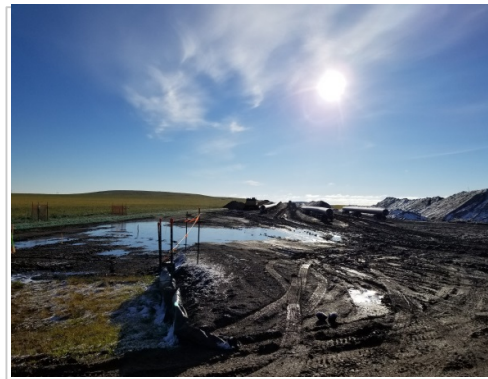
SF33 Facing East
Excavater digging trench.
Lots of water and ice on ROW.

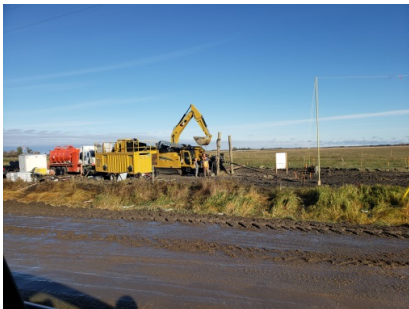
Photo facing North West
SF 22A North side of the road
Drill rig in place dilling underneath road

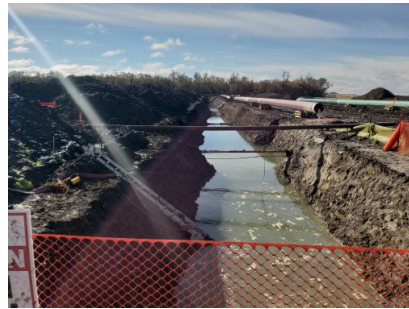
Photo facing South
SF 26 South side of road
View of trench that needs water pumped out.
