**MANITOBA METIS FEDERATION – MATRIX
SOLUTIONS INC. PARTNERSHIP**

INDIGENOUS CONSTRUCTION MONITORING

WEEKLY REPORT

SPREAD 8

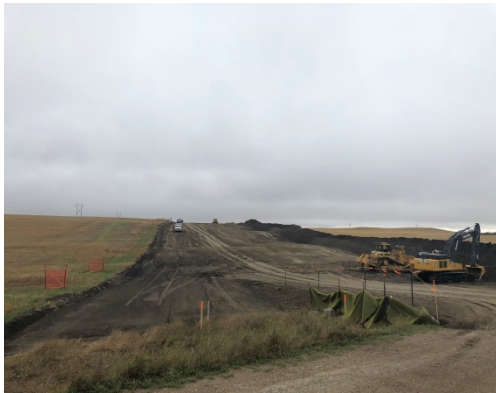
SF 44, photo facing east, one dozer pushing transition soil.

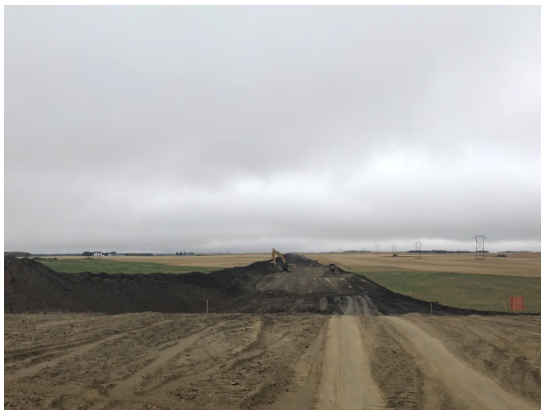
SF 44, photo facing west, 2 dozers pushing transition soil, one excavator moving soil between piles.

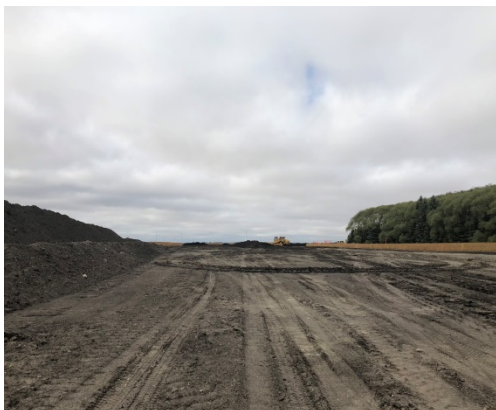
SF 49, photo facing west, one dozer pushing top soil.

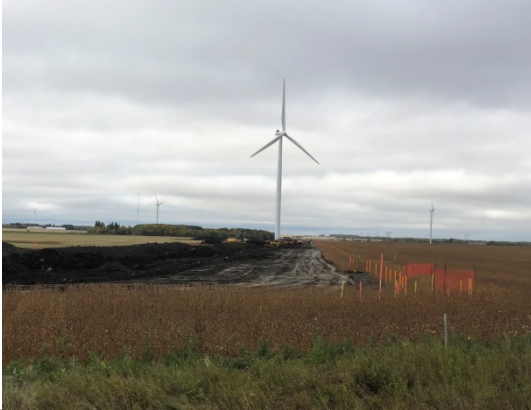
SF 48, photo facing west, multiple dozers and excavators pushing top soil to the side of the ROW.

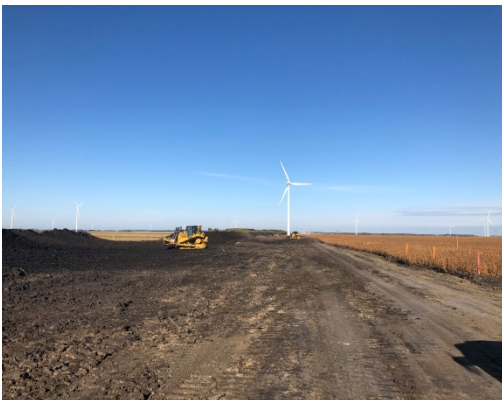
SF 48, photo facing west, topsoil stripping.

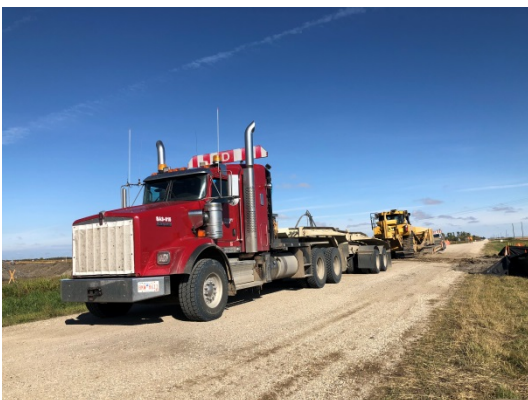
SF 47, photo facing north, lowbed came to pick up 4 dozers total and move them.

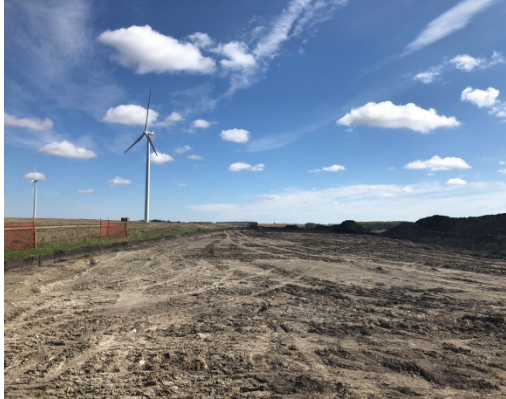
SF 49, photo facing east, 3 dozers pushing top soil, one excavator moving top soil, one grader grading the ROW.

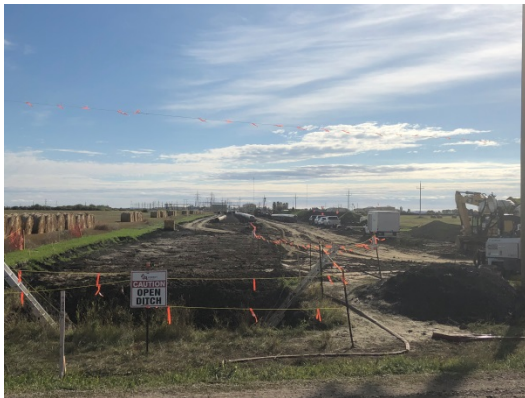
SF 19, photo facing west, crews working on pipe.

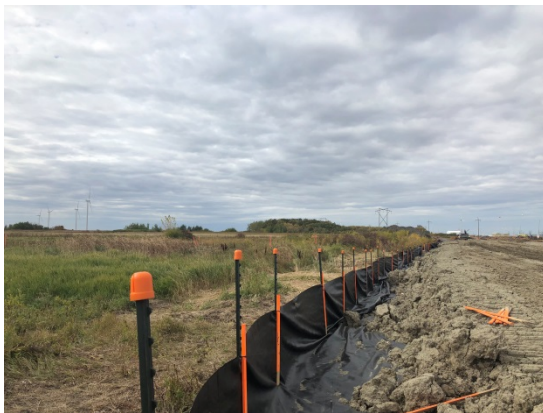
SF 48A, photo facing west, wetland habitat, KP 993.21 - 993.95, wetland ID MB-178, wetland class III.

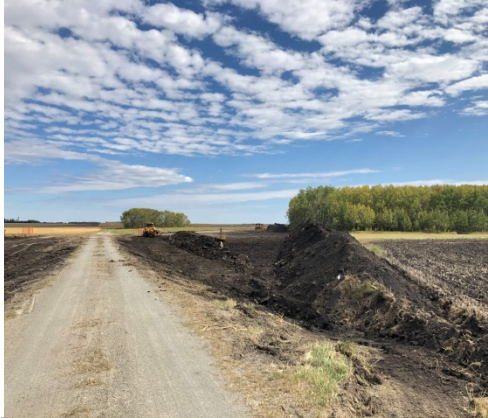
SF 49A, photo facing north east, dozers pushing topsoil, there is a grader and 4 more dozers around the corner.

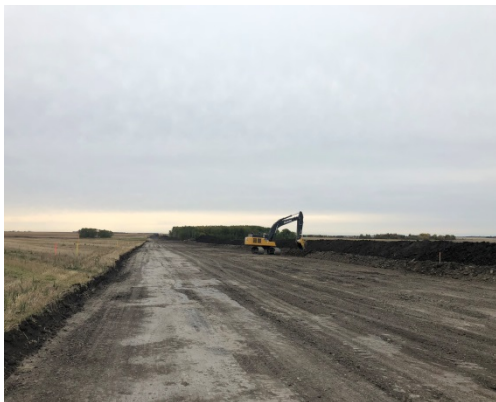
SF 49, photo facing east, one excavator separating topsoil and transition. A spotter is being used.

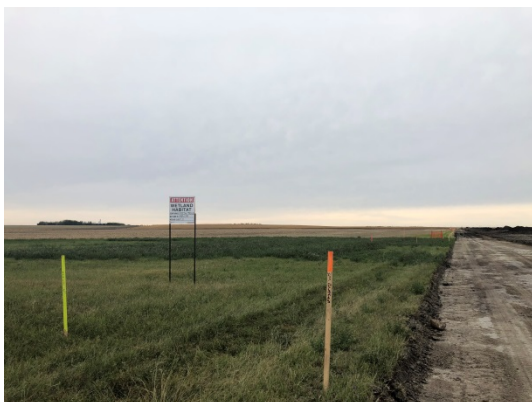
SF 49A, photo facing east, wetland habitat, SSKP 997.54-998.00.

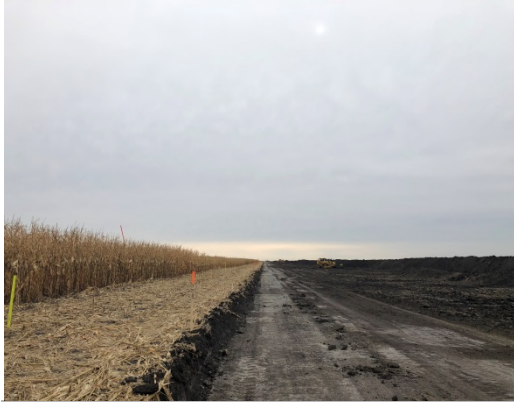
SF 49A, photo facing east, 3 dozers pushing up the remaining transition soil.

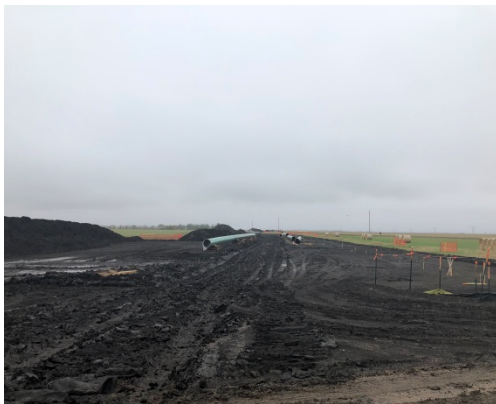
SF 24 A, photo facing west, one crew was spray-painting markings onto the pipe, there on the right hand side it's hard to see, you can also see how muddy the ROW is.

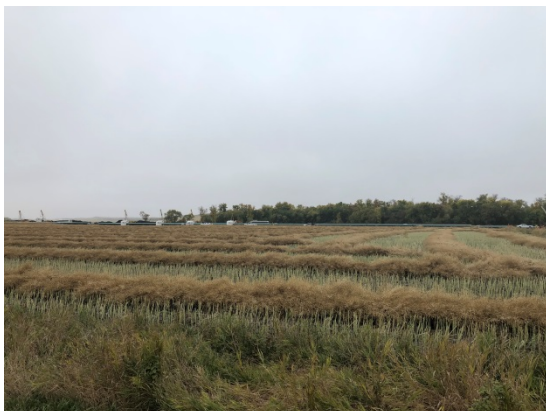
SF 26, photo facing south, pipe gang welding the pipe together.
