**MANITOBA METIS FEDERATION – MATRIX  
SOLUTIONS INC. PARTNERSHIP**

**INDIGENOUS CONSTRUCTION MONITORING**

**WEEKLY REPORT**

**SPREAD 8**

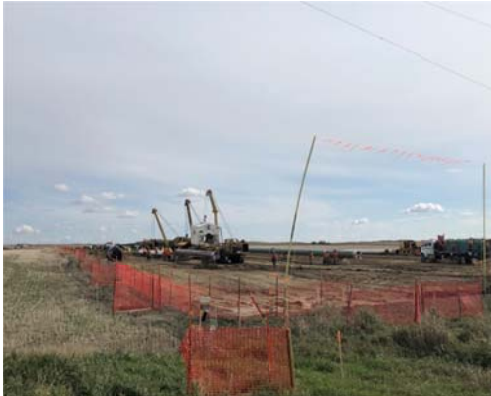
SF 28, photo facing south east, pipe gang crew welding pipe together.

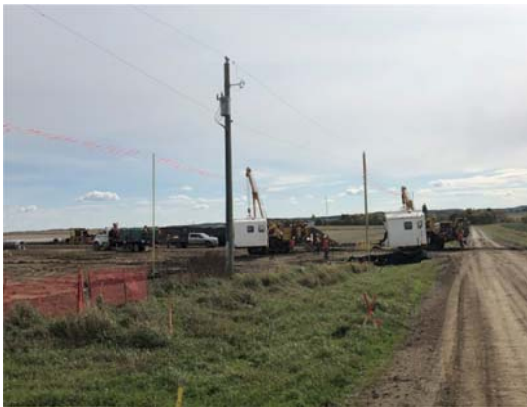
SF 28, photo facing south, pipe gang crew moving welding shacks across the road, flaggers were used.

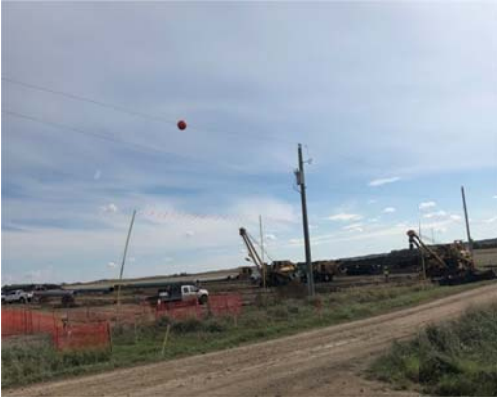
SF 28 photo facing south east, two side booms moving the welder that goes inside the pipe across the road.

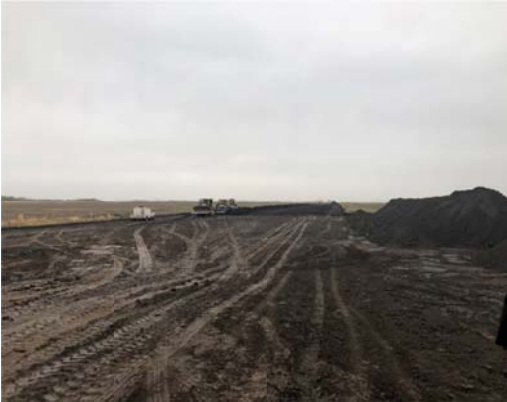
SF 14, photo facing west, speed dozer being pulled by dozer pushing topsoil, one grader grading the ROW.

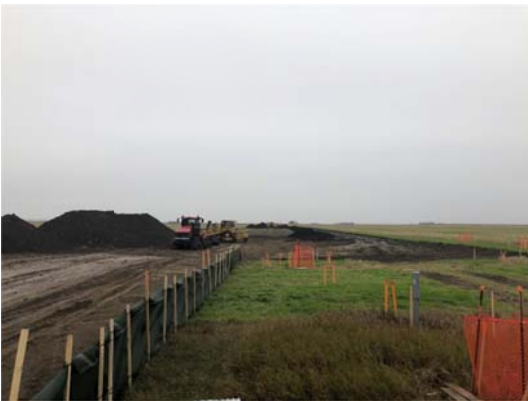
SF 14, photo facing east, 11 dozers total all striping top soil pushing it to the side of the ROW.

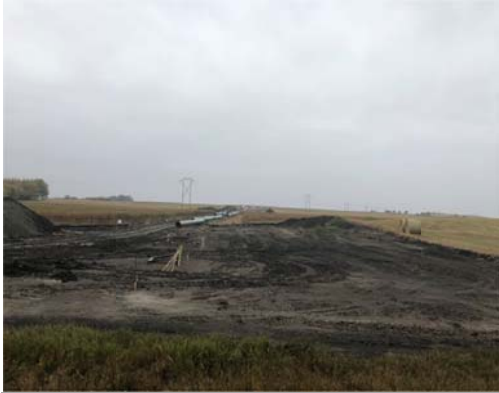
SF 30, photo facing west, pipe gang working on the pipe off in the distance, ROW was very wet and muddy.

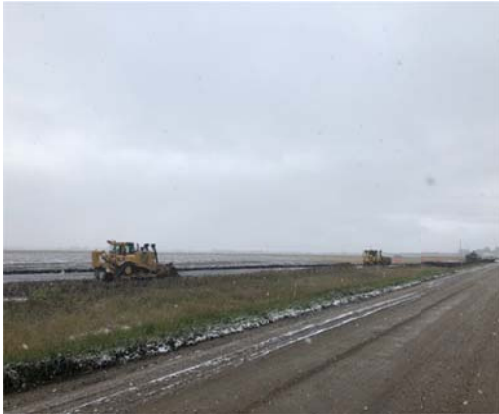
SF 17, photo facing north east, 2 dozers stripping soil.

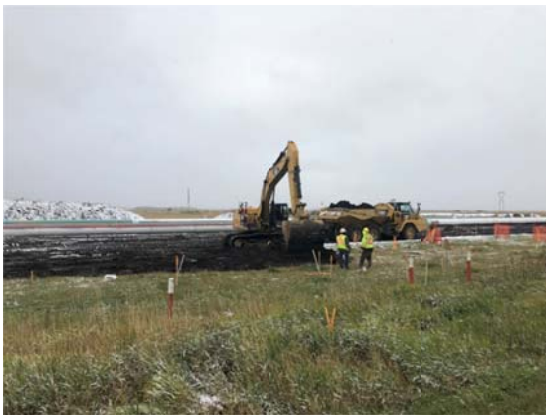
SF 22, photo facing south, one excavator digging soil loading it into the back of the rock truck.

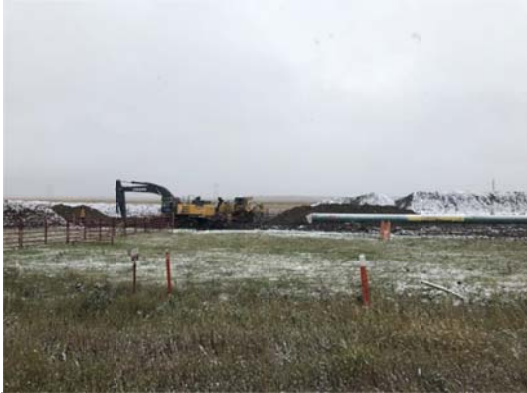
SF 24, photo facing east, coating crew on sight coating the weld on the pipe.

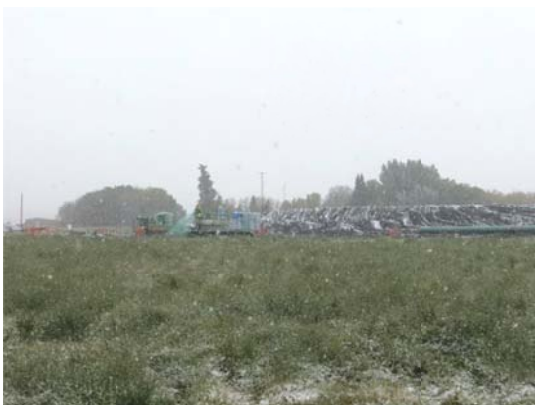
SF 27, photo facing south, crews spraying mulch off the back of the truck onto the north side of the ROW.

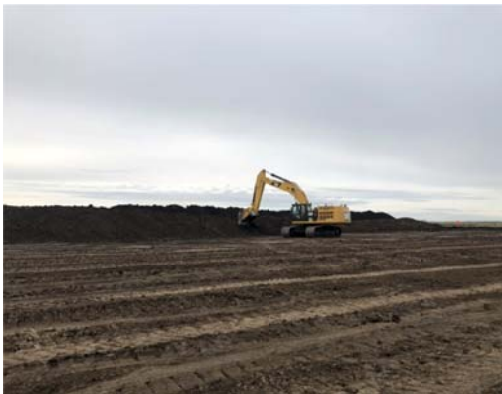
SF 17, photo facing south west, excavator smoothing down transition pile with the back of his bucket.

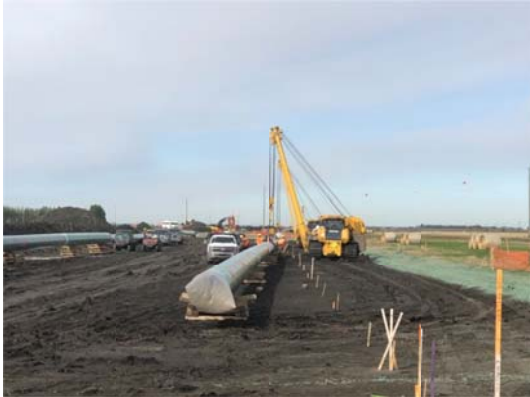
SF 24, photo facing west, crews jeeping the pipe.

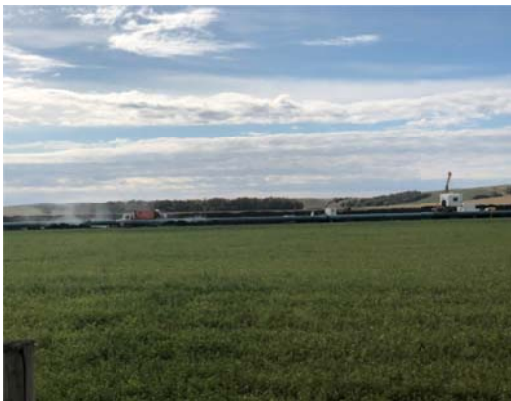
SF 27, photo facing south. Coating crew coating the pipe.

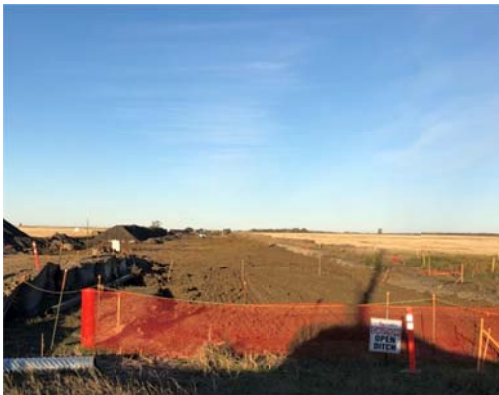
SF 4, photo facing west, one grader grading and one dozer pushing soil.

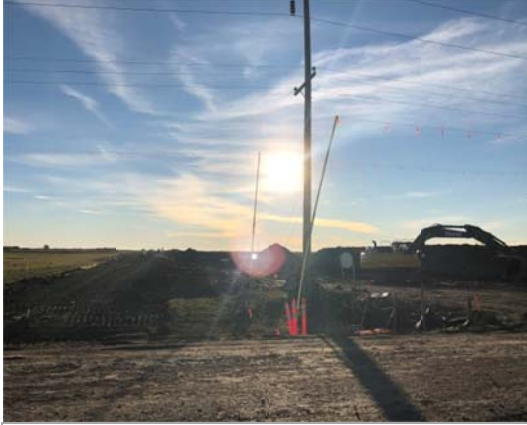
SF 4, photo facing east, crews packing dirt on the ROW.

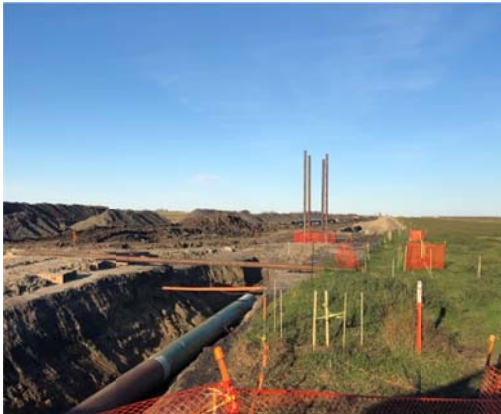
SF 5, photo facing west, three excavators back filling pipe, (excavators are a little hard to see)

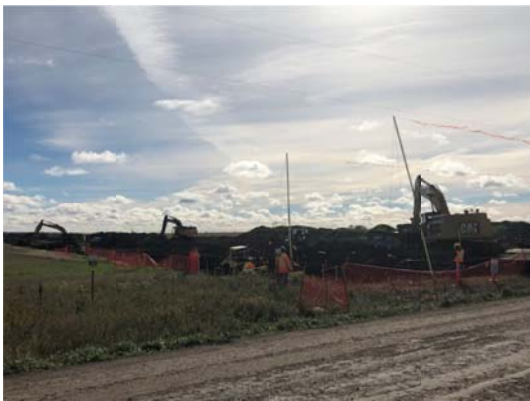
SF 5, photo facing east, crews backfilling pipe.

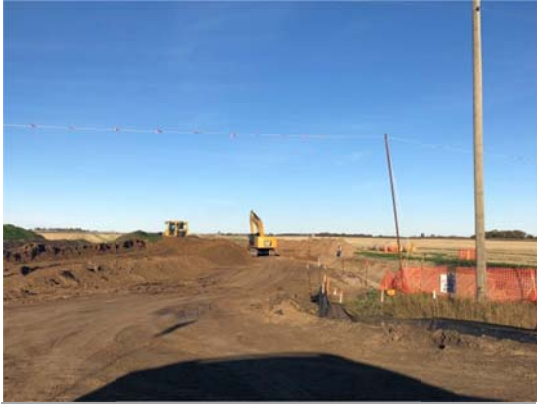
SF 7, photo facing west, excavator and dozer backfilling pipe.
