**MANITOBA METIS FEDERATION – MATRIX
SOLUTIONS INC. PARTNERSHIP**

INDIGENOUS CONSTRUCTION MONITORING

WEEKLY REPORT

SPREAD 8

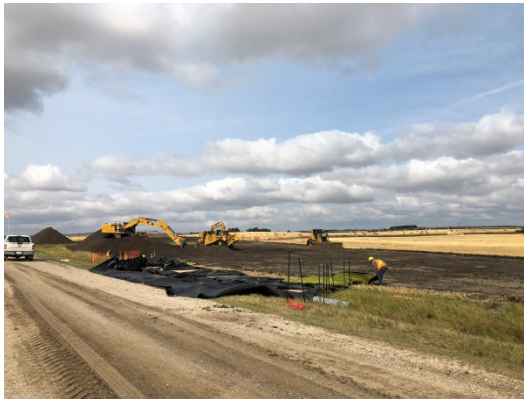
SF 35, photo facing north west, top soil being stripped.

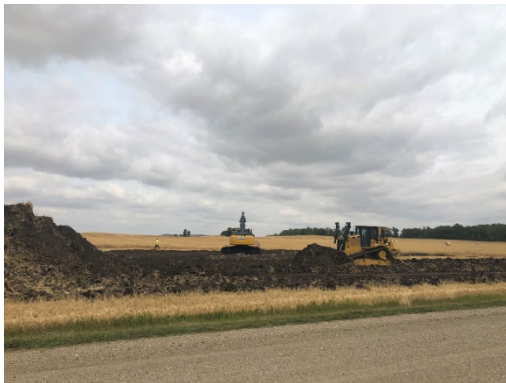
SF 37, photo facing north, top soil being stripped.

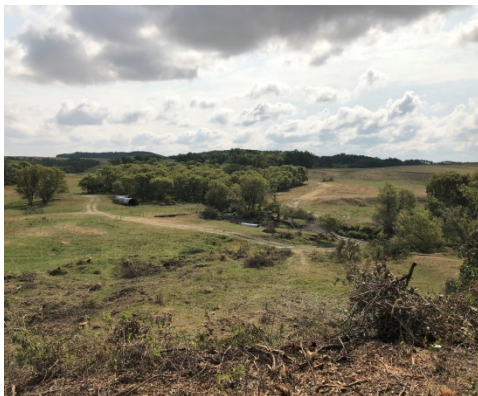
SF 35, east side, ROW where logging took place, photo facing south east down the hill.

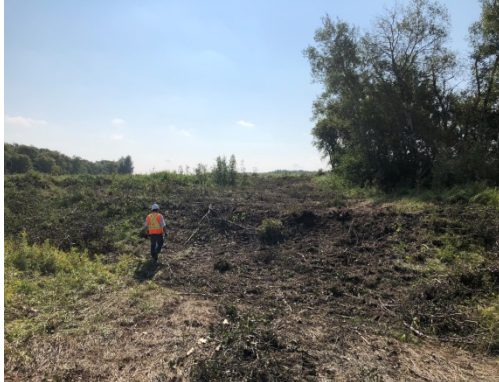
SF 38, photo facing south east, sweeping the land after the logging was done for any artifacts. Will return when topsoil starts getting stripped.

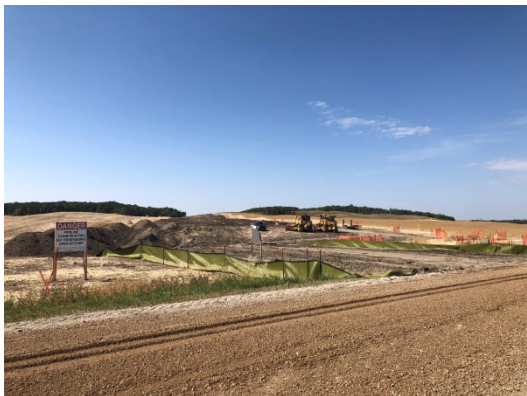
SF 36, photo facing west, the first little bit of the ROW is stripped but the rest going west is only disked.

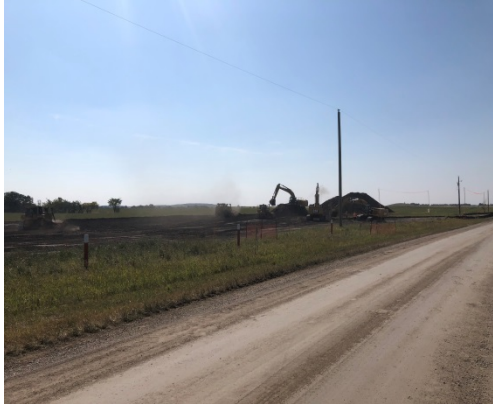
SF 35, south side, photo facing west, ROW being stripped.

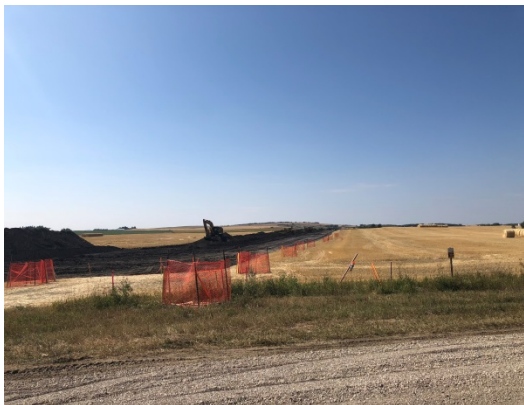
SF 34, photo facing west, topsoil being stripped and pushed by multiple dozers.

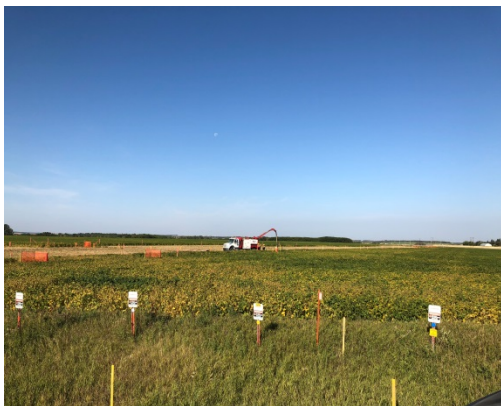
SF 41A, photo facing west, one hydrovac just doing what a hydrovac does.

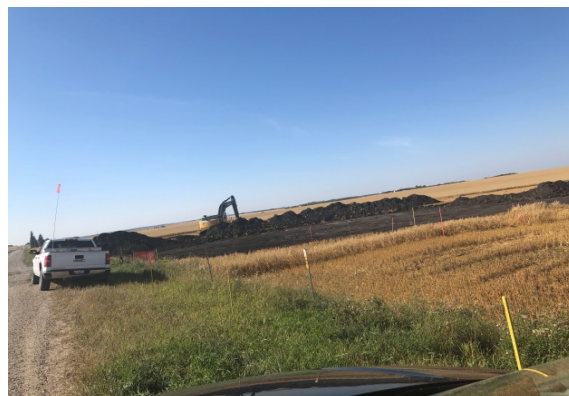
SF 42, photo facing south, excavator pilling top soil.

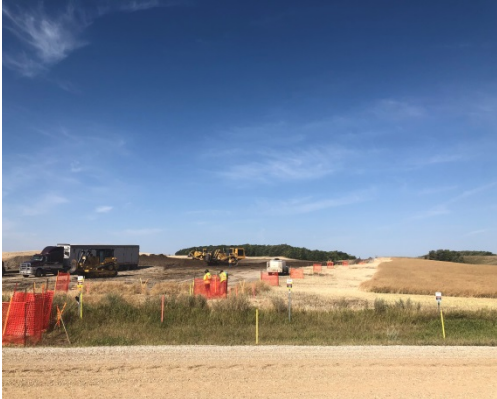
SF 36, photo facing west, crews pushing dirt, you can also see one of the semis that collects the woodchips.

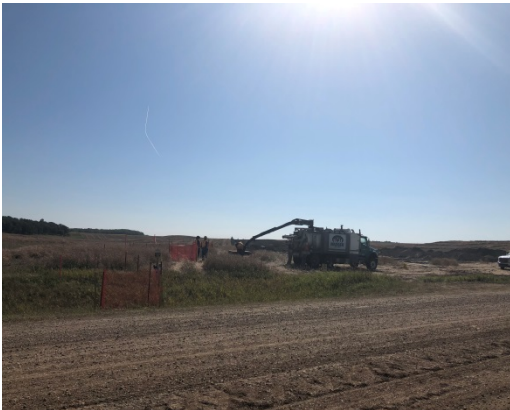
SF 36, photo facing east, badger hydro vac just hydrovacating.

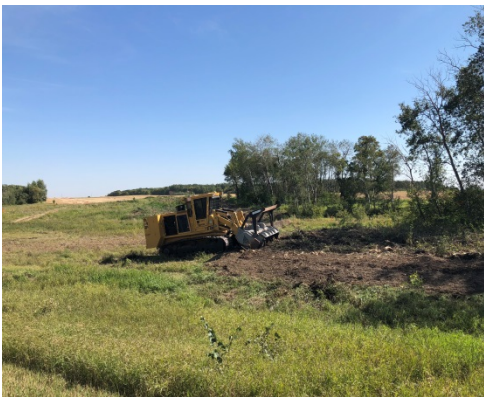
SF 38, photo facing north east, mulching taking place.

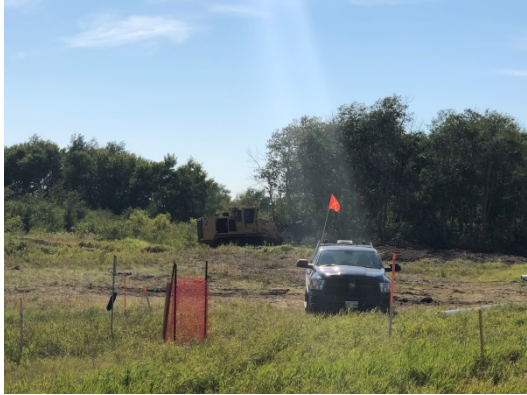
SF 38, photo facing east, mulching taking place, photos of mulcher aren't the best because we can't go close to it.

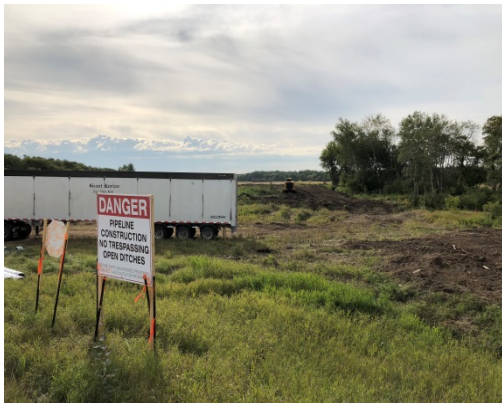
SF 38, photo facing south east, mulching taking place.

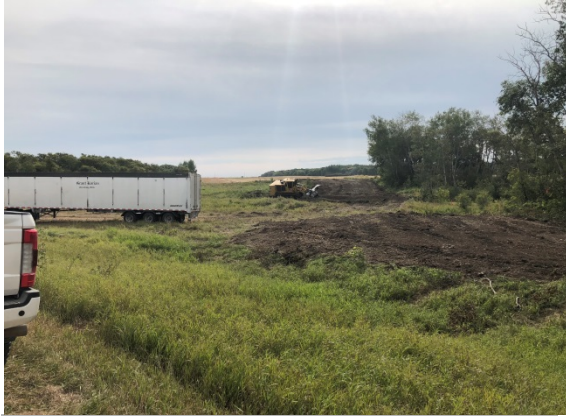
SF 38, photo facing south east, mulching taking place.

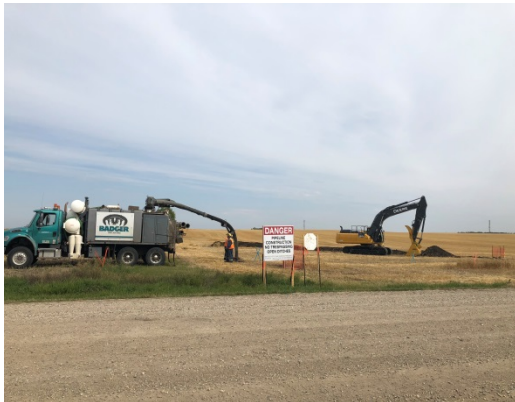
SF 38, photo facing north, hydrovacating taking place and topsoil being stripped by excavator.

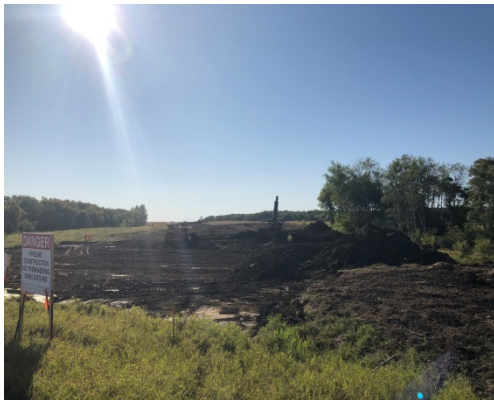
SF 38, south side, photo facing south east, excavator and dozer pushing dirt.

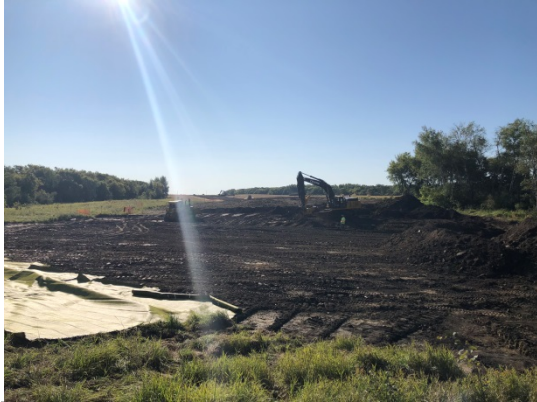
SF 38, south side, phot facing east, another photo of the equipment pushing dirt.

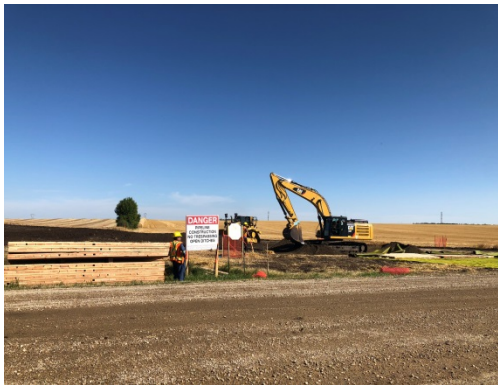
SF 38, north side, photo facing north excavator and dozer pushing topsoil.
