**MANITOBA METIS FEDERATION – MATRIX
SOLUTIONS INC. PARTNERSHIP**

INDIGENOUS CONSTRUCTION MONITORING

WEEKLY REPORT

SPREAD 8

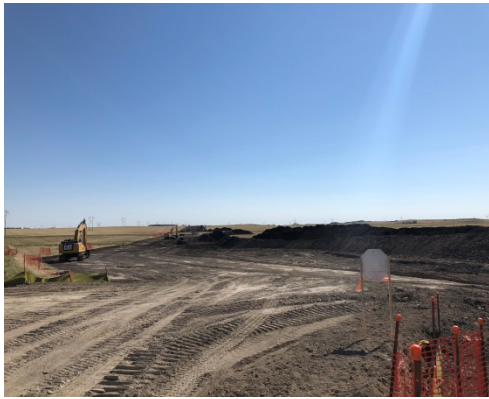
SF 43, photo facing south, one excavator and one grader working on the ROW.

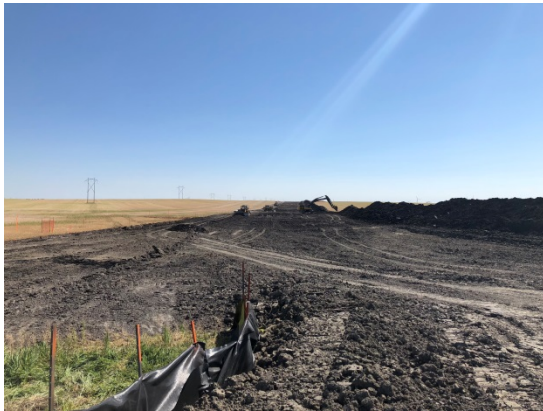
SF 43, photo facing east, 2 dozers pushing dirt, 1 excavator scraping the edges of the ROW, and 1 grader grading the ROW.

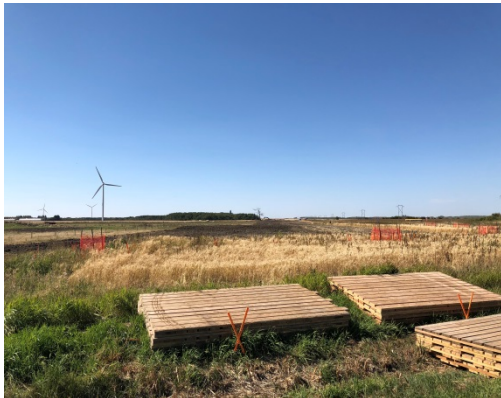
SF 47, photo facing west, ROW disked and rig mats set in the ditch as well as the culvert.

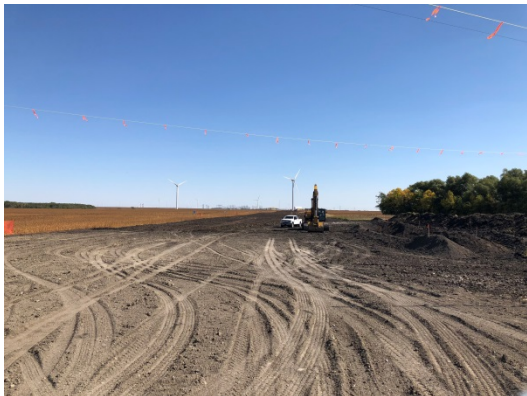
SF 47, photo facing east, first little bit of the ROW is cleared but the rest is only disked.

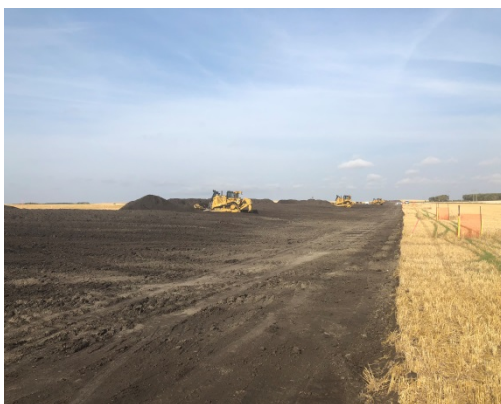
SF 44A, photo facing west, top soil stripping.

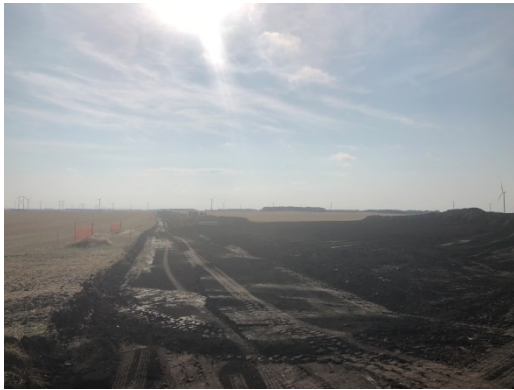
SF 44A, photo facing east, top soil stripping.

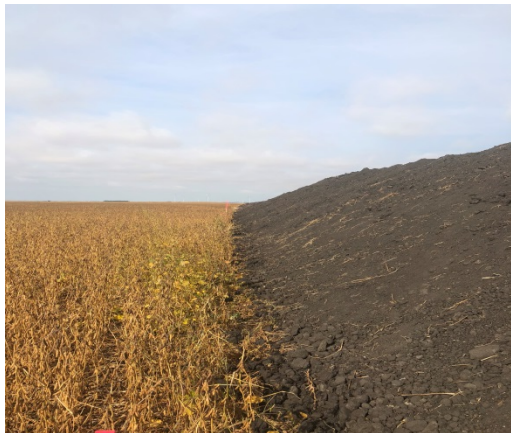
SF 49, photo facing west, checked the top soil to make sure its within the boundary and it is.

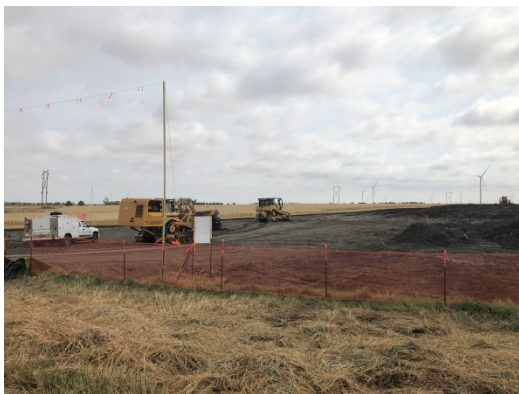
SF 45, photo facing east, speed dozer just crossed the road and getting ready to push more dirt.

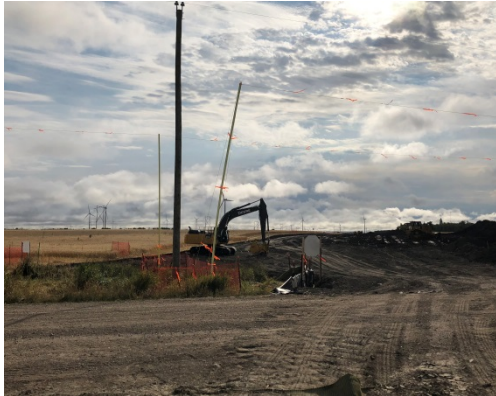
SF 45, photo facing east, 4 dozers pushing dirt all the way down the ROW.

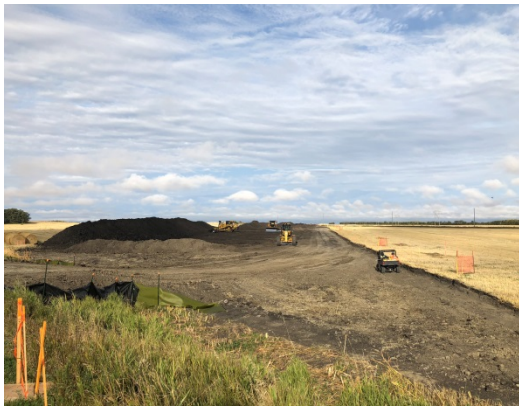
SF 45, photo facing west, 4 dozers pushing dirt to the side of the ROW, also one grader grading the ROW.

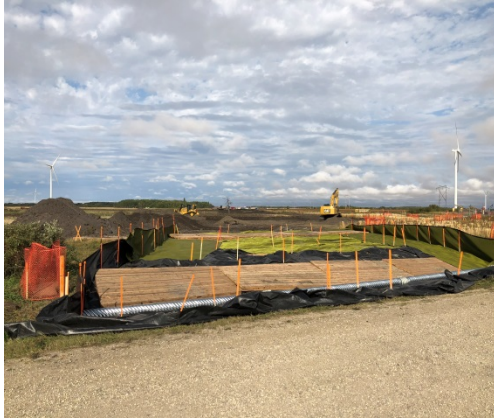
SF 47, photo facing west, geotech, culverts, and rig mats laid in the ditch, one dozer and one excavator moving dirt to the side on the ROW.

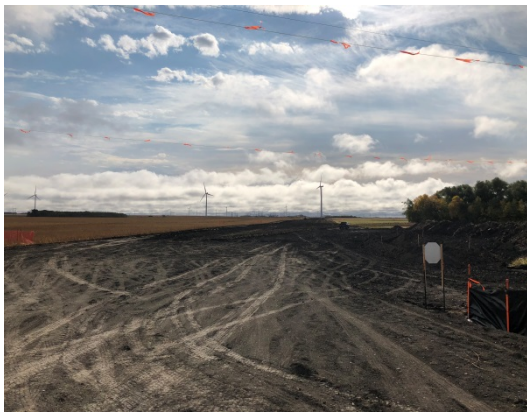
SF, 47, photo facing east, one grader grading the north side edge of the ROW, one dozer eventually came and started stripping topsoil.

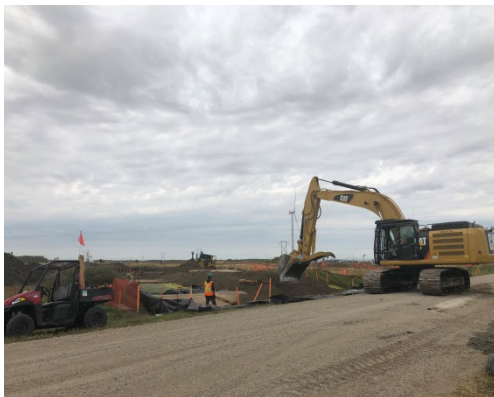
SF 47, photo facing west, excavator starting to pile dirt onto the approach, shortly after a dozer came and finished off making the approach.
