**MANITOBA METIS FEDERATION – MATRIX  
SOLUTIONS INC. PARTNERSHIP**

**INDIGENOUS CONSTRUCTION MONITORING**

**WEEKLY REPORT**

**SPREAD 8**

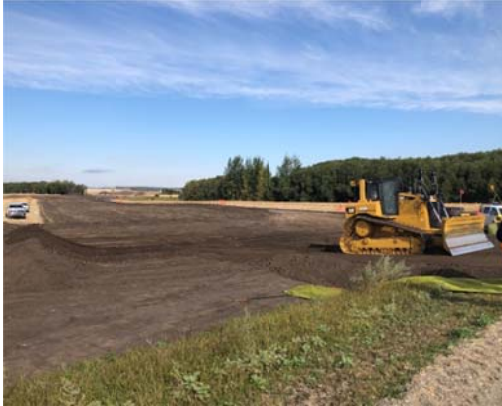
SF 38, (half way through) photo facing north west, dozer smoothing out approach.

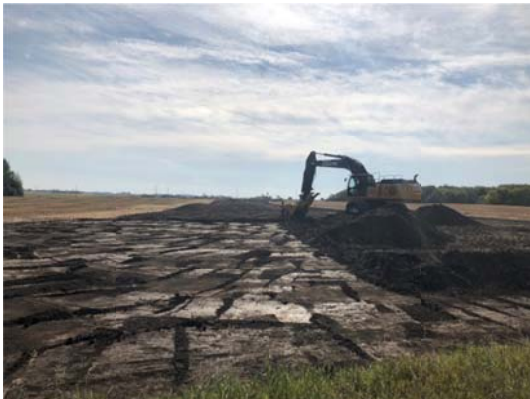
SF 38, (half way through) photo facing east, excavator pulling dirt to the side smoothing out the ROW.

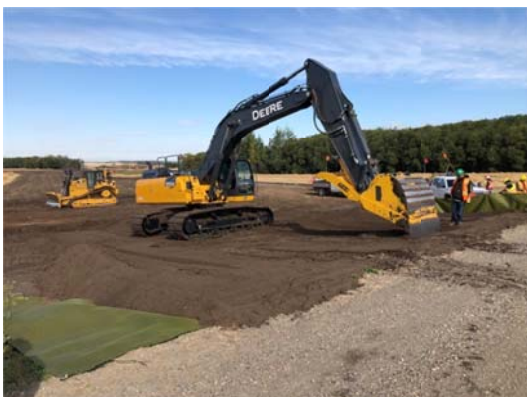
SF 38, (half way through) photo facing north west, excavator removing dirt from approach because topsoil was used instead of clay.

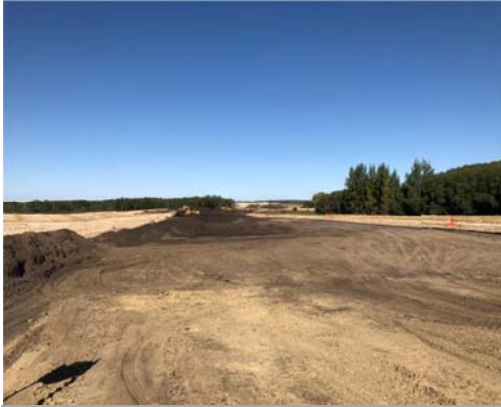
SF 38, half way through the ROW, photo facing west, top soil stripping.

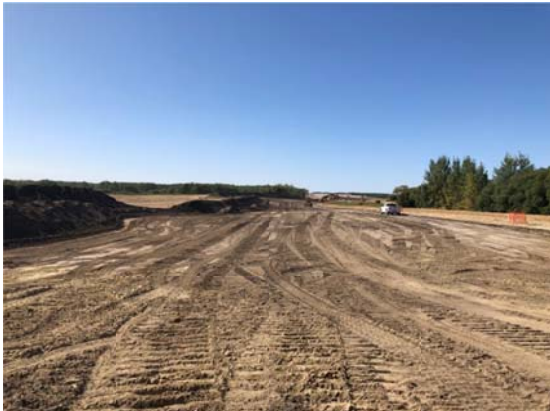
SF 38, half way through the ROW, photo facing west, top soil stripping almost complete, grader started grading.

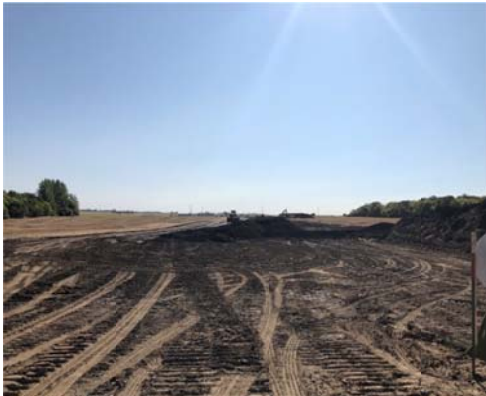
SF 38, half way through the ROW, photo facing east, top soil starting to be pushed to the side of the ROW.

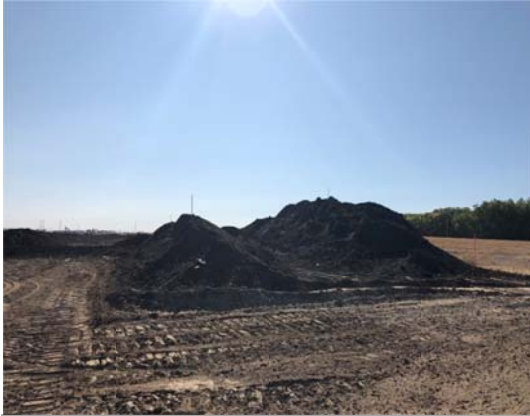
SF 38, half way through the ROW, photo facing east, dirt piles have been marked with stakes on the top.

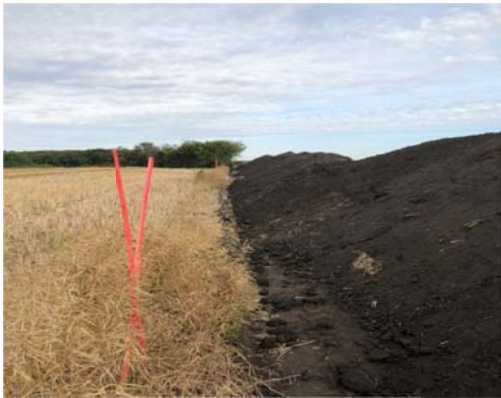
SF 38, photo facing west, top soil along boundary line.

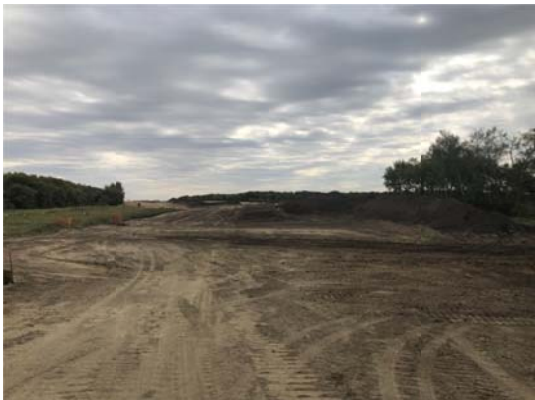
SF 38, photo facing east, looked for any artifacts after top soil was stripped and pushed but never found anything.

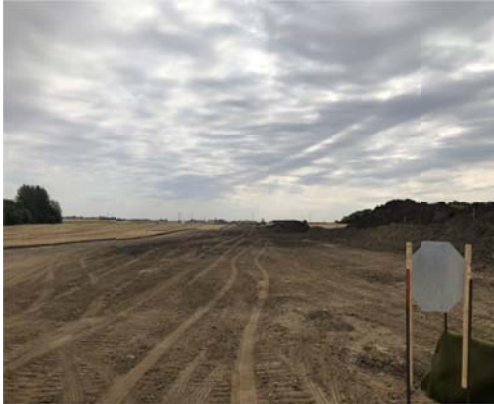
SF 39, (I think), photo facing east, top soil all stripped.

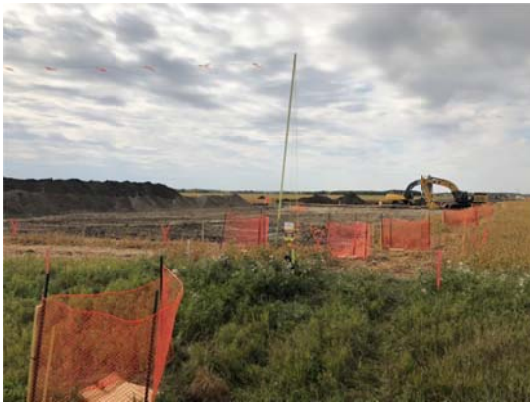
SF 41A, photo facing south west, excavators digging and some topsoil stripped.

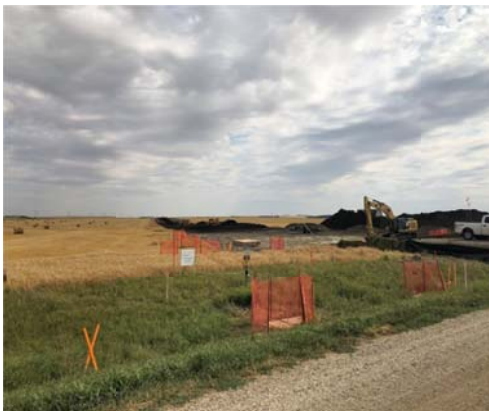
SF 41A, photo facing east, top soil being stripped by multiple dozers.

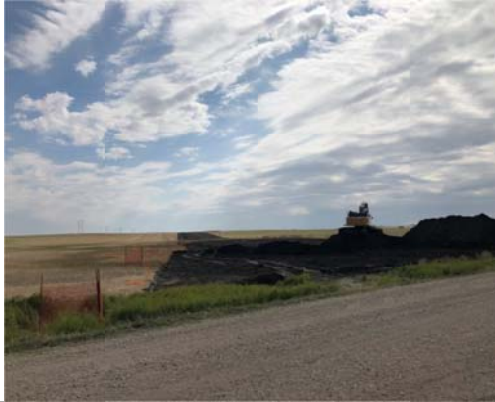
SF 43A, photo facing east, excavator piling topsoil.

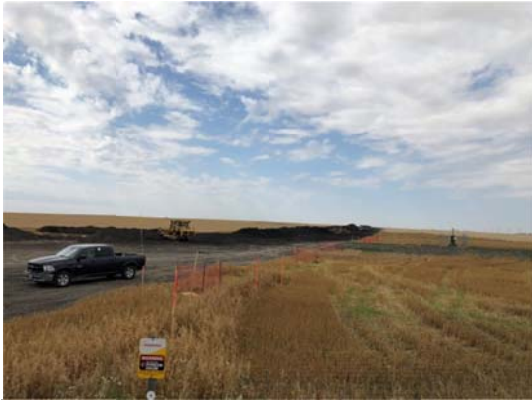
SF 42, west side, photo facing west, 6 dozers pushing dirt.

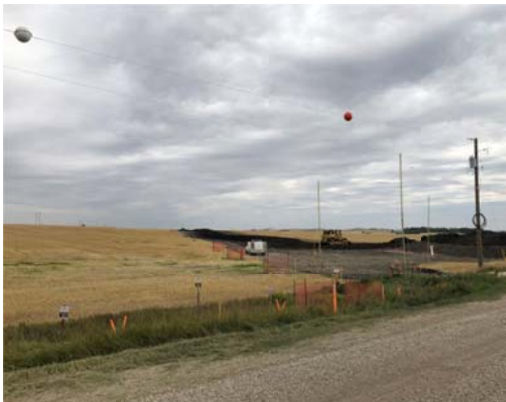
SF 42, east side, photo facing east, one dozer starting to push dirt after speed dozer just went through.

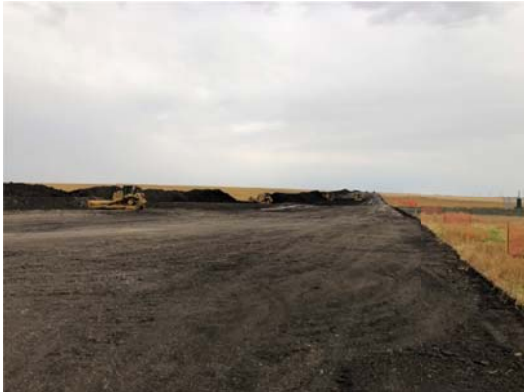
SF 42, photo facing east, dozers pushing dirt.

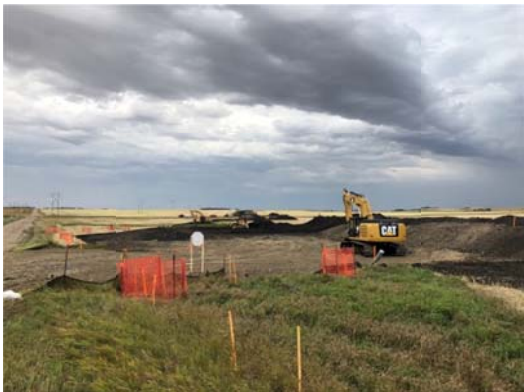
SF 43, photo facing south east, 2 excavators and 2 dozers pushing dirt.

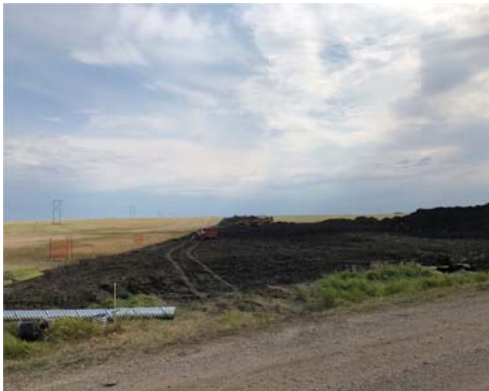
SF 43A, photo facing east, dozers pushing dirt all the way down the ROW.

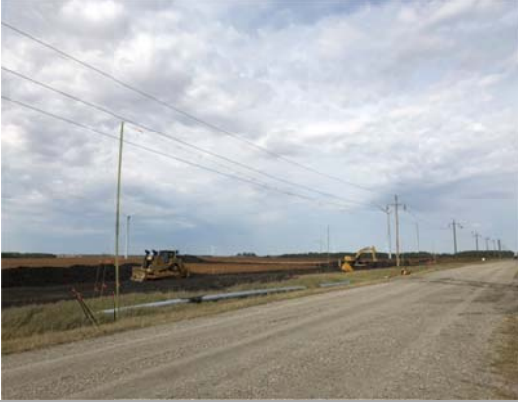
SF 48, photo facing north west, excavator moving dirt, crew preparing culvert in ditch, pump station is just on the other side of the road.

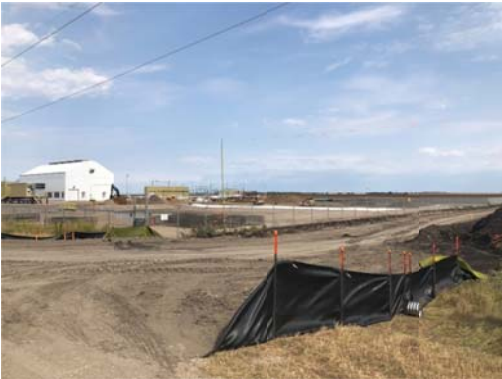
SF 48, photo facing north east, pump station.
