**MANITOBA METIS FEDERATION – MATRIX  
SOLUTIONS INC. PARTNERSHIP**

**INDIGENOUS CONSTRUCTION MONITORING**

**WEEKLY REPORT**

**OCTOBER 15<sup>TH</sup> TO OCTOBER 20<sup>TH</sup>**

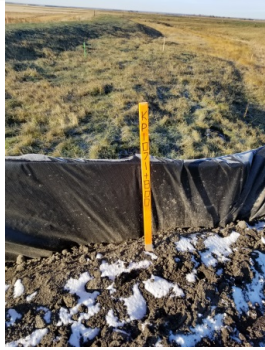
Monitor arrived at inspectors meeting at 6:00 for safety, environment, and construction meetings, monitored Rosenheim Drain Heritage site (HER-176) SSKP 1071-1071.600 and (MB-WC76) SSKP 1071.790 referring to Section 9.0 in the E.P.P. and Appendix D15. At Rosenheim drain they are setting up the horizontal direction drill to begin drilling under the creek sometime soon. Monitored Buffalo Creek 1078.780 (MB-WC1013) referring to section 9.0, Appendix D15 in the E.P.P. and details 39 and 40 in Appendix E. Monitored the bridge crossing the creek heading into site has geo tech along the railing for erosion control measures, the geo tech barrier set up was in good condition and holding strong.

Geotec barrier on Bridge  
Rosenheim Drain (MB-WC76)  
Photo taken South West

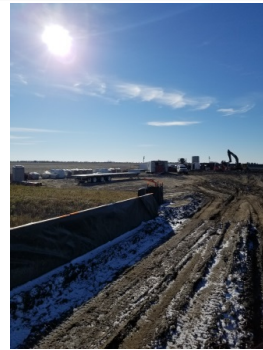
Monitored the horizontal directional drill site at Buffalo Creek, the same measures and precautions were in place as stated above as well checked for emergency response equipment such as sandbags, filter cloth (Silt fence), straw bales and shovels. Signage for buffer zones and no refuelling signs were in place and separate soil piles that had come from the berms on both sides of the creek.

Geotec barrier on bridge at  
Buffalo Creek (MB-WC1013)  
Photo taken South East

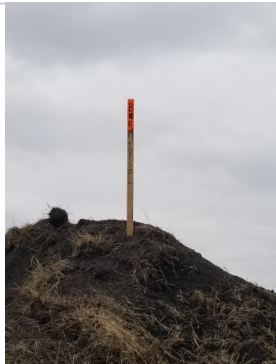
Separated Berm Soils at Rosenheim Drain  
SSKP-1071.790-(MBR-WC76)  
Photo Taken facing South West

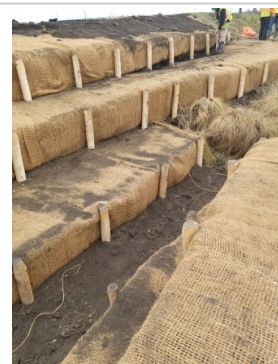
Monitored Thornhill Coulee SSKP 1035-(MBR-WC3) Referring to Section 9.0 in the E.P.P. Thornhill Coulee banks and channel had its native soils replaced and seeded with native grass mix, disturbed areas stabilized with bank wrap, posts bracing the

berms and banks to help keep their original state until its new revegetated state will hold its shape. Informed that bank wrap is composed of organic and natural materials (coconut fibre and hemp) and acts as erosion control to keep the native soils where they existed before ground disturbance took place. The channel and banks looks to be as close as feasible to their pre-construction profile.

Bank Wrap and Posts Reclamation  
at Thornhill Coulee SSKP-1035-(MBR-WC3)

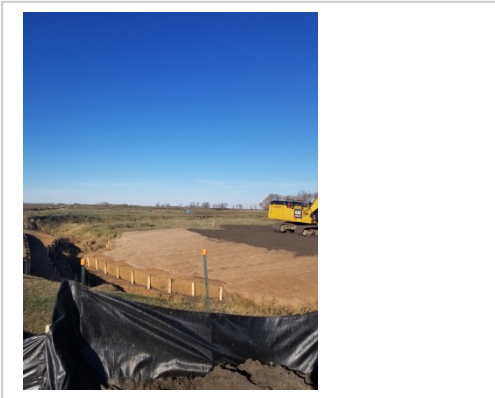
Jute matting at Thornhill Coulee  
SSKP-1035-(MBR-WC3)  
Photo taken facing North West

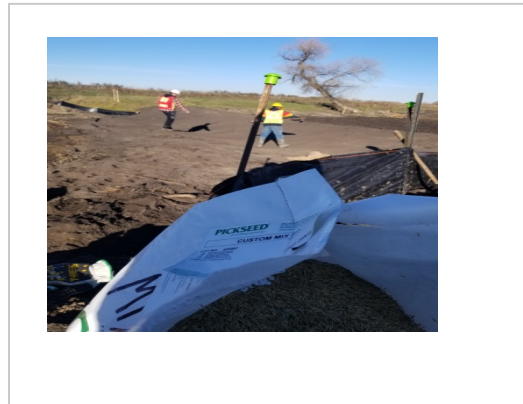
Monitored Thornhill Coulee SSKP-1035-(MBR-WC3) referring to section 9.0 in the E.P.P. In process of re-creating a berm on the south side of a stripped area, re-enforced with jute matting(bio-degradable erosion control made of coconut fibres) S/A Energy Environmentalist was on site seeding a drainage ditch with seed mix 17 to the west of the Coulee and workers were installing the Jute matting.

Environment seeding drainage and workers  
installing jute matting West of Thornhill  
Coulee  
Photo taken Facing North West

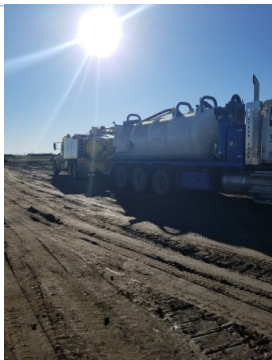
Monitored Rosenheim Drain SSKP-1079.790-(MB-WC76) referring to section 9.0 and Appendix D15 in the E.P.P. Monitored HDD at Rosenheim drain, drill not operations but saw the crew had their emergency response equipment on site and close by in the event of a mud release, this equipment consists of sandbags, filter cloth (silt fencing), T-bar posts, straw bales, light towers, shovels and have a vac truck permanent on site.

Hydro Vac and water truck and  
at Rosenheim Drain  
Photo facing East

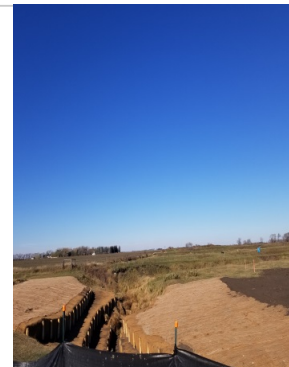
Monitored Thornhill Coulee SSKP-1035-(MBR-WC3) referring to section 9.0 in the E.P.P. Watercourse at Thornhill coulee had been reclaimed and is now awaiting revegetation, they had seeded the banks, berms and reinforced it with jute mat, hemp cloth and braced with un-treated fence posts. Monitored SSKP 1026-(Escarpmnt)

Thornhill Coulee Restoration  
Jute Matt and Hemp cloth  
Photo taken North

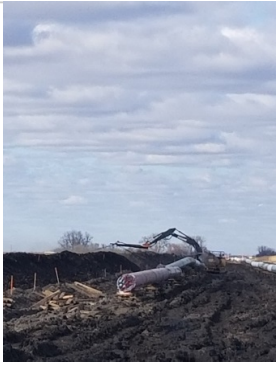
Monitored Tackifier Rd.57 heading west, referring to Appendix D17 in the E.P.P The Tackification is a stabilizing substance and or binding agent that acts as a erosion control for topsoil piles, it is meant to prevent the loss of soils due to wind erosion potential. The tackifier has met Enbridge's requirements such as: fully operational equipment, bio-degradable/non-toxic products (Beet Juice) and approved water source for applications. Monitored Wash Station at Rd.16 referring to Appendix G in the E.P.P. The wash station is in place for equipment cleaning, bleach will be used to disinfect once the equipment has been cleaned. The wash station has been designed and built according to code in Appendix E in the E.P.P.

Tackifier at Rd.57  
Photo taken facing North West

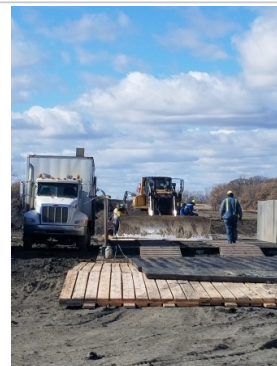
Wash Station at Rd.16  
Photo taken facing West

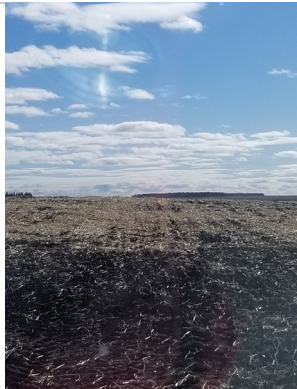
Monitor arrived at Rd.2 and viewed the work of the straw crimper and restoration of the R.O.W. Day ended early due to personal reasons.

Straw Crimper results at RD.4  
Photo taken facing South East
