**MANITOBA METIS FEDERATION – MATRIX  
SOLUTIONS INC. PARTNERSHIP**

**INDIGENOUS CONSTRUCTION MONITORING**

**WEEKLY REPORT**

**SPREAD 9**

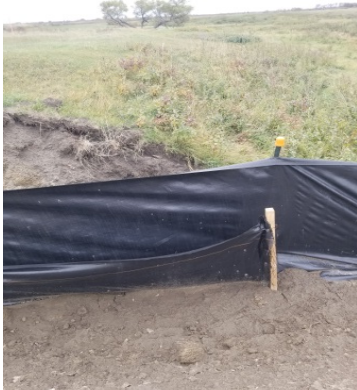
Silt Fencing installed at Thornhill Coulee  
Photo taken facing North

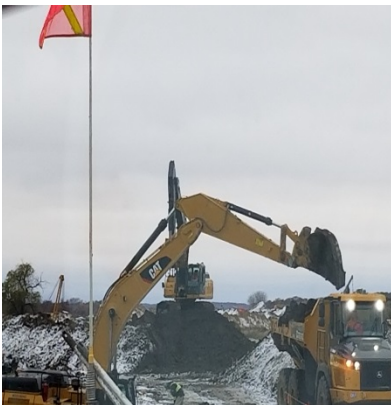
Excavator loading rock truck with soils from  
Thornhill Coulee to be kept separate  
Photo taken West

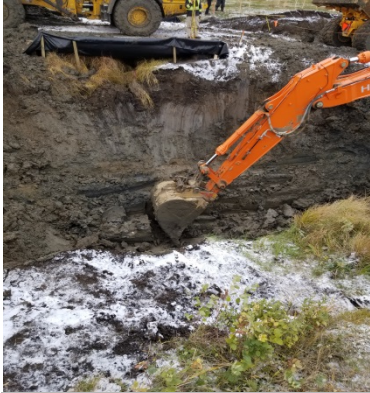
Excavator Ditching to 5.2 meters beneath the channel at Thornhill Coulee.  
Photo taken facing North East

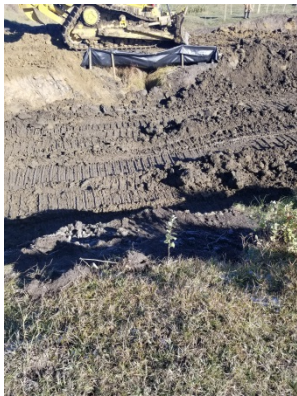
Backfill progress at Thornhill Coulee  
SSKP 1035.079 (MBR-WC3)  
Photo taken facing North

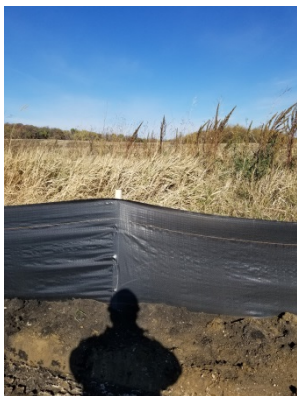
Erosion control (Silt fence) at SSKP 1014  
(MB-189) Photo taken facing North

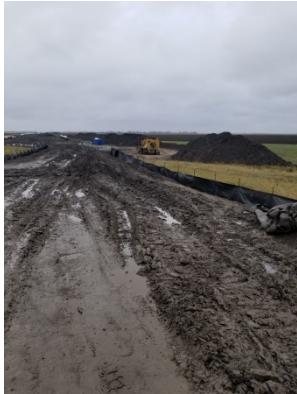
Access to 1071 bad conditions  
Photo taken facing East

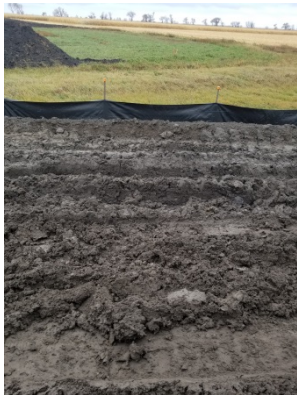
Access to 1071 ROW conditions  
Photo taken facing South
