**SWAN LAKE FIRST NATION – MATRIX SOLUTIONS
INC. PARTNERSHIP**

INDIGENOUS CONSTRUCTION MONITORING

WEEKLY REPORT

SPREAD 9

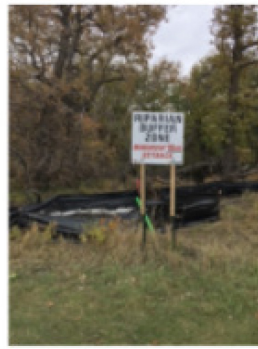
kp 1041+650 sweep the buffer zone
picture was taken south west

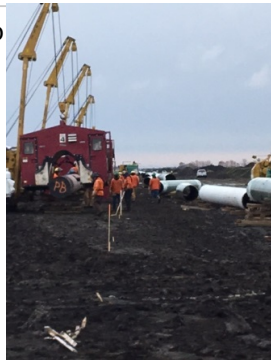
kpp1071+950 welding crew
picture was taking facing east

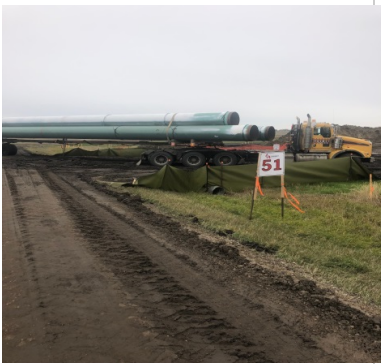
Shoo-fly 51 crew placing pipe for welding
looking
north

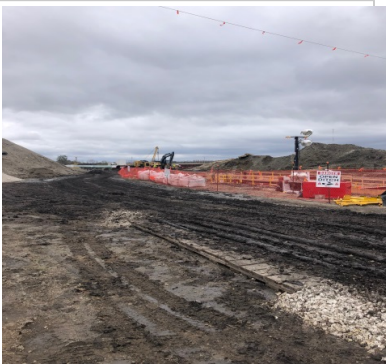
SSKP 1047.5 looking south pipe crossing hwy 3

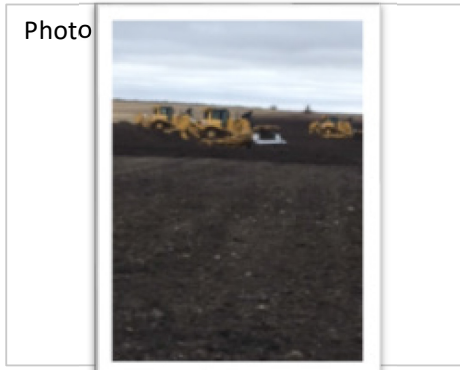
General: Safety meeting this morning Conducted by senior monitor. Areas suggested to be monitored are as follows: SSKP 1000-SSKP 1026- SSKP 1018 -Mary Jane-SSKP,1000.800-MB-WC58, Morning journey on to Mary Jane area. Found that the kick off construction area is back filled and graded. Hill escarpment SSKP 1026.400 the pipeline in this area has been buried with grey clay. The top soil has to be re-applied. While here also monitored hill area for signs of stones and bones. SSKP 1018.900-MB-192 wetland complex repairman buffer zone in good condition and standing. Today was given direction by our senior monitor to travel to kpp 1026+100 and did a sweep checking the ROW soils and conditions of all top soil, subsoil and clay were in good condition as we swept up to 1027+400 ROW for the morning. We had travelled to 1018+600 to check on the Riparian Buffer Zone as we check out geo tech around the area and check out the burlap that was put in placed at 1027+475 as picture shown it was taken facing north east. We had travelled to1009+500 as the 3 dozers were covering the final top soil at 1009+475 as in the picture shown taken facing west.

KKP 1009+475 3 DOZERS PICTURE WAS
TAKEN
FACING WEST

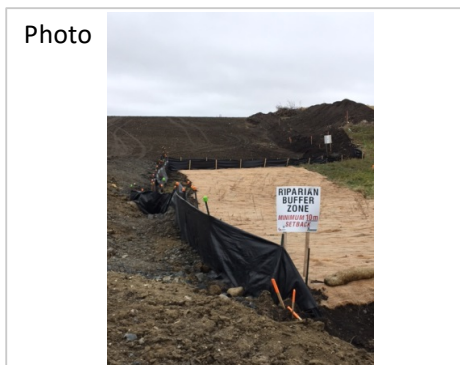
RIPARIAN BUFFER ZONE AT 1018+675
PICTURE TAKEN FACING NORTH EAST

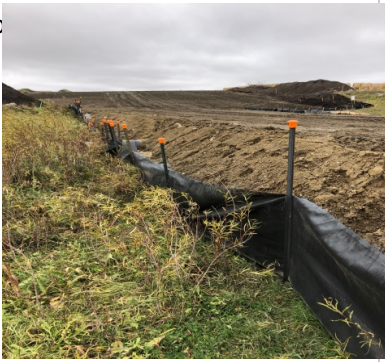
SSKP 1018 riparian buffer zone good condition

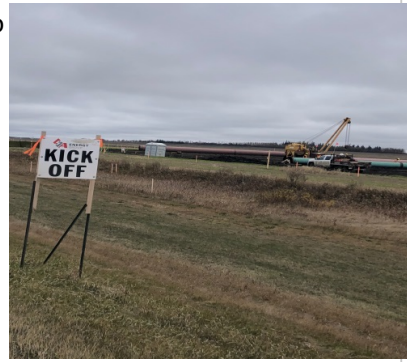
kick off area ready for revegetation

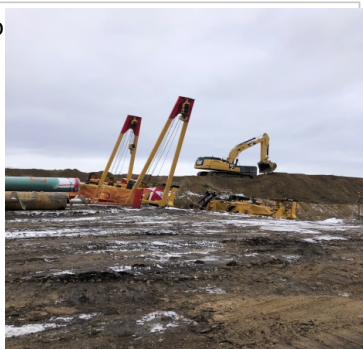
Pipes are drawn through at SSKP 1047.40
looking East

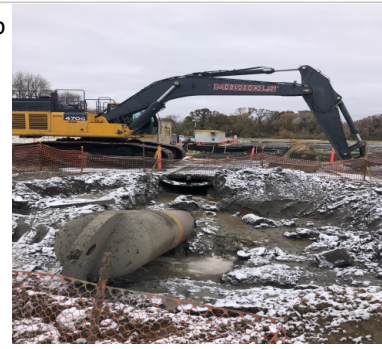
Pipe pushed on through under Dead Horse
Creek looking North

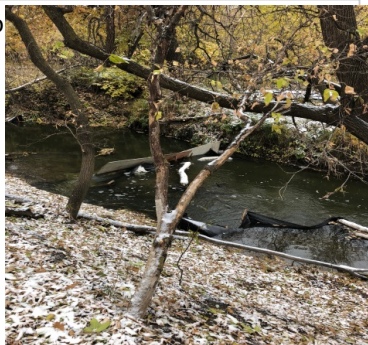
Photo of water flowing at Dead Horse Creek
looking North

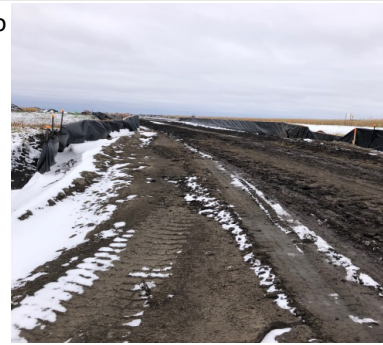
SSKP 1078.78 moisture barriers holding fast
looking North

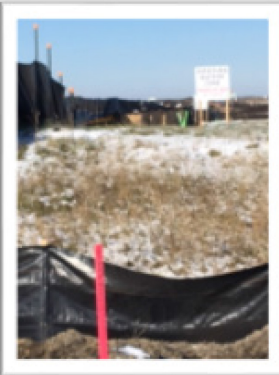
kp1071-49-1071.71-her-176
did a sweep
Photo taken facing west

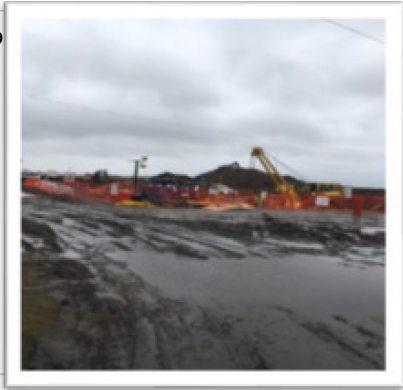
kp 1048.99-WC-1004
Monitored till weather got to
bad picture was taken facing
southwest

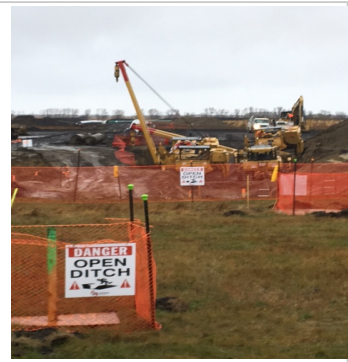
kp 1047.860-HWY 3 as they shut down
the picture was taken facing north

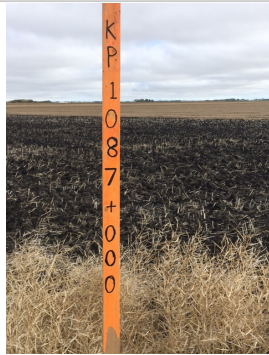
travel to monitor the crew on
the line kp1087+000
