**SWAN LAKE FIRST NATION – MATRIX SOLUTIONS
INC. PARTNERSHIP**

INDIGENOUS CONSTRUCTION MONITORING

WEEKLY REPORT

SPREAD 9

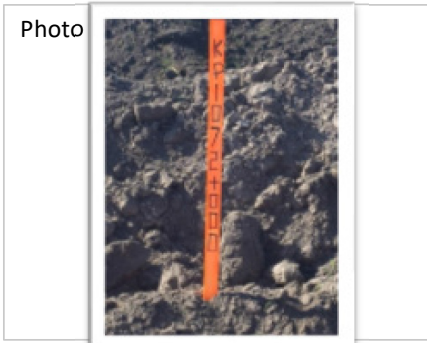
kp 1027+000 picture was taken face south

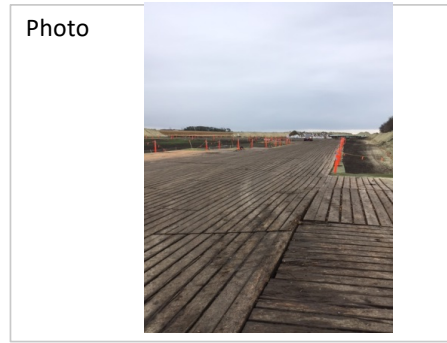
Dead horse creek 1041.790-mb-we-1002 picture was taken facing south as we did the clean up sweep

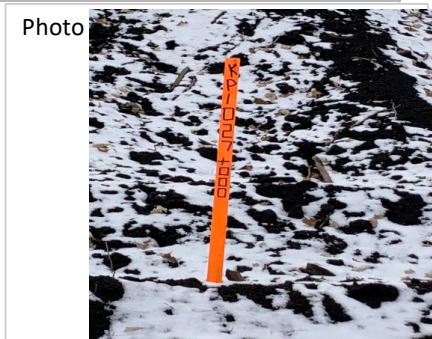
Escarpment SSKP 1027 facing south

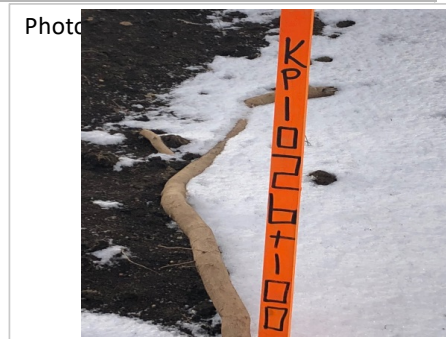
Escarpment SSKP 1027 south

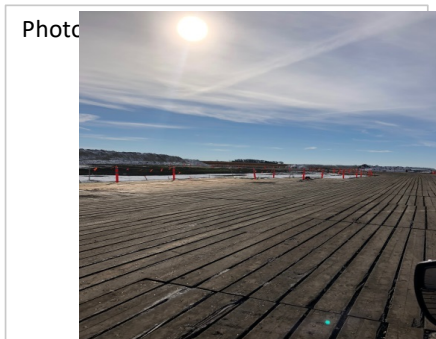
Dead horse creek SSKP 1041.44 facing north

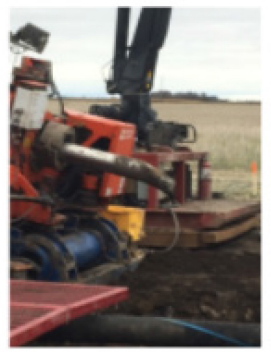
GRASS DANCERS1071+700 DITCH
WITCH DRILL THE PICTURE WAS TAKEN
FACING NORTH EAST

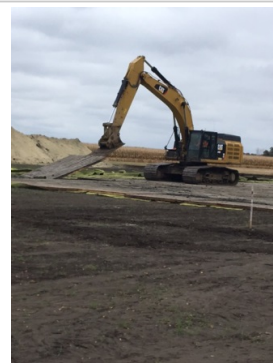
DEAD HORSE CREEK 1041.03-1041.44
(HER-175 AS THE PICTURE WAS TAKEN
FACING SOUTH EAST

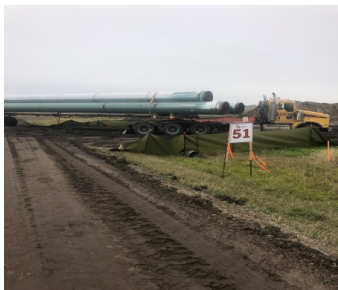
rd. 51 looking north

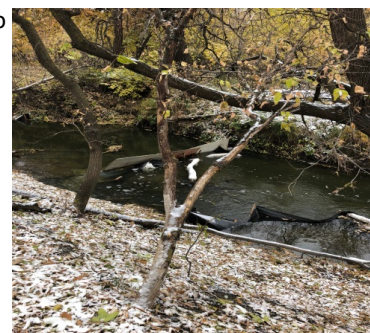
photo of Dead horse Creek looking south

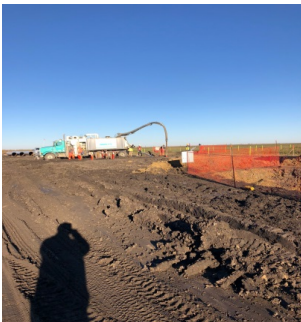
KP 1071 hydro vac crew facing west

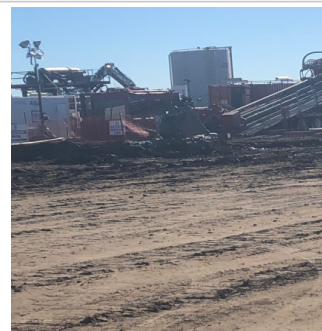
SSKP 1078.78 looking east

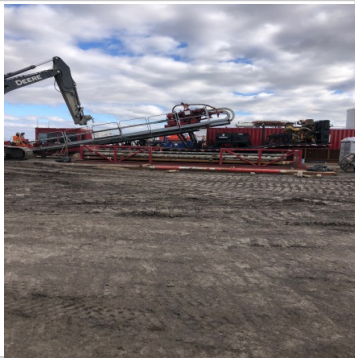
SSKP 1078 looking east

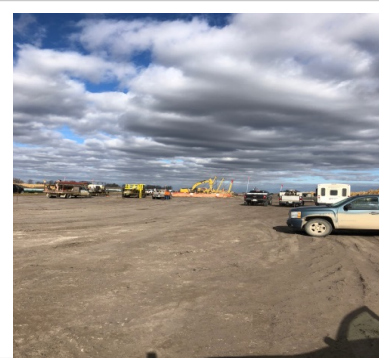
SSKP 1078 looking North

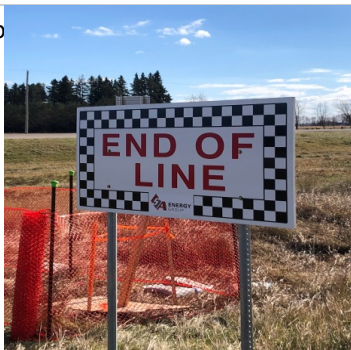
Gretna Mb End of the line looking south

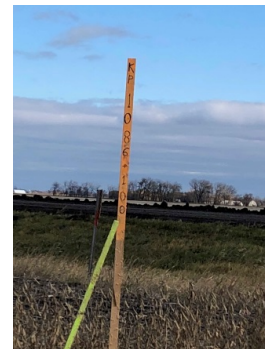
Photo of SSKP 1091 Looking north

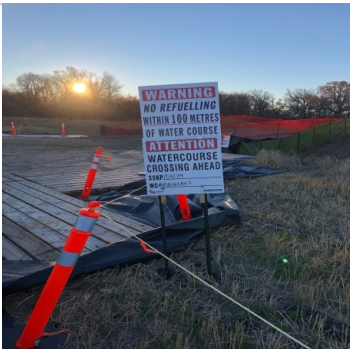
SSKP 1041 looking east

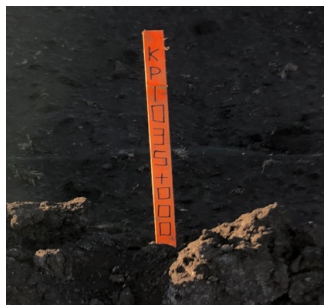
SSKP 1035 looking south

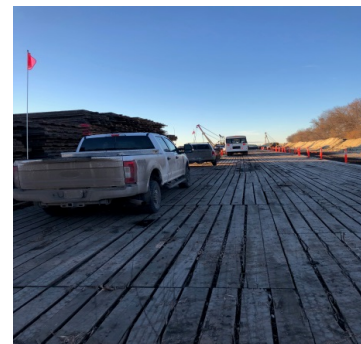
photo of Dead horse Creek looking south
