**SWAN LAKE FIRST NATION – MATRIX SOLUTIONS
INC. PARTNERSHIP**

INDIGENOUS CONSTRUCTION MONITORING

WEEKLY REPORT

SPREAD 9

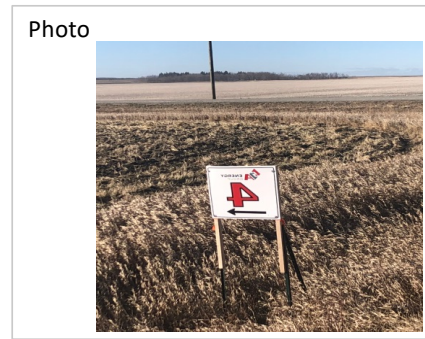
SSKP 1005 reclaimed fields

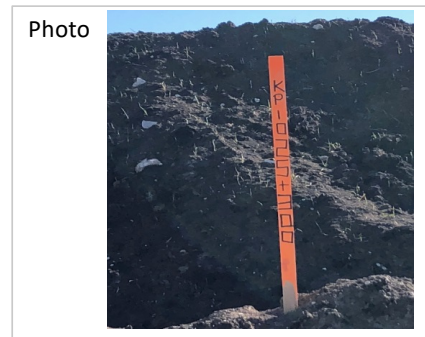
as close to the sskp as machines would let me pass

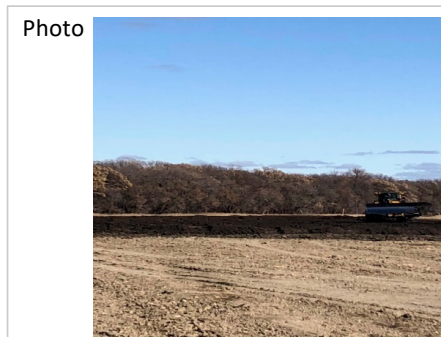
SSKP 1027 machines leveling top soil

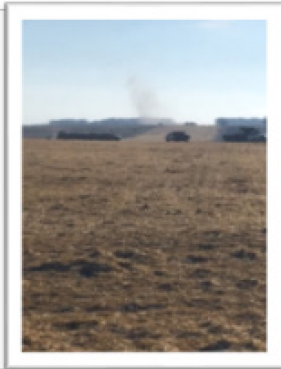
Rd6 1008+061
picture was taken facing
east

Today was given direction by our senior monitor to travel to straw crimping and seeding from RD 1008+061 heading east as I walk in 300 meters and did a sweep of the area it was in good shape as the picture is shown first part of the morning. Travelled to DEAD HORSE CREEK and monitored as they were taking the bridge down at kp 1041-79-wc#Mb-wc 1002 as shown in the picture below. Travel to 1054+000 as the tie-in and welding crews were there and spent the afternoon there monitoring and I did a sweep up to kp 1054+ 300 as they were set up along the area mentioned. Finished up the for the afternoon came back to office to do our reports and finished up the day.

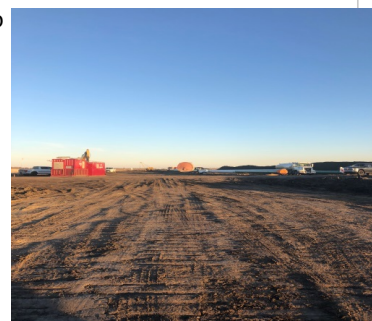
SSKP 1071 equipment moving out

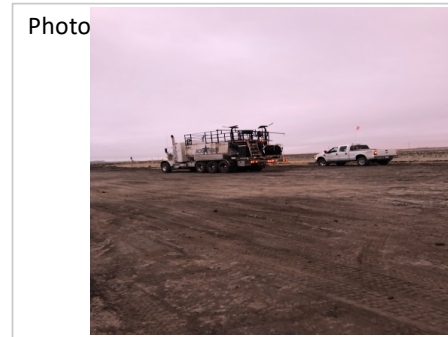
Tackifier at SSKP 1071

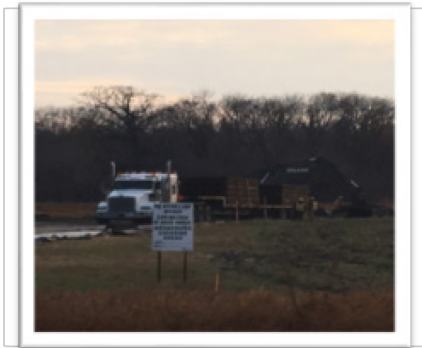
Dead horse creek sskp 1041.790-mb-wc-1002
picture was taken facing east of the road to much traffic
