**SWAN LAKE FIRST NATION – MATRIX SOLUTIONS
INC. PARTNERSHIP**

INDIGENOUS CONSTRUCTION MONITORING

WEEKLY REPORT

SPREAD 9

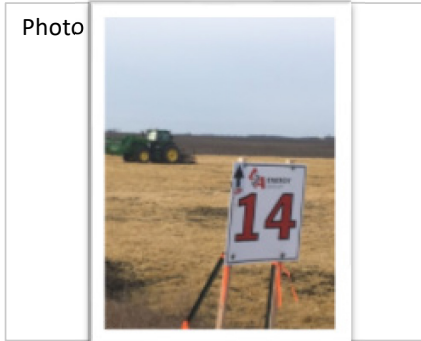
Given direction by our senior monitor sskp 1018+750 heading east as they were straw crimping and spreading it around, we did a sweep to check on it if they had meet the target depth of 5cm and stand vertically a minimum of 5-20cm out of the ground as a environment monitor thing were done properly and in good shape as the picture is shown. SSKP 1070 Commencing bore and welding and at SSKP 1071.49-1071.71 (HER-176) excavating. SSKP 1057.77 Allot of activities. Equipment and men working. Installing tie ins here at Hesper drainage. Dead Horse Creek 1041.03-1041.44 (HER-175) Monitored area all quiet. SSKP 1026-1027 quiet. SSKP 1025 Support Testco. prepping test heads at road #17. SSKP 1037.85 Rework and prepping for trucking new water source for mainline test. SSKP 1018.75 Reclamation site energy. Straw crimping Heading east. installing warning signs and marker posts. Returned to Morden field office to compile daily report.

SSKP 1018+750 STRAW
CRIMPING picture was taken
facing west off Rd 14

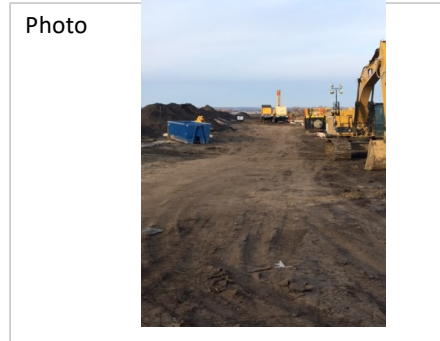
SSKP1025+000 PREPPING TEST HEAD
picture was taken facing west

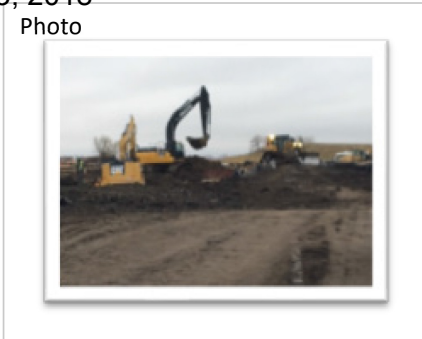
Description & Location:
RESTORING MB-WC 1005
(1057+180)
PICTURE WAS THAKEN FACING
SOUTH
