**SWAN LAKE FIRST NATION – MATRIX SOLUTIONS
INC. PARTNERSHIP**

INDIGENOUS CONSTRUCTION MONITORING

WEEKLY REPORT

SPREAD 9

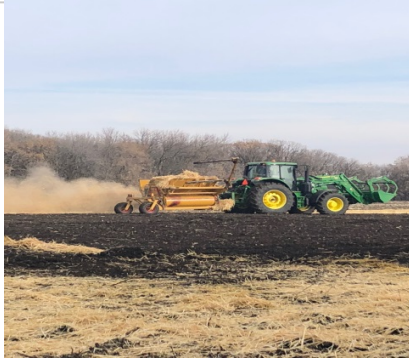
KP 1026 Crimping crew Bail buster looking north

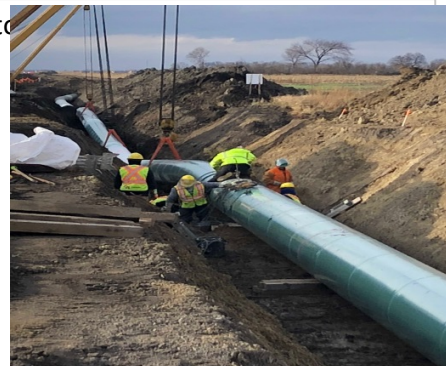
tie in crew welding SSKP 1076

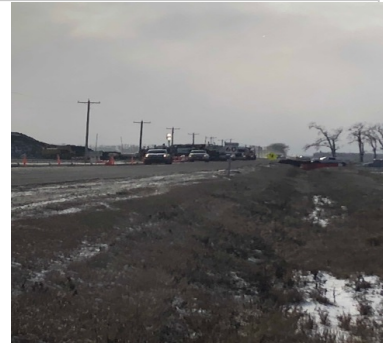
Water trucks at Roar #54

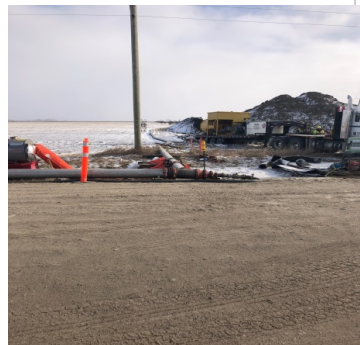
Water pressure testing at #54
