**SWAN LAKE FIRST NATION – MATRIX SOLUTIONS  
INC. PARTNERSHIP**

**INDIGENOUS CONSTRUCTION MONITORING**

**WEEKLY REPORT**

**SPREAD 9**

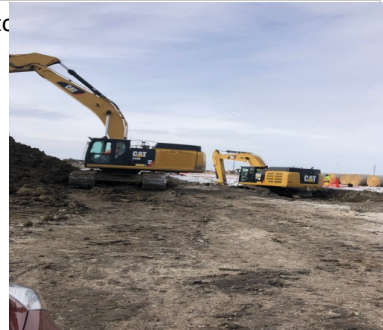
excavators SSKP 1096.200 facing west

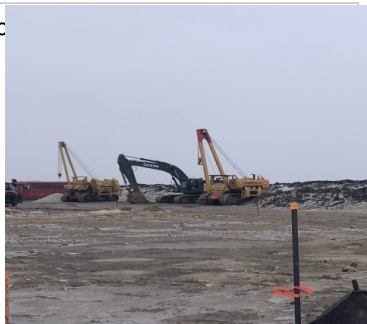
SSKP 1073-74-75 men and equipment  
working facing East

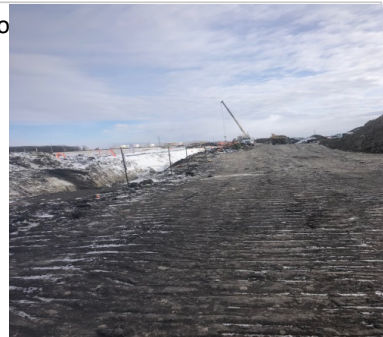
excavators SSKP 1058.078 facing east

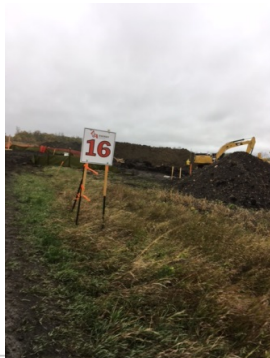
Road 16 excavator digging

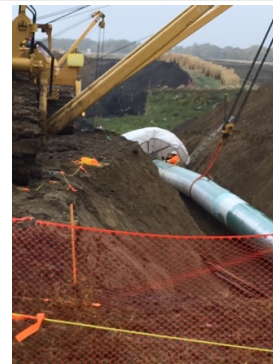
EAST SIDE ROAD 16 LOWERING PIPE

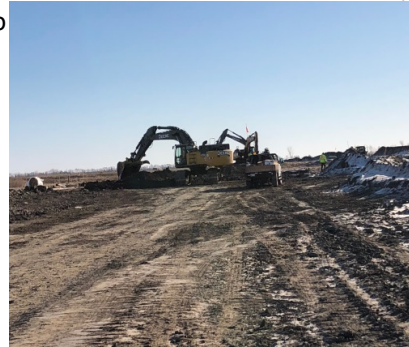
excavators SSKP 1071 facing east
