**SWAN LAKE FIRST NATION – MATRIX SOLUTIONS
INC. PARTNERSHIP**

INDIGENOUS CONSTRUCTION MONITORING

WEEKLY REPORT

SPREAD 9

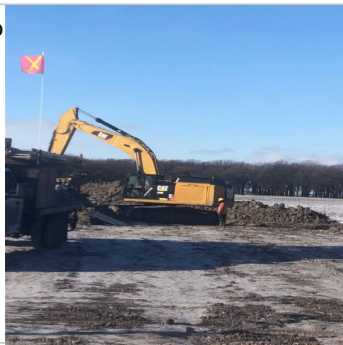
SSKP 1095 looking east

SKP 1095.024 Here at the end of the line areas are extremely congested with personal and equipment as crews install tie-ins.

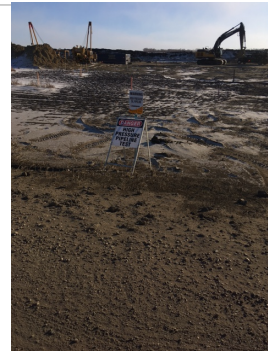
sskp 1058+178 high pressure pipeline test picture was taken facing east

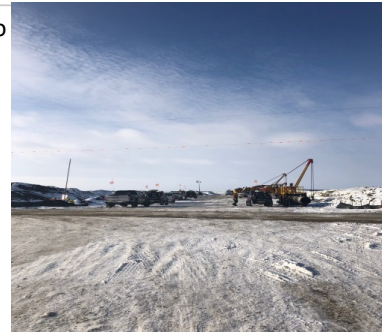
excavators SSKP 1025 facing west

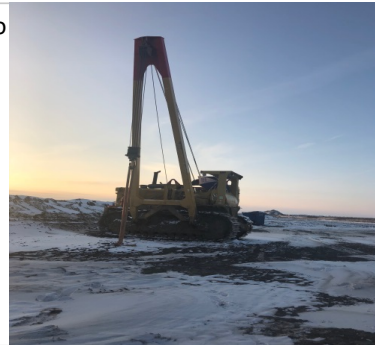
SSKP 1071 facing west

SSKP 1071.49-1071.71 (HER-176) Hemp mats along with silt fences laid out here at this KP in an attempt to help with wind erosion and further on in the spring season in 2019. Bridge here was removed and limited.

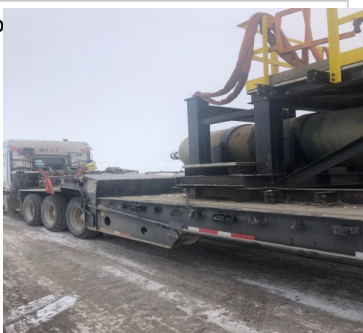
SSKP 1084.700 facing west

SSKP 1084.600 Multiple crews here preparing for test head here. Spoke to head safety welder. Couldn't sign on to safety sheet as area was extremely busy. Drove R.O.W. SSKP 1070-SSKP 1087. Returned to Morden field office to complete daily report.

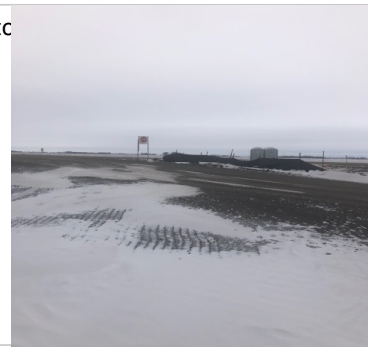
SSKP 1087 facing west

Today was given direction by our senior monitor to travel to Rd 47-1075.089 as we travel to check on the removing of the bridges, ramps and the road approaches as they were heading east. We had travel the ROW checking on the cleaning crews that were still cleaning the ROW from sskp 1070+000-1085+100 as we drove along watching for garbage/debris and any fallen stakes as well. Travelling to sskp 1058+202 to 1084+488 as they were doing assisting Testco with transfer of water the sections as they were getting the testing head ready. SSKP 1025 Monitored activity here at KP. Crew here are coating the tie-ins and completing section welds and are moving as the UT and X-Ray crews are releasing them to do so. Area is quite congested with personal and equipment also on other side of the road excavator digging for potential tie-in. SSKP 1087.606 Monitored area. Waited for scheduled approach installation and found there to be no activity.

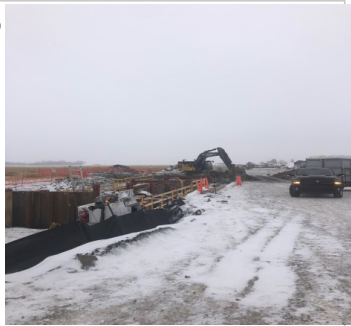
SSKP 1096 facing east

SSKP 1096.210-1096.330 Monitored activity here at KP. Restoring MB-WC82/82a. Crew here are back filling and the tie-ins and completing section bores 2. Area is quite congested with personal and equipment also on other side of the road excavator digging for potential tie-in. Crews are cleaning up and working on berm installs.

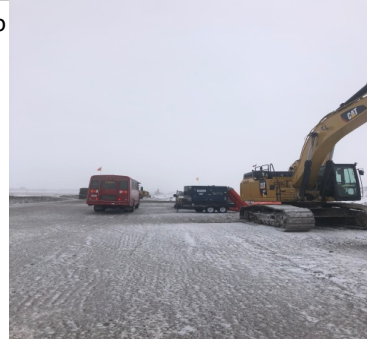
road 58-59 facing east

SSKP 1059 Monitored area. Waited for scheduled approach installation. Men and equipment working here turning R.O.W. back to the condition ditches were in prior to pipeline installation. Much activity happening here from road 58-road 59. Some areas were impassable as unloading of heavy equipment and bridge timer was being work on whole R.O.W. SSKP 1049 Crews here are returning R.O.W. back to preconditions by removing bridges ramps and approaches back to original conditions. Drove R.O.W. SSKP 1070-SSKP 1087 in search of garbage. Returned to Morden field office to complete daily report.

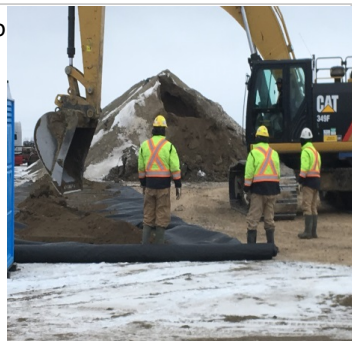
Southside of Hwy#3 stock piling facing
north
