**SWAN LAKE FIRST NATION – MATRIX SOLUTIONS
INC. PARTNERSHIP**

INDIGENOUS CONSTRUCTION MONITORING

WEEKLY REPORT

SPREAD 9

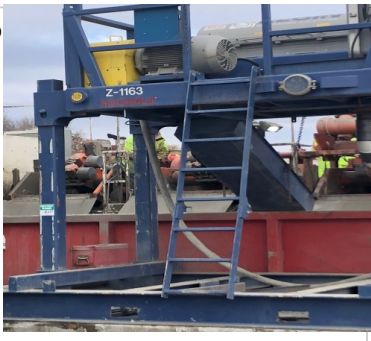
photo Dead Horse Creek crew cleaning
machine SSKP 26 looking north

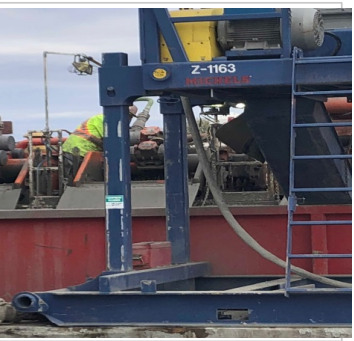
Photo SSKP 1026 crew working at dead
horse
creek

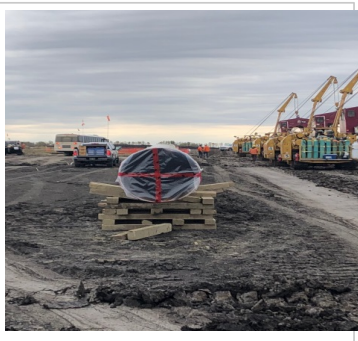
Photo of side booms SSKP 1057

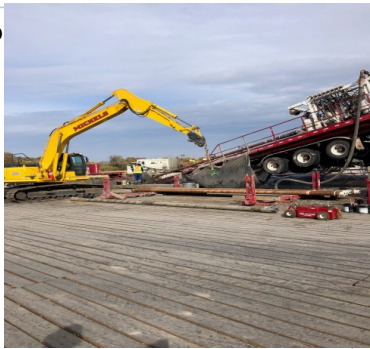
photo shoo-fly 26 pipe crossing creek

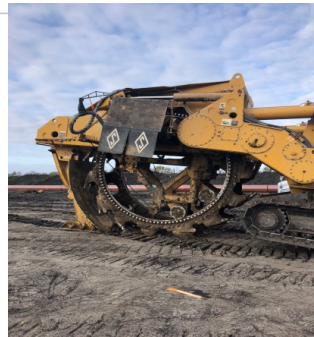
Ditcher crew cleaning machine shoo fly 27

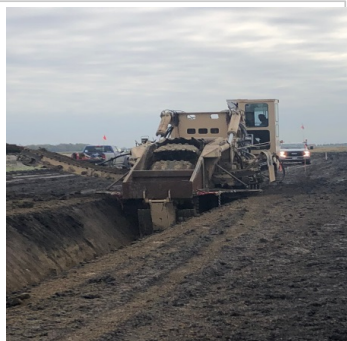
Photo shoo-fly 27 crew ditching trench

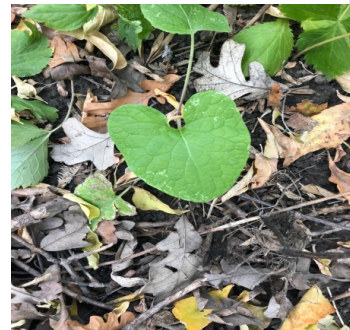
Photo of medicinal plant at dead horse creek

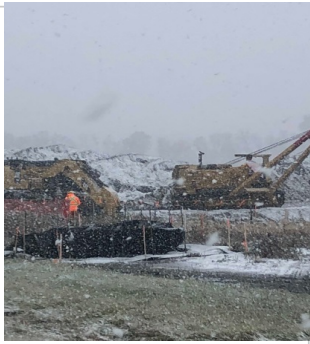
photo SSKP 1063 welding pushing crew

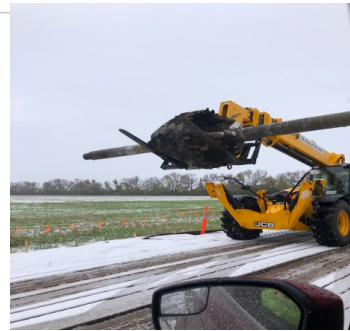
horizontal diagonal drill crew machine
SSKP 1047 bringing drill head back

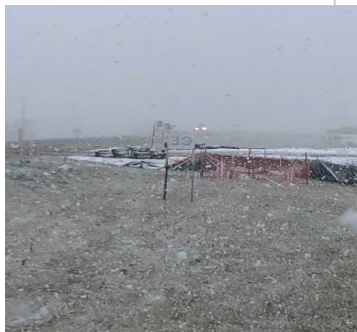
Photo SSKP 1063 welding crew working in
thick
snowfall

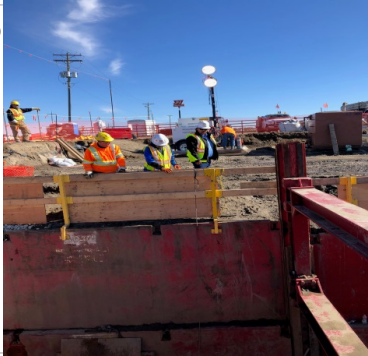
photo SSKP 1047 track bore pushing crew

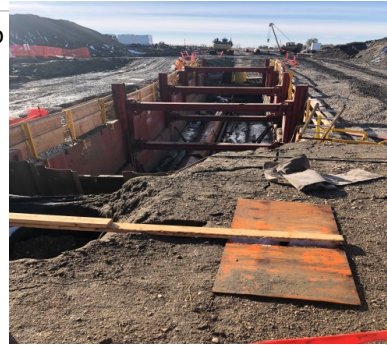
track bore crew machine SSKP 1047
looking South

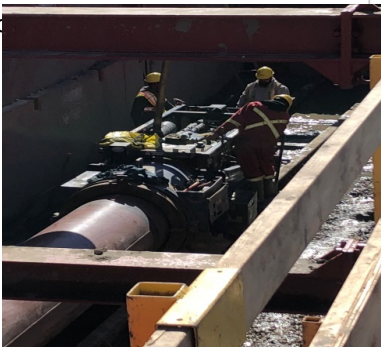
Photo SSKP 1047 track bore driving pipe
under
hwy 3

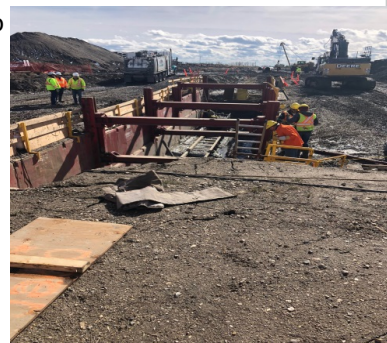
Photo SSKP 1047 crew pushing pipe under
hwy 3

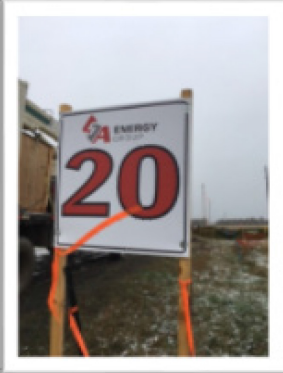
starting point road 20
picture was taken facing
south

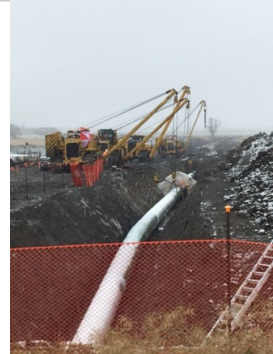
lowering pipe and connecting at kp
1030+900

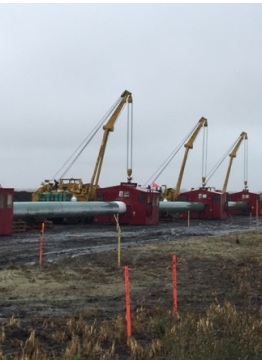
travel to 1071+000 as the crew shut
down do to the weather wet snow
picture was taking south west

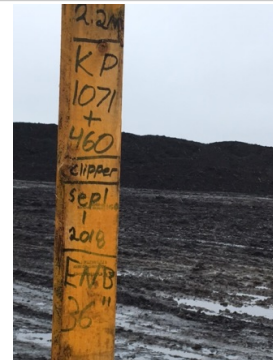
picture of 1071+460 as picture facing
south

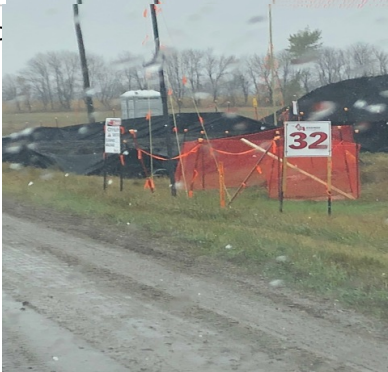
photo SSKP 1026 pipe crossing creek

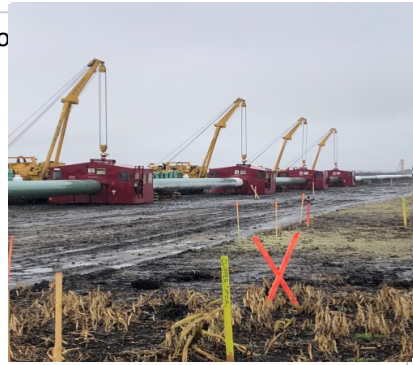
machines @ SSKP 1071

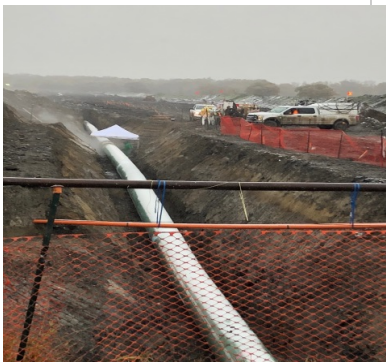
Sand blasting @ Shoo-fly 20

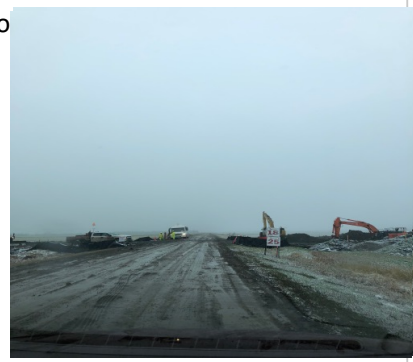
Photo of men and equipment working at SSKP 1026

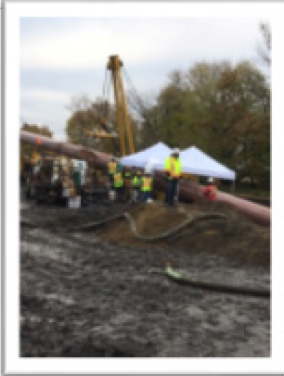
kp 1041+750 bore support at dead horse .

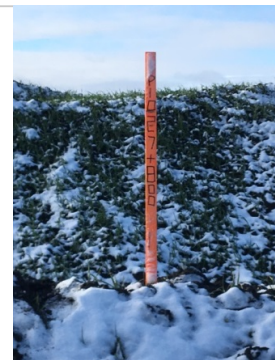
1027+800 side boom, rock truck, dozer.

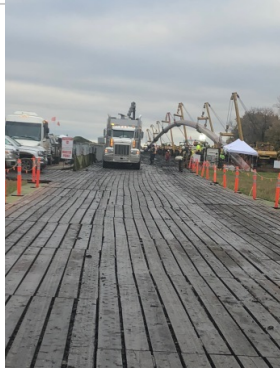
photo looking north at dead horse creek

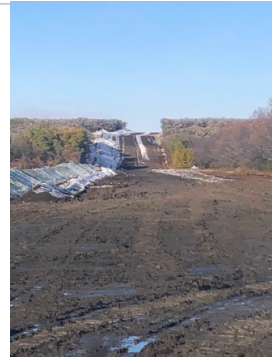
hill escarpment SSKP 1026 looking west

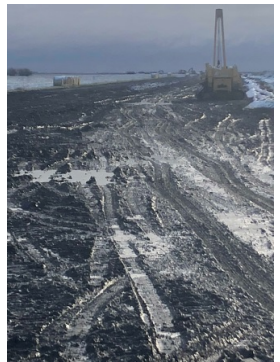
photo of hill escarpment looking east
